HOME INSPECTION SERVICES

221B Baker Street, London
Thursday, September 2nd 2021

John Smith
Home Inspector
Home Inspection Services
☎ **123-456-7890**
✉ **john@demoinspections.com**
🌐 **demoinspections.com**

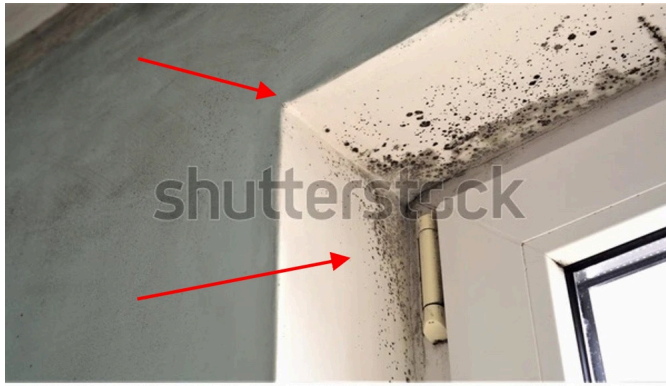
Cracks on ceiling and wall

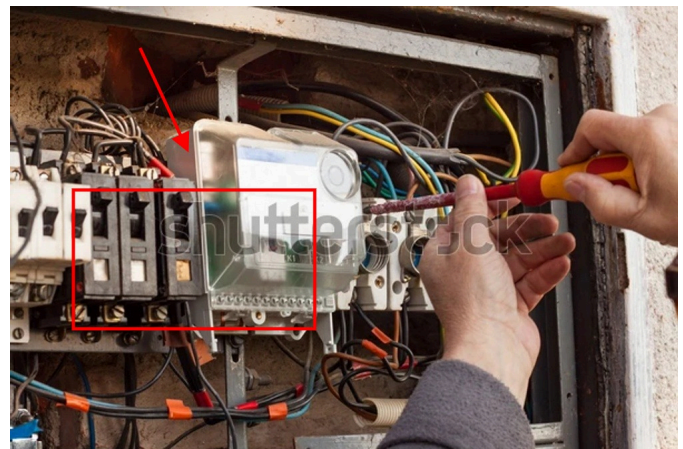
Electric panel needs proper labelling

3. Electric panel should be properly labelled after doing necessary upgrades/repairs/corrective measures due to deficiencies noticed such like:
 - a. Non working and Non-GFCI receptacles at wet locations

<u>Main Panel:</u>	<input checked="" type="checkbox"/> Proper labelling of electric panel recommended
<u>Receptacles / switches:</u>	<input checked="" type="checkbox"/> Safety covers plates missing
	<input checked="" type="checkbox"/> Loose on walls
<u>Installation of A.F.C.I's is recommended for:</u>	<input checked="" type="checkbox"/> All bedrooms
<u>Installation of G.F.C.I's is recommended at locations:</u>	<input checked="" type="checkbox"/> Bathrooms
	<input checked="" type="checkbox"/> Exterior outlets (including carports)
	<input checked="" type="checkbox"/> Kitchen outlets near sinks and tubs
	<input checked="" type="checkbox"/> Saunas
	<input checked="" type="checkbox"/> Garages
	<input checked="" type="checkbox"/> Whirlpool tubs
	<input checked="" type="checkbox"/> Swimming pools and spas
