STM32F405/407xx and STM32F415/417xx device errata

This document applies to the part numbers of STM32F405/407xx and STM32F415/417xx devices and the device variants as stated in this page.

It gives a summary and a description of the device errata, with respect to the device datasheet and reference manual RM0090.

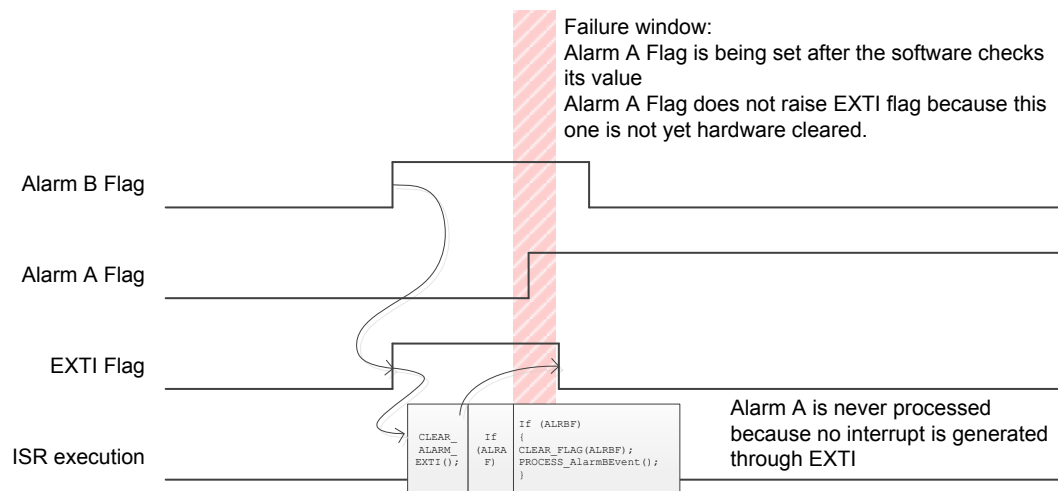
Figure 1. Masked RTC interrupt

The following code example and figure illustrate the failure mechanism: The Alarm A event is lost (fails to generate interrupt) as it occurs in the failure window, that is, after checking the Alarm A event flag but before the effective clear of the EXTI interrupt flag by hardware. The effective clear of the EXTI interrupt flag is delayed with respect to the software instruction to clear it.

```
void RTC_Alarm_IRQHandler(void)
{
    CLEAR_ALARM_EXTI(); /* Clear the EXTI line flag for RTC alarms*/
    If(ALRAF) /* Check if Alarm A triggered ISR */
    {
        CLEAR_FLAG(ALRAF); /* Clear the Alarm A interrupt pending bit */
        PROCESS_AlarmAEvent(); /* Process Alarm A event */
    }
    If(ALRBF) /* Check if Alarm B triggered ISR */
    {
        CLEAR_FLAG(ALRBF); /* Clear the Alarm B interrupt pending bit */
        PROCESS_AlarmBEvent(); /* Process Alarm B event */
    }
}
```

Workaround
