From: Roadwall, Elizabeth
Sent: Tuesday, December 19, 2023 11:57 AM
To: Bunk-Jensen, Keenan; 5mm Lap Top Level
Cc: RSM-DMP1 Energy
Subject: EB211-1510778 Yield Breakdown

Yield Breakdown	
Model:	EB211
Shop Order:	1510778
P/N:	101476433
Lot Size:	280
Type:	PRD
Date Completed:

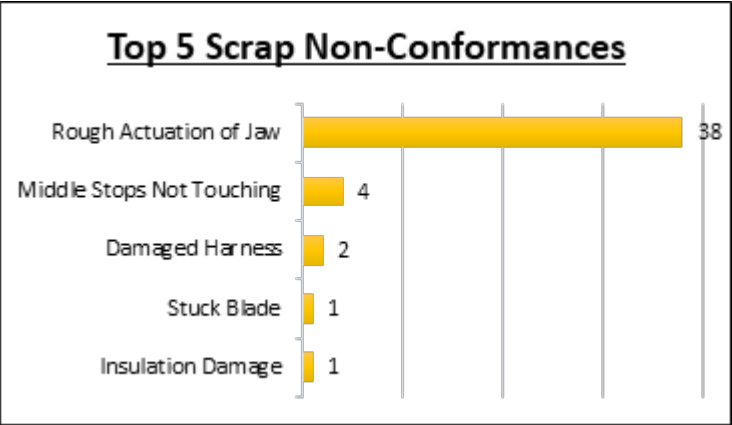
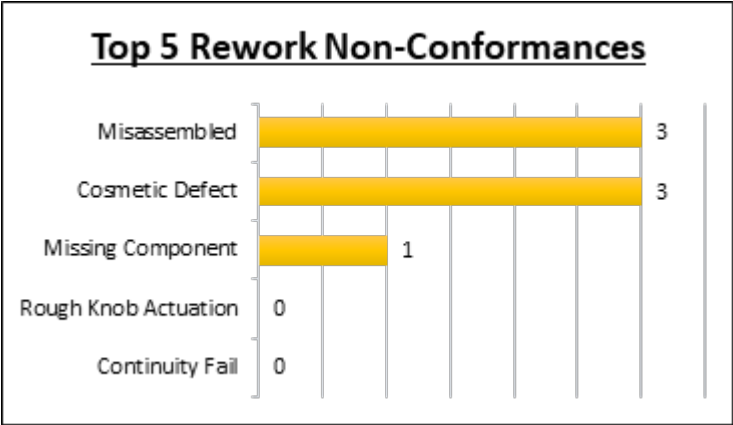
Results		
Accepted:	284	86.1%
Scrap:	46	13.9%
Rework:	7	2.1%

Scrap Non-Conformance	Initial Build	Total	Scrap %
Rough Actuation of Jaw	38	38	11.3%
Middle Stops Not Touching	4	4	1.2%
Damaged Harness	2	2	0.6%
Stuck Blade	1	1	0.3%
Insulation Damage	1	1	0.3%
Blade Activation		0	0.0%
0.003 Jaw Gap Fail		0	0.0%
0.006 Jaw Gap Fail		0	0.0%
Front Stops Not Touching		0	0.0%
Front and Middle Stops Not Touching		0	0.0%
Blade Does not Pass Front Stop		0	0.0%
Jaw Short		0	0.0%
Incorrect Insulation Orientation		0	0.0%
Missing Jaw Crimp		0	0.0%
Blade Pusher Coming Out		0	0.0%
Device Key Not Reading Device		0	0.0%
Incorrect/Missing Weld		0	0.0%
Cosmetic Defect		0	0.0%
Contamination		0	0.0%
Engineering Sample		0	0.0%

Rework Non-Conformance	Initial	Total	Rework %
Misassembled	3	3	0.9%
Cosmetic Defect	3	3	0.9%
Missing Component	1	1	0.3%
Rough Knob Actuation		0	0.0%
Continuity Fail		0	0.0%
High Jaw Force		0	0.0%
Low Jaw Force		0	0.0%
Return Spring Pop Out		0	0.0%
Fuse Switch		0	0.0%
Blade Lever Stop Pop Out		0	0.0%
Scratched Logo		0	0.0%
Particulate Matter		0	0.0%
Engineering Sample		0	0.0%
Total	7	7	2.1%
