# Room Inspection Report

Generated: 8 January 2026 at 11:24

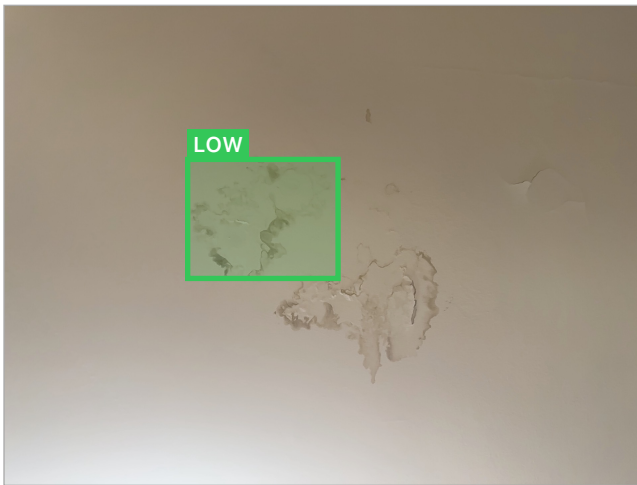
### 1. Water Damage - Floor

Size: 13.8 cm × 10.9 cm (150 cm<sup>2</sup>)

Significant brownish water stain with signs of peeling paint and potential mold growth in the left portion of the affected area.

*Recommendation: Investigate and repair the source of the water leak (roof or plumbing) before repairing the ceiling. Once dry, remove damaged material and repaint.*

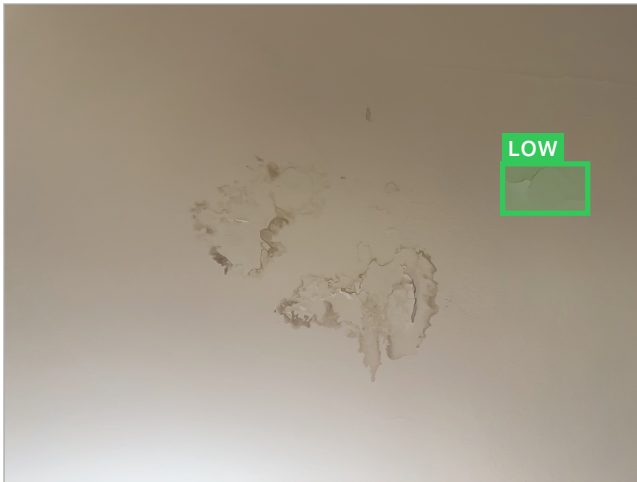
### 2. Peeling - Floor

Size: 10.3 cm × 6.0 cm (61.6 cm<sup>2</sup>)

Section of paint peeling away from the surface, likely caused by moisture penetration.

*Recommendation: Remove peeling paint, ensure the surface is dry, and apply a stain-blocking primer before repainting.*

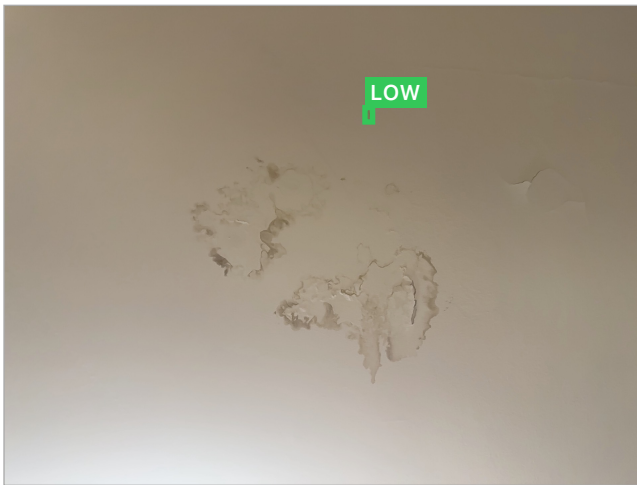
### 3. Stain - Floor

Size: 8.2 mm × 1.5 cm (1.2 cm<sup>2</sup>)

Small, isolated water spot located above the main damaged area.

*Recommendation: Monitor for further growth to determine if there is an active pinpoint leak.*
