Room Inspection Report

Generated: 7 January 2026 at 9:58 AM

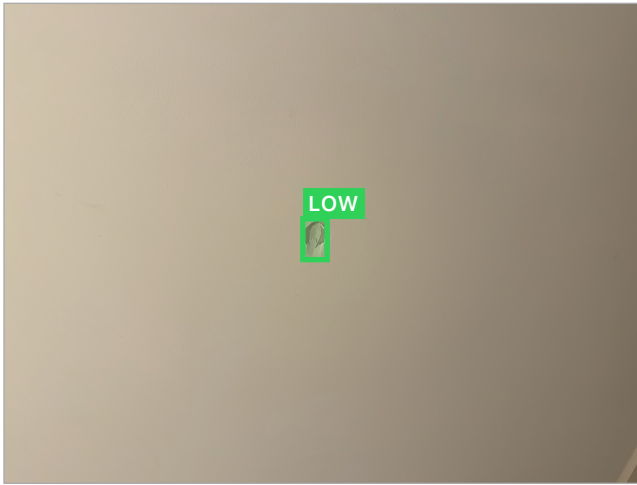
1. Hole - Wall

LOW PRIORITY

Size: 3.0 cm × 5.0 cm (14.9 cm²)

A small hole or indentation in the wall with chipped edges.

Recommendation: Patch with spackle or joint compound, sand smooth, and repaint.
