Job #14-358

API 653 INSPECTION

TANK #52

Location: Kerrobert Terminal

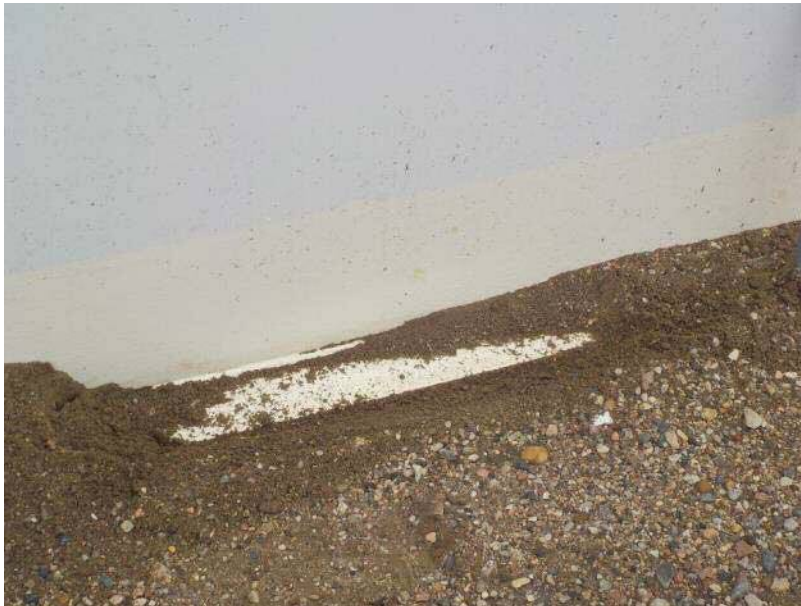
PHOTOGRAPH 2 SHELL TO BOTTOM WELD

An external visual inspection was performed on the shell to bottom weld, soil debris was present on a majority of the BPP, where soil was removed no corrosion was observed.

No indications of corrosion or weld defect were observed as a result.

Debris on the BPP should be removed to prevent corrosion as a result of moisture being held against the tank.

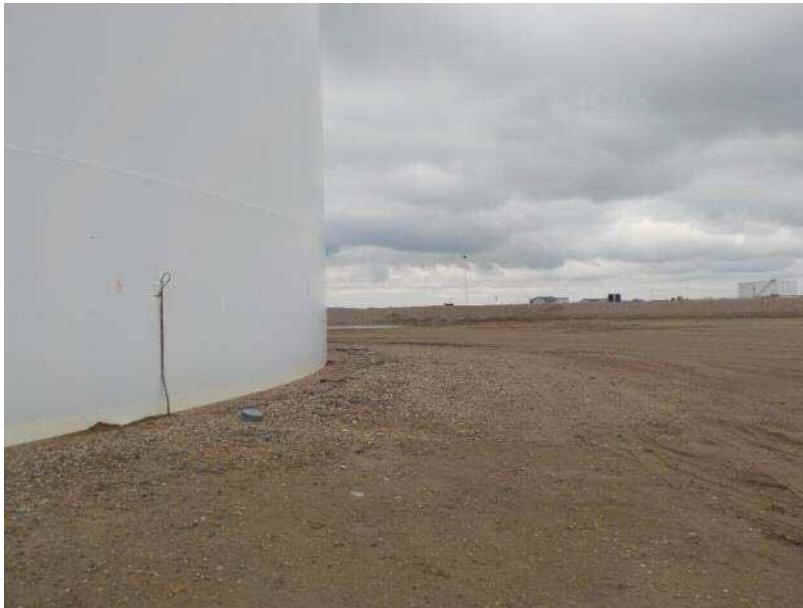
PHOTOGRAPH 4 TANK FOUNDATION

Tank 52 was situated on an elevated earthen berm area, fill material was a sand/gravel mixture.

A settlement survey was performed; tank 52 did not meet the requirements of API 653.

Considerations for repair can be made based upon the settlement failure.

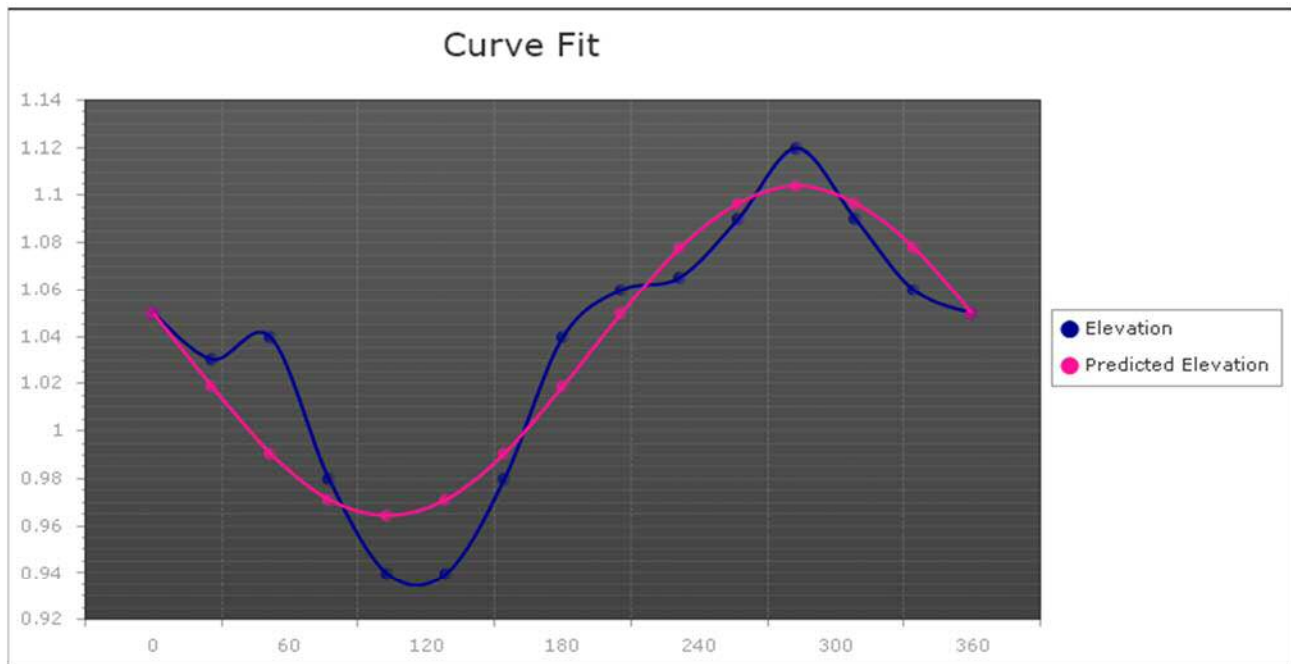
An external settlement survey was performed to examine for out of plane or tilt settlement. The settlement was found to be not within compliance of API Standard 653, Annex B.

Tank Diameter (Meters) = 42.073171
Tank height (Meters) = 17.987805
Max. Out-of-Plane Permitted (inches) = 0.0272545
Max. Observed Out-of-Plane (inches) = 0.0393005
Percent of Permitted = 144.20% **API UNACCEPTABLE**
R-Squared Value of Cosine Curve Fit = 0.857425 **CURVE FIT UNACCEPTABLE**

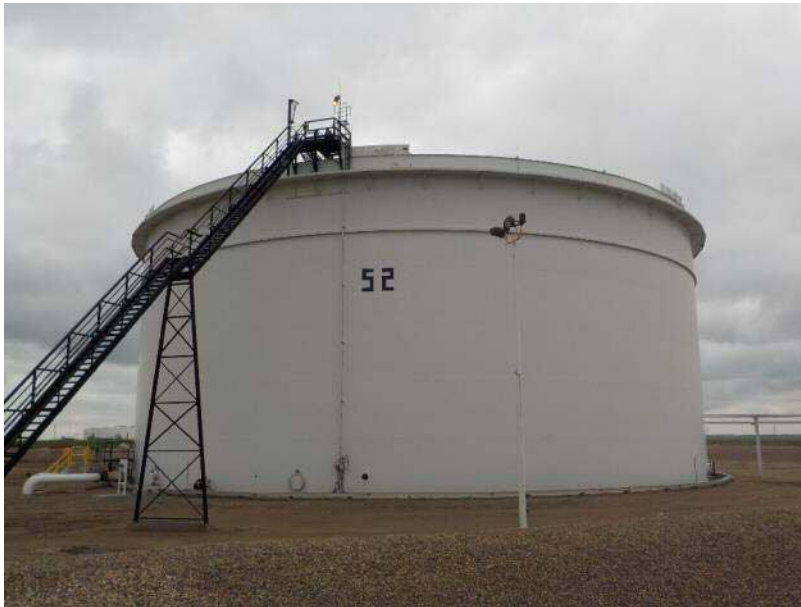
PHOTOGRAPH 3 SHELL PLATES

External visual inspection was performed, no areas of paint failure or corrosion were observed.

Minor deformations of the shell plate were noted.

UT survey was performed on all shell courses around the circumference of the tank, no corrosion was observed as a result of the inspection.

No UT was performed on the 6th shell course due to a 5th course tensioning ring present at the period of inspection.

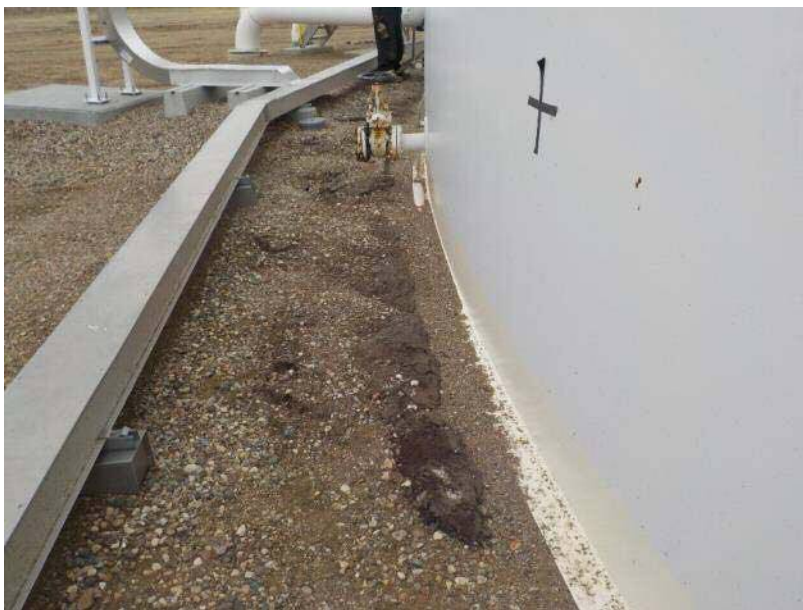
PHOTOGRAPH 4 EXTERNAL NOZZLES AND PIPING

An external visual was performed on the nozzle necks during this outage, no weld defect or corrosion was observed.

UT was performed on external nozzle necks, no corrosion was identified as a result.

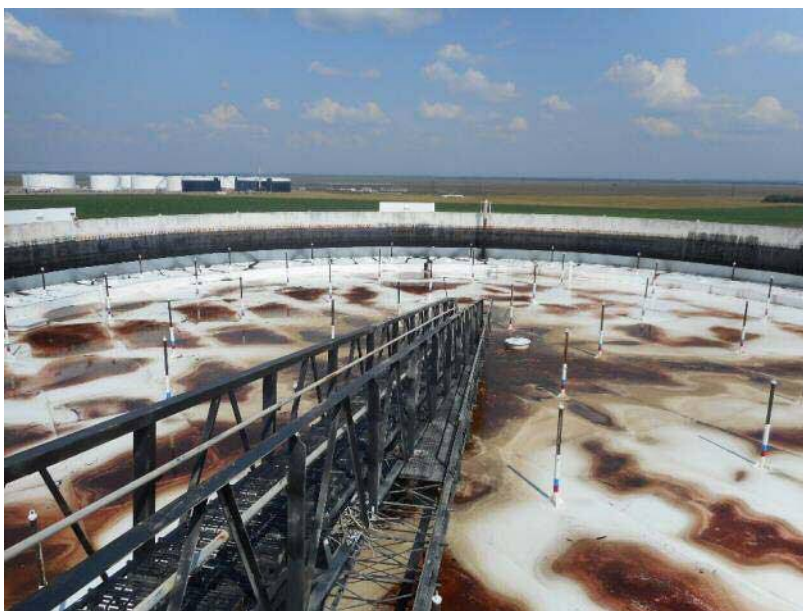
PHOTOGRAPH 8 EXTERNAL FLOATING ROOF AND ROLLING LADDER

Roof deck plates were visually inspected, no corrosion was observed.

Rolling stair case was in acceptable condition, no damages observed.

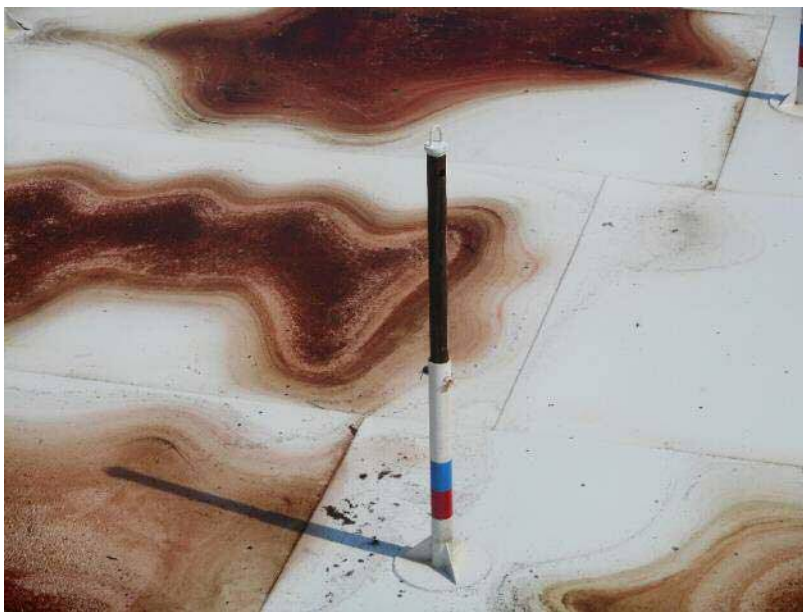
PHOTOGRAPH 9 EXTERNAL FLOATING ROOF LEG

Rood legs are free of corrosion and are pinned so roof is in low position.

Due to vacuum breaker legs being pinned operating the tank below, landing level of the legs is not recommended.

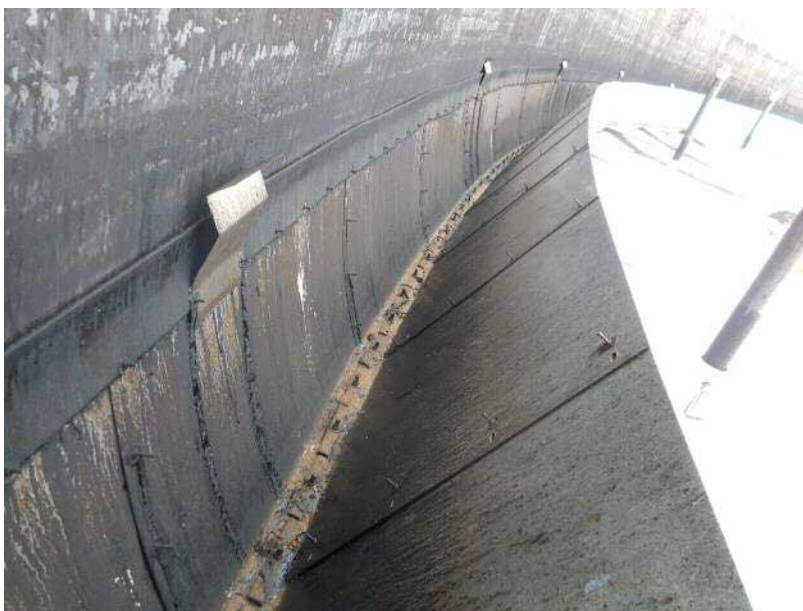
PHOTOGRAPH 10 EXTERNAL FLOATING ROOF SEAL

Secondary wiper installed, no gaps observed.

Wiper tip is in excellent condition, no damages were observed.

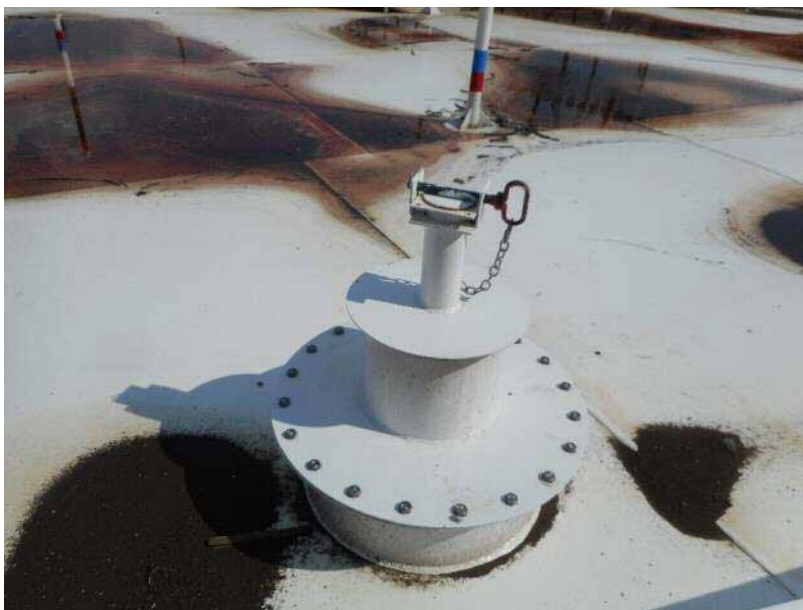
PHOTOGRAPH 11 EXTERNAL FLOATING ROOF VACUUM BREAKER

Vacuums breakers are free of corrosion, sitting level and are pinned into position.

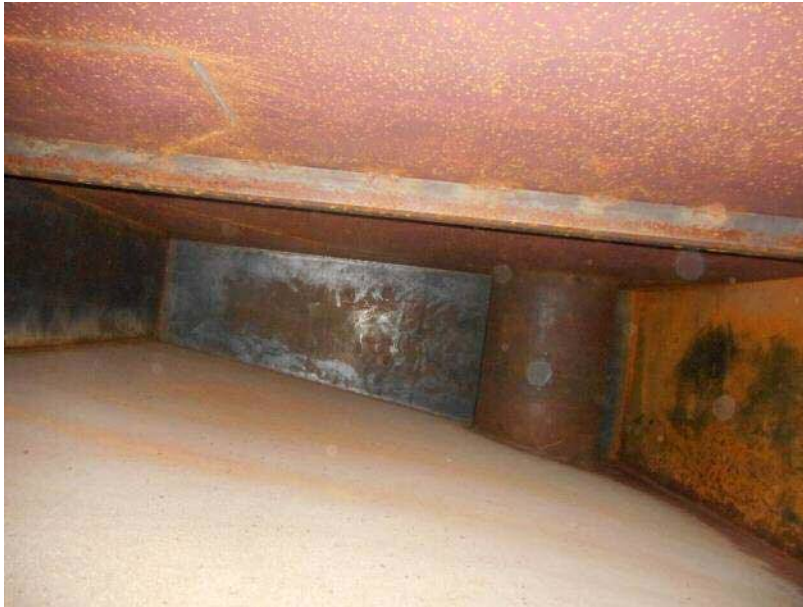
PHOTOGRAPH 12 FLOATING ROOF PONTOON

A visual inspection was performed on all 24 pontoons. No stains or product were observed within.

Pontoons were observed to be of a vapor tight construction.

Random UT was performed on the outer pontoon side wall, nominal thickness of 0.212" recorded, several pontoons showed minor corrosion on the upper portions of the sidewall.
