## MSP430F5308 Device Erratasheet

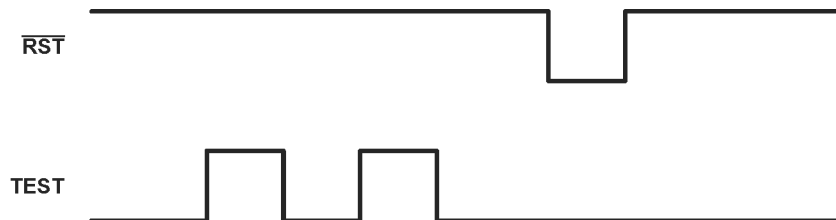
BSL does not exit to application code

#### Description

The methods used to exit the BSL per MSP430 Programming Via the Bootstrap Loader

([SLAU319](#)) are invalid.

To exit the BSL one of the following methods must be used.

- A Power cycle

or

- Toggle the TEST pin twice when nRST is high and then pull nRST low.

Note: This sequence is not subject to timing constraints and the appropriate level transitions are sufficient to trigger an exit from BSL mode.
