TMS320F2837xD Dual-Core Delfino™ MCUs Silicon Revisions C, B, A, 0

This document describes the silicon updates to the functional specifications for the TMS320F2837xD microcontrollers (MCUs).

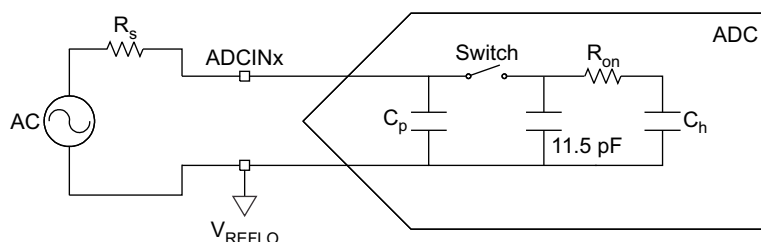
Figure 3. Single-Ended Input Model

Advisory	ADC: 12-Bit Input Capacitance When Switching Channel Groups
Revision(s) Affected	0, A, B
Details	The ADC input model should be used to select the sample-and-hold (S+H) duration for each ADC input. For the revisions affected, if the currently converting channel is an even-numbered channel and the previously converted channel was an odd-numbered channel (or vice versa), then the 12-bit input model will not accurately predict ADC input performance. Under these conditions, an additional capacitance should be added to the model. This capacitance has a value of 11.5 pF and should be placed between the S+H switch and R_{on} as shown in Figure 3 .

Workaround(s)	For the revisions affected, when subsequent conversions switch between channel groups, the S+H duration should be chosen to account for the additional capacitance.
----------------------	---
