AURIX™ TC37x errata sheet

Marking/Step: (E)ES-AA, AA

10525AERRA

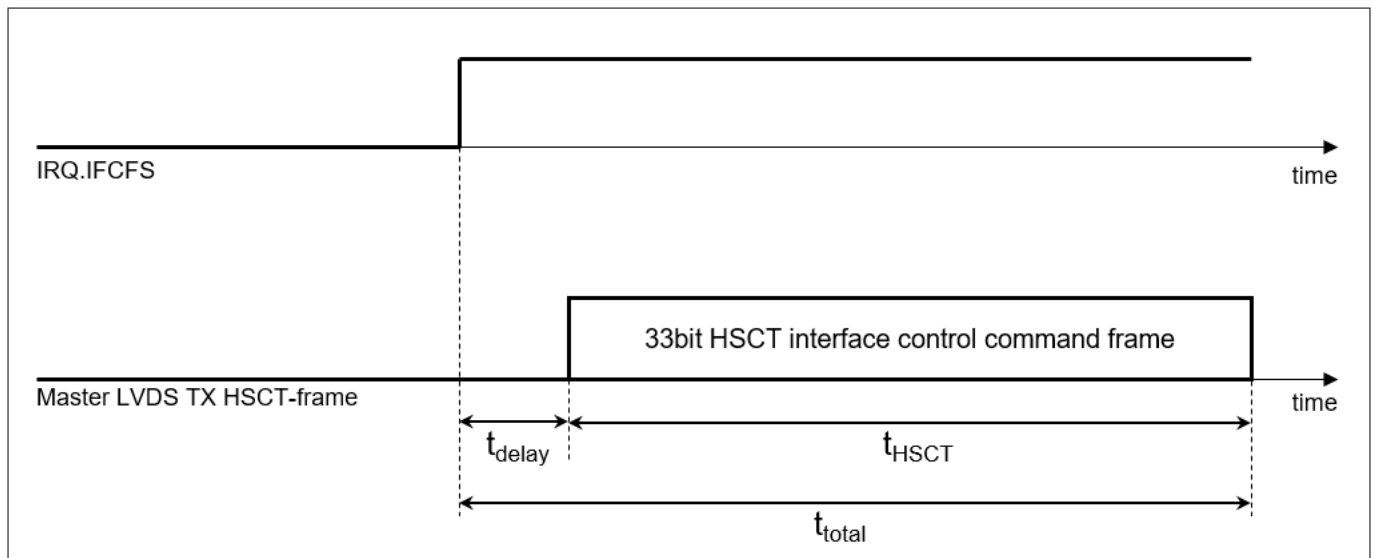
Figure 12 Timing of LVDS TX interface command sending in relation to IRQ.IFCFS

the user might falsely assume that also the actual sending on the LVDS TX port has already occurred once the IRQ.IFCFS flag is set, which is not true.

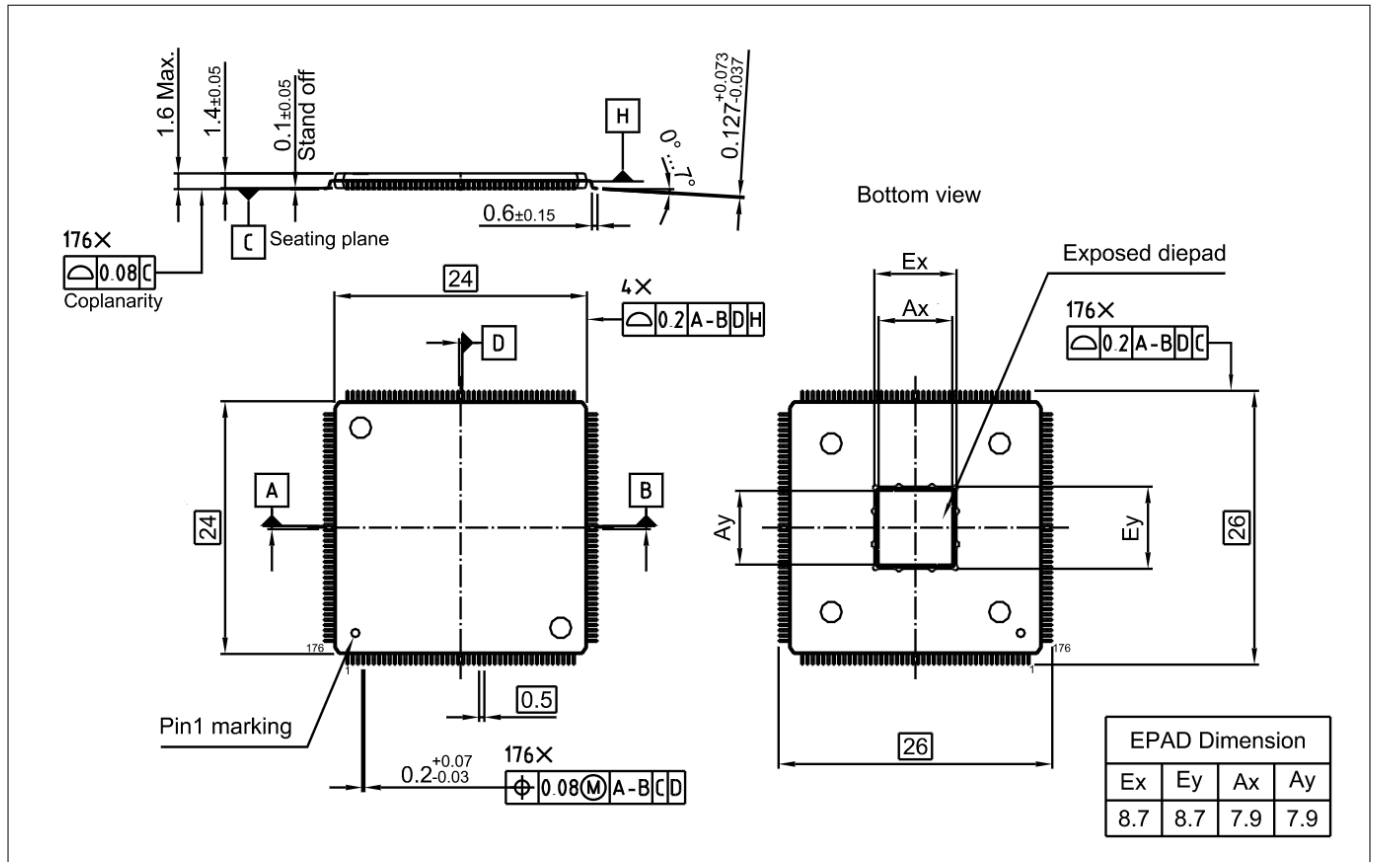
Figure 13 Package Outlines LQFP-176 for TC37x

Note: For the exposed diepad of the LQFP-176 package of the TC37x, structural corner protrusions have to be considered for purposes of system design and integration with a maximum boundary of 9.4 mm.
