Lattice Boom Crawler Crane

<b>Owner/User:</b> Midtown Steel		<b>Date:</b> Fri 5/1/2009
<b>Manufacturer:</b> LINKBELT	 	<b>Inspector:</b> Greg Beam
<b>Model:</b> LS248H		<b>Certification:</b> 08-6333
<b>Serial No:</b> C5L13-0778		<b>Inspection No:</b> T610001906
<b>Unit No:</b> 240		<b>HrsUp:</b> 7392 <b>HrsLo:</b>
<b>Location:</b> At the steel mill in South Pittsburg, TN

Inspection Deficiency Report

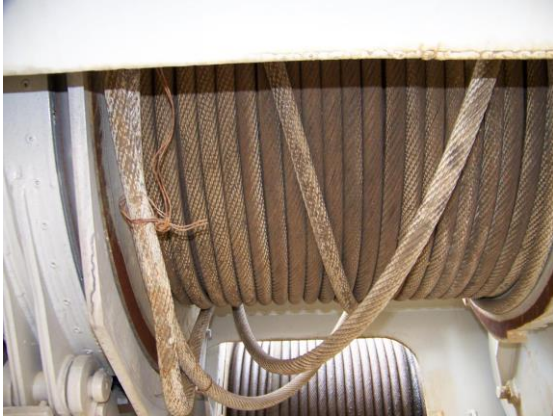
(23) Wire Rope Main Hoist - M. Lubrication							
23-M	The cable is very rusted and needs to be lubricated						
(24) Wire Rope Auxiliary Hoist - O. Spooling condition							
24-O	The front drum is misspooled and needs to be pulled off to the point where it straightens out and then respoiled.

Picture of main hoist (rear drum) that is not being used and the rusted up condition of the cable.

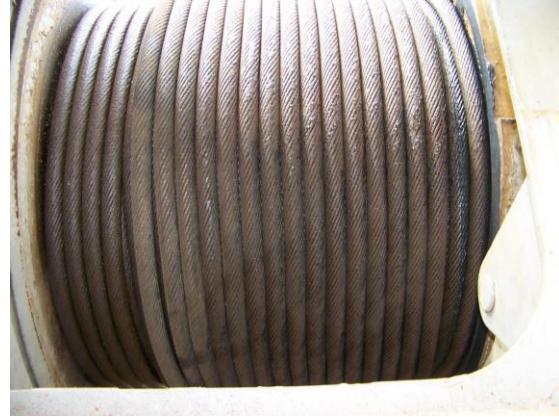
Picture of Au. Hoist (front drum) cable that needs to be lubricated.

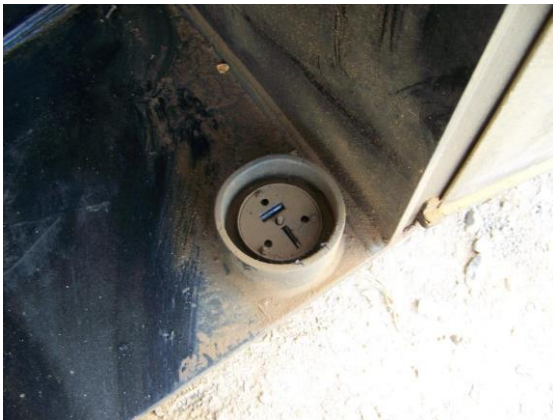
(17) Truck & Crawler Crane & Cab(s) - K. Condition of bubble level							
17-K	The bubble level that is located on the lower front of the main frame is bad and should be replaced. (see attached photo)

Picture of bubble level on the lower front frame that is unreadable.

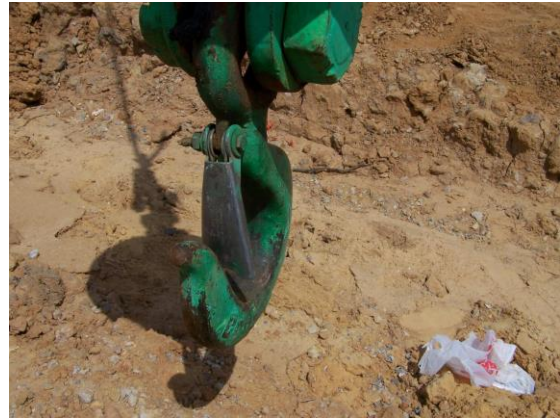
(31) Headache Ball Component Identification - A. Throat Latch							
31-A	The throat latch is bent to one side and should be replaced.						
(31) Headache Ball Component Identification - B. Capacity & Weight Labeled (PCSA #2 7.11.6)							
31-B	The capacity and weight is not labeled on the ball. Also the thru bolt that ties the swivel and the hook together is missing the nut and a homemade piece is welded to the bolt in it's place, Thru bolt should be replaced with the correct bolt and nut.

Picture of safety latch is bent to one side and should be replaced with a correct safety latch.

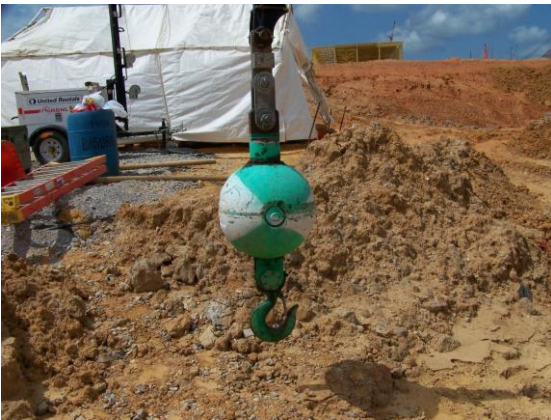
Picture of homemade weldment that is retaining the thru bolt.

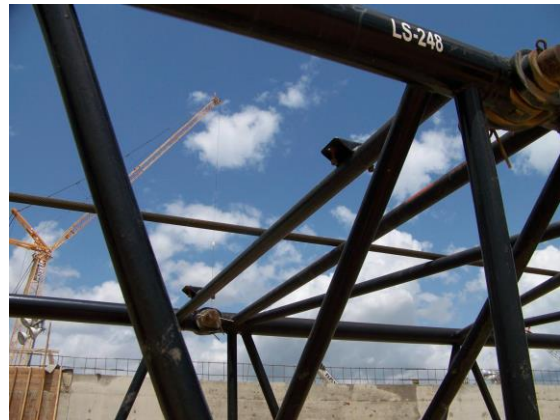
(10) Swing - A. Condition of house lock							
10-A	The house lock is very hard to pull out at times.						
(13) Boom & Jib - C. Cable guide rollers							
13-C	There are 2 cable rollers missing from the top of the boom that need to be reinstalled (see attached photo)

Picture of missing cable guide rollers on top of the boom.

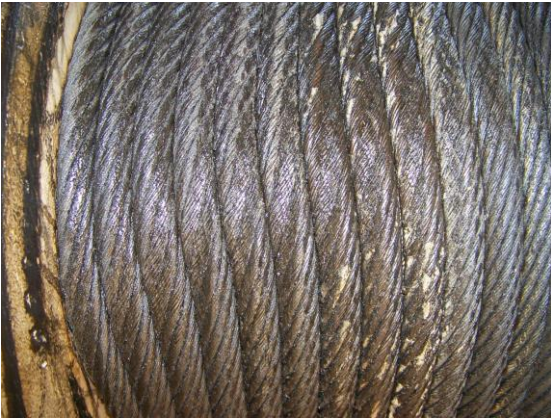
(25) Wire Rope Boom Hoist - C. Rope Damage							
25-C	The cable is crushing badly on the second layer from the drum, Also the cable is measuring below nominal value for a 7/8" cable.

Picture of boom hoist cable crushing.

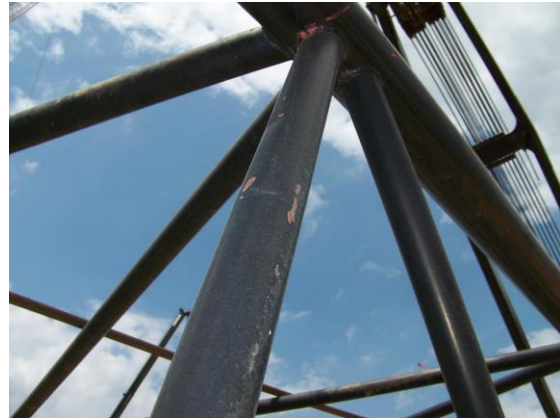
(13) Boom & Jib - K. Condition of lacing, cords, & welds							
13-K	There is a piece of lacing in the 1st section of boom past the butt that has 2 dents in it and should be replaced. It is the 4th piece from the front picture window on the left side (see attached picture)

Picture of dents in the lacing in the first section.
