In-situ Out-of-Plane Airbag Testing of Infill Masonry Cavity Walls

Testing at 151-165 Victoria Street West
Auckland, New Zealand
Automotive Garage
August 2013

Submitted by
Anthony Adams

University of Auckland
Department of Civil and Environmental Engineering
Auckland, New Zealand

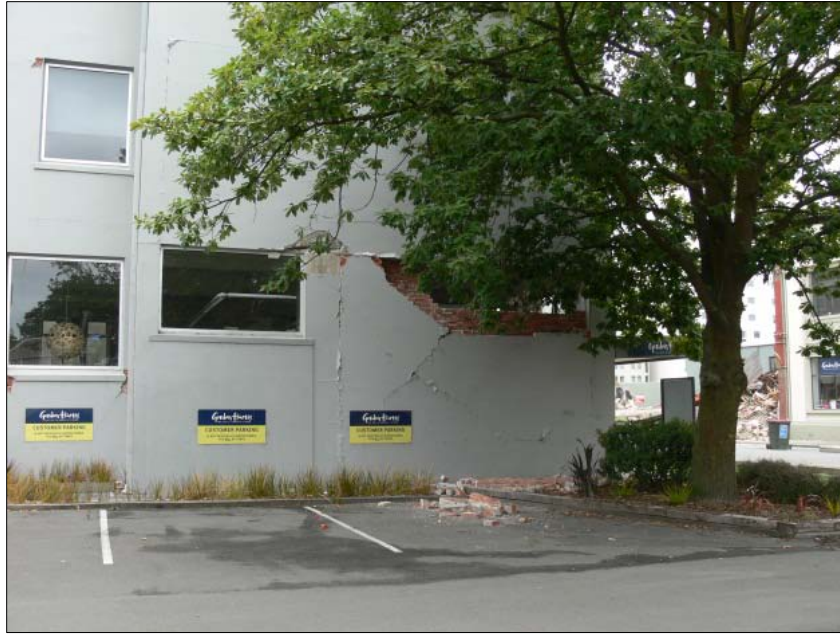
Figure 1: Partial failure of two leaf URM wall during 2011 Christchurch earthquake.

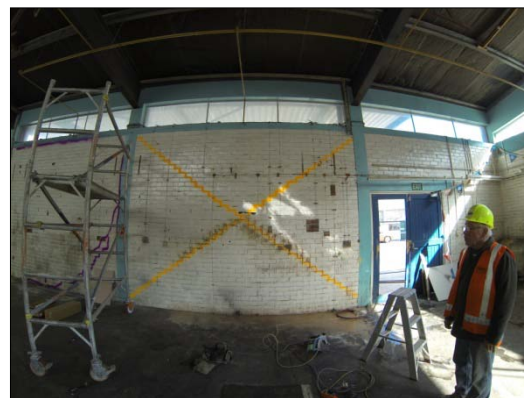
(d) 50mm deep simulated in-plane crack, Wall 5

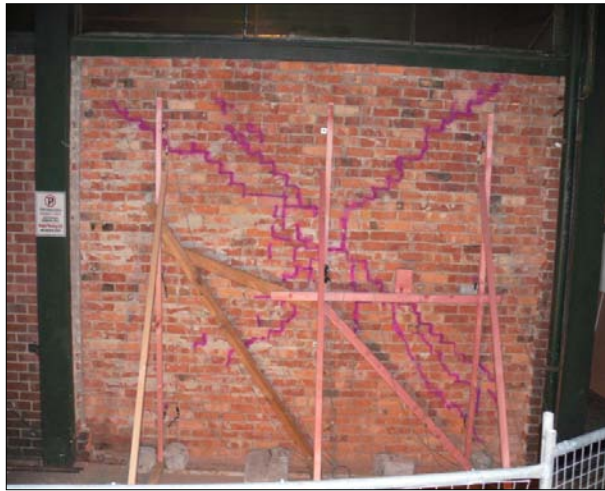
(a) Crack Pattern of wall 4 on tensile side

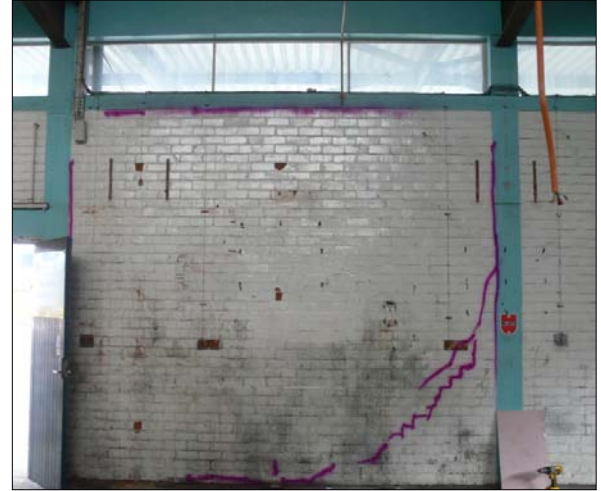
(b) Crack pattern of wall 4 compressive side

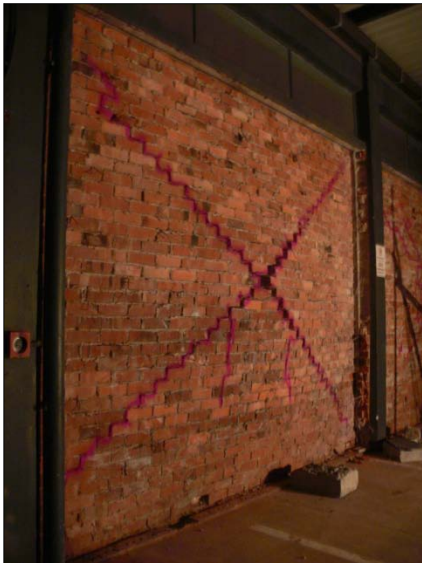
(c) Crack pattern of wall 5 on the tensile side

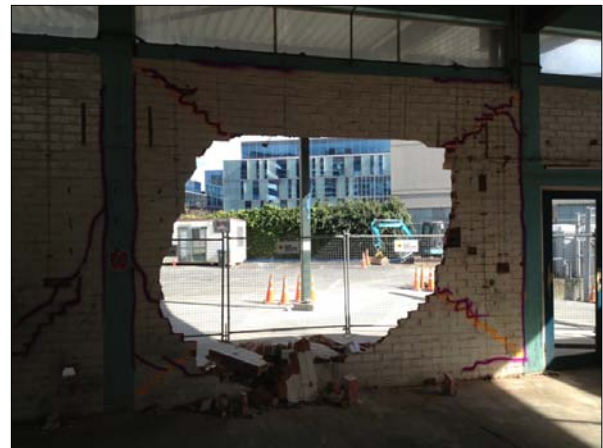
(d) After complete failure of wall 5 compression side.

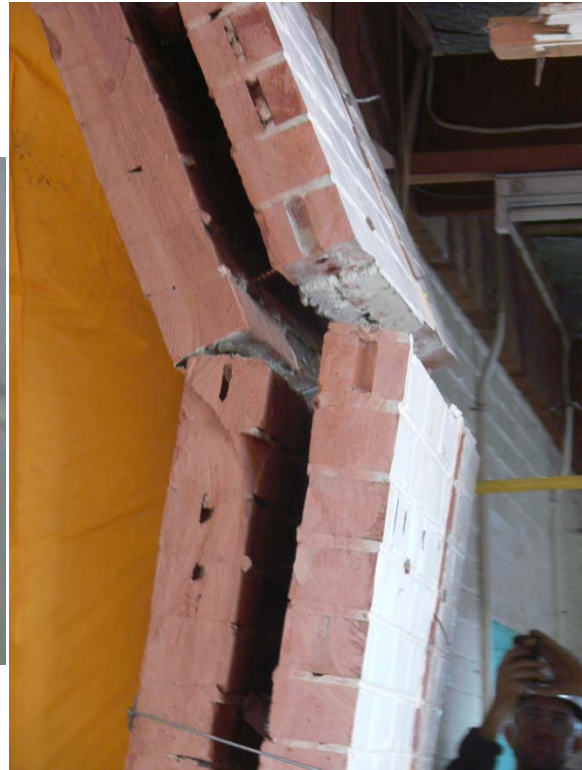
Figure 19: Reid ties just before complete failure of wall 1. Complete separation of tensile leaf at crack.

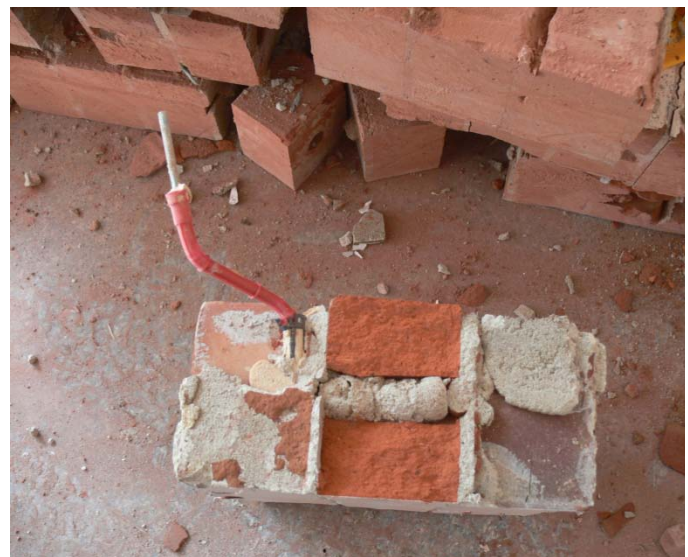
Figure 21: Hilti Tie after complete failure of wall 2.

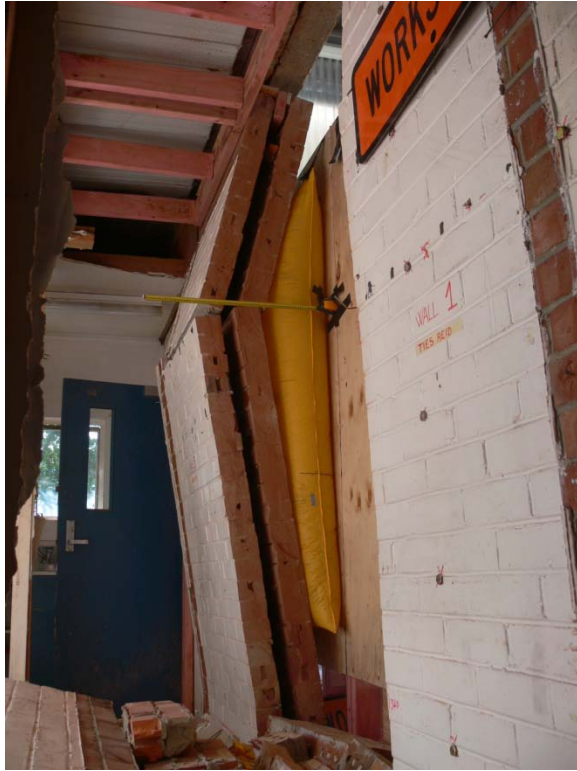
Figure 22: Wall 3 Helifix ties just before complete failure

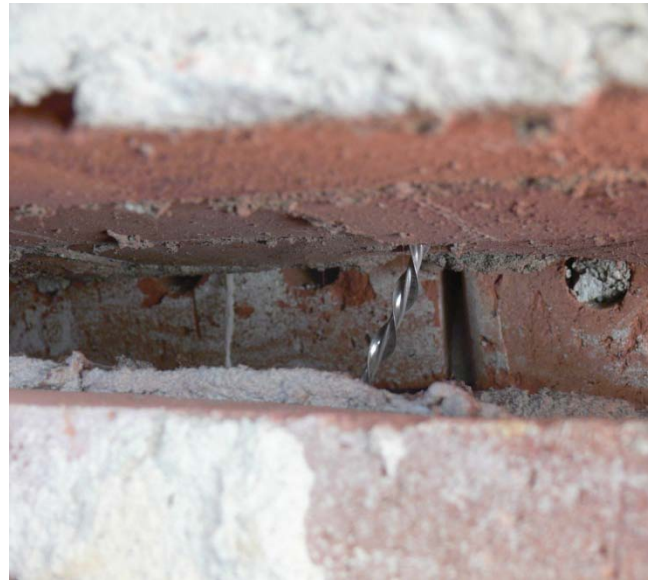
Figure 23: Helifix tie still in place after failure, slightly bent.

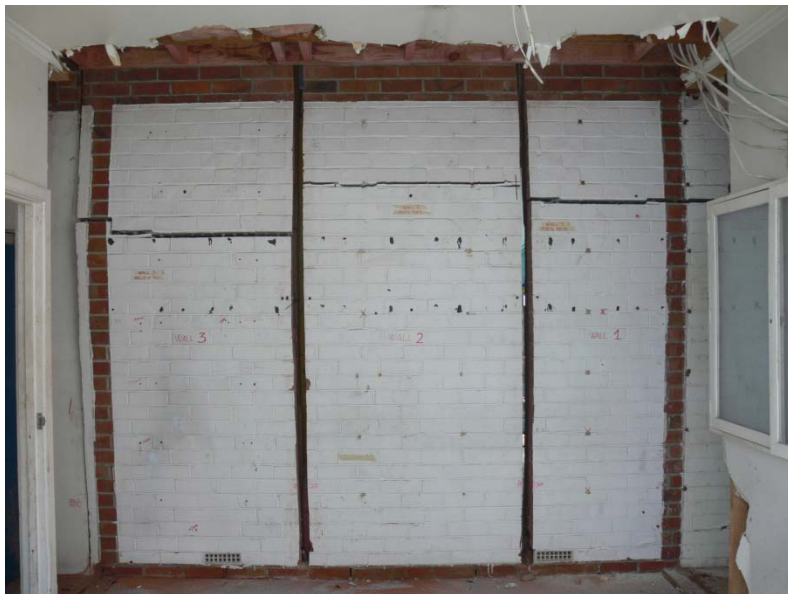
Figure 24: Crack placement on wall 3 (left), wall 2 (middle), and wall 1 (right)

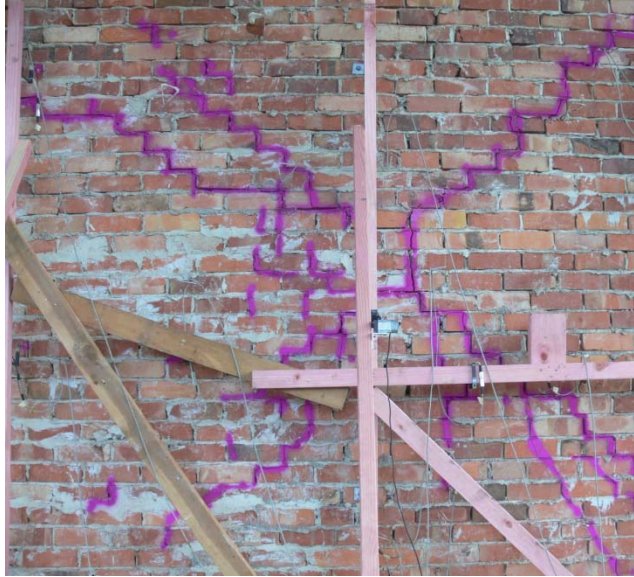
Figure 25: Wall 4 crack pattern during testing.

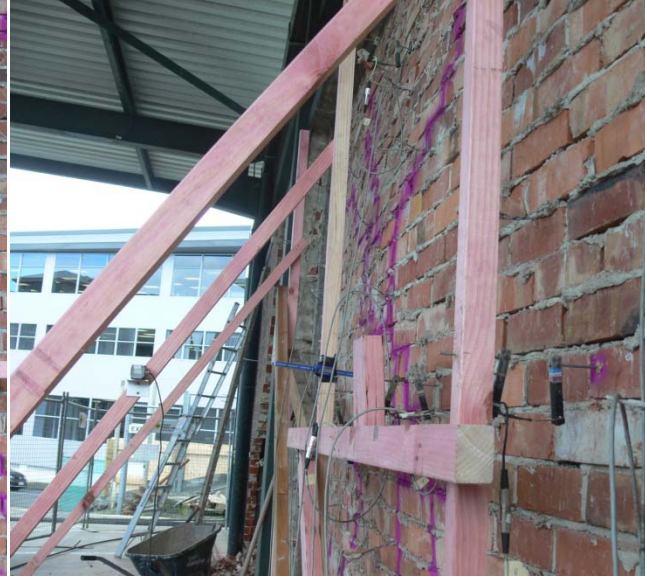
Figure 26: Wall 4 bulging at the center during testing.

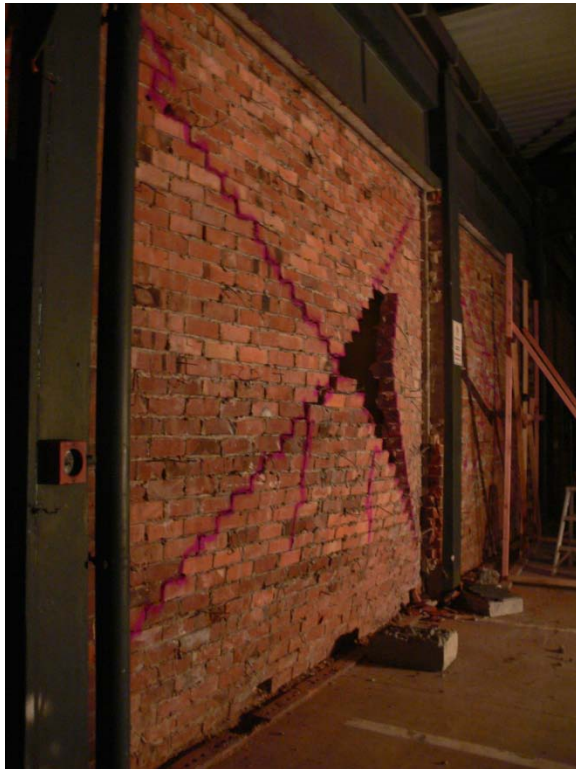
Figure 27: Wall 5 with simulated in-plane crack just prior to complete failure.

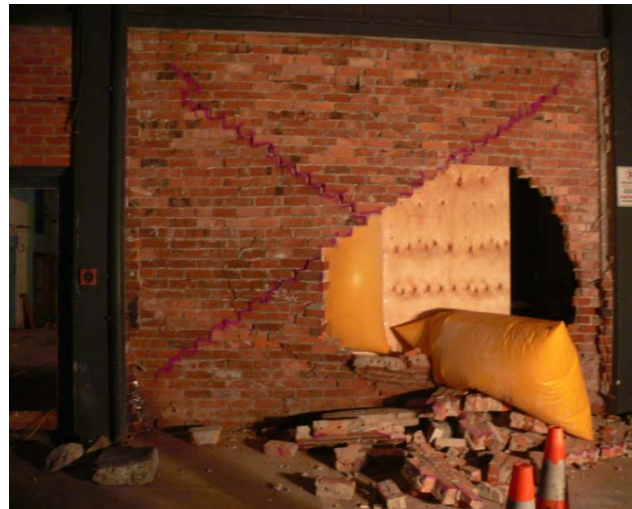
Figure 28: Wall 5 after failure of wall.
