PREVENTION OF UNDERSIDE CORROSION OF LEAD USING CHALK RICH COATINGS

David Farrell

ABSTRACT

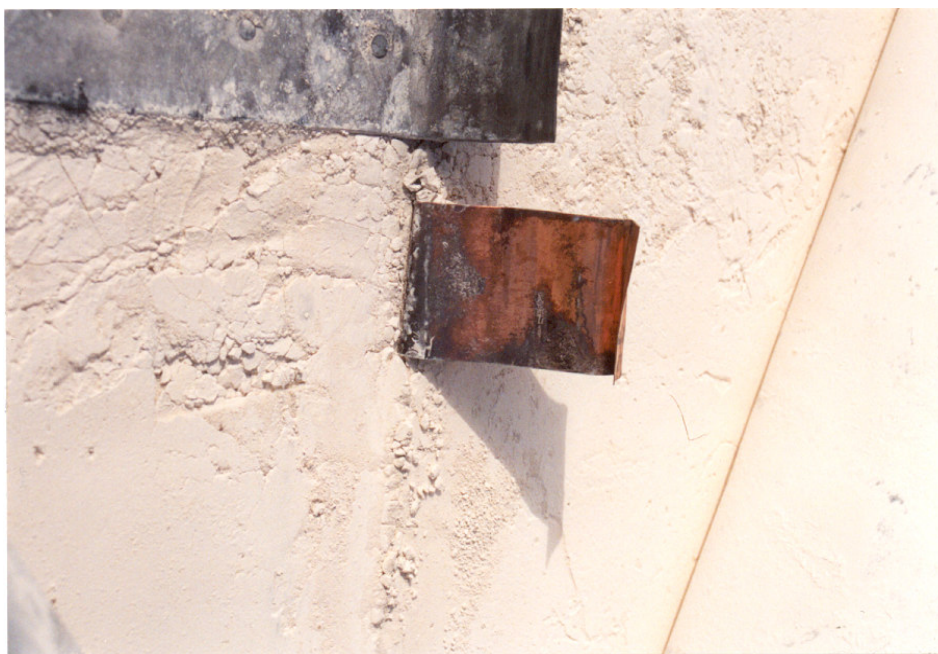
A number of inspections have been carried out since this time. To date, the chalked areas of the roof have been found to be free from underside corrosion, Figure 1. Underside corrosion was noticed in some areas of the rolls and the laps where chalk slurry had been deliberately avoided (to inhibit capillary rise of rainwater into the roof). However, some of the dried chalk powder had fallen down the underside slope and had become lodged in the laps; this had drawn in some rainwater by capillary suction in the lower corners. Despite local moisture levels of up to 27% in the wood, the chalk protection system had succeeded in stopping corrosion on this roof. Note - moisture levels above 21% are normally sufficient to initiate corrosion on unchalked lead roofs.

Figure 1. Village Church 1. View of the thick chalk layer floated onto the geotextile underlayer

Plain building paper was laid over the softwood decking in order to control air and vapour movement. A geotextile layer was then laid over the building paper to even out the substrate, provide a slip layer and to provide retention of a reasonable quantity of chalk slurry on the slope. A thick chalk slurry coating was applied over the geotextile to a thickness of some 3mm using a plaster's float. Finally, a thin painted

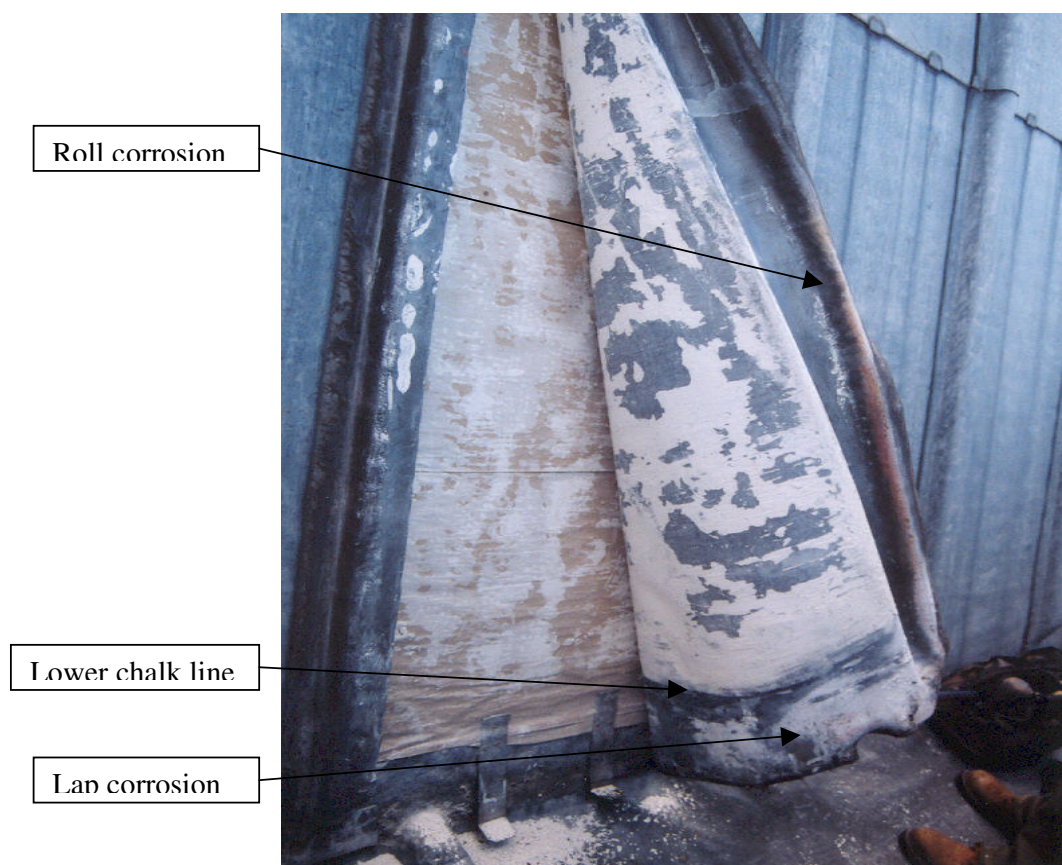
The underside of the replacement roof was inspected after 5 years. On lifting the lead sheets some of the dry chalk powder dropped off the back of the lead and fell into the gutter. Some of the chalk powder was brushed off the lead sheet to reveal the normal grey protective patina, i.e. similar to that formed on the topside of lead, Figure 2. The non-chalked areas in the laps and the rolls showed significant amounts of both white (hydrocerussite) and red (lithage) corrosion products indicating that this roof structure was still capable of inducing significant rates of corrosion.

Figure 2. The Great Hall. View of the thinner chalk protection coating in combination with plain building paper. Note exfoliation of the dry chalk.

A revised specification was developed for the replacement lead roof to help protect the lead against the environmental conditions: Softwood boards of 26mm thick were laid over the oak boards. A plain reinforced building paper was used as a slip layer between the lead and the softwood. This allowed the roof to breathe while controlling the diffusion of air. The underside of the replacement lead was treated with two applications of chalk slurry which were allowed to dry. (The R&D project had previously found that any carboxylic acids emitted from the boards could react directly with chalk in the presence of moisture, thus neutralising the acids). Sand cast lead was used, the rough side of which helps adhesion of the chalk. Note, to suppress capillary rise of rainwater into the roof the application of the chalk was restricted to: 1) just over the top of the laps 2) up to the 12 o'clock position of the batten roll.

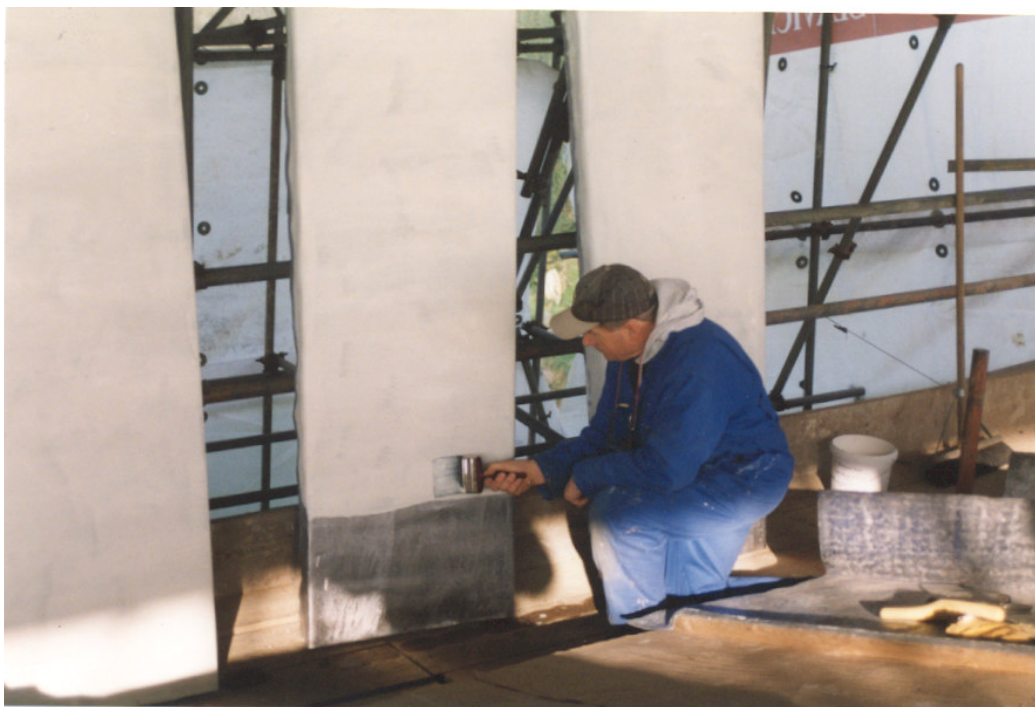
During installation, the sand cast lead was typically bossed into shape but then lifted and the chalk emulsion applied to the underside, to cover the top of the laps and the top position of the roll, Figure 3. When dry, the lead was re-fitted to the roof.

Figure 3. Village Church 2 View of the batch application of the chalk emulsion coating on the underside of the sand cast lead.

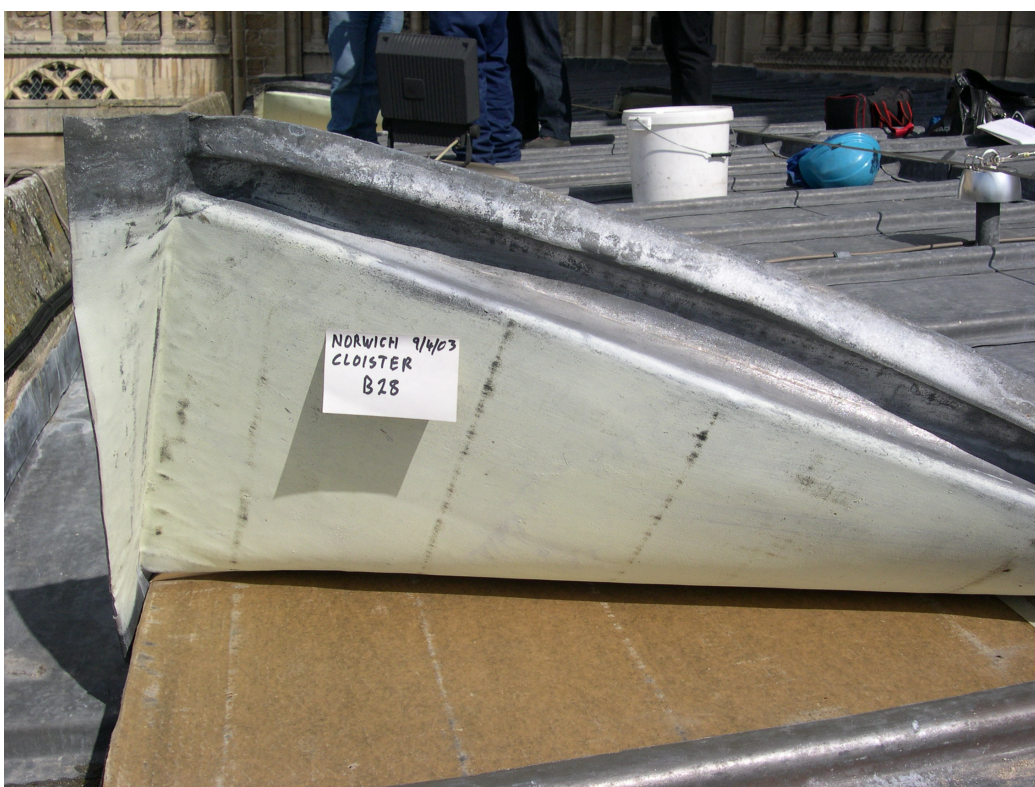
The roofs were replaced between 2001 and 2002 and two coats of the chalk enriched emulsion were used to protect the new lead. These roofs were inspected after two years and the coated surfaces were found to have adequately protected the lead, Figure 4. Note – the chalk enriched emulsion is supplied with a green tint to differentiate it from the white lead corrosion product. Again, the laps were found to

have suffered some underside corrosion indicating that these roofs were still corrosive to unprotected lead.

Figure 4. Cathedral Cloister Roof View of the chalk enriched emulsion coating – note white corrosion initiating in the laps.
