**Bridge No.** 111-3/5-5.95(01110)

Vietnam Veterans Memorial Bridge  
I-470, Wheeling, WV 26003, United States  
Marshall  
District - 6  
ADT-39,864

## **BRIDGE INSPECTION REPORT**

Fracture Critical, In-Depth Inspection and Report

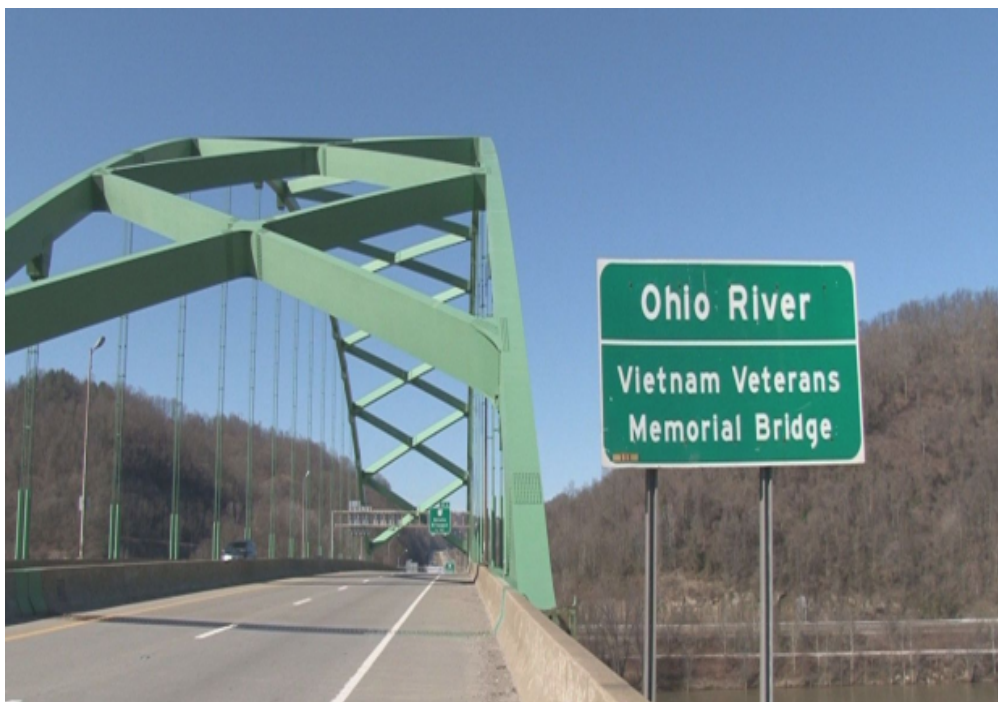
[I470] PHOTO 1 - POSTING SIGN @ ABUTMENT ONE APPROACH.png
