STM32F101xC/D/E, STM32F103xC/D/E device errata

This document applies to the part numbers of STM32F101xC/D/E, STM32F103xC/D/E devices and the device variants as stated in this page.

It gives a summary and a description of the device errata, with respect to the device datasheet and reference manual RMxxxx.

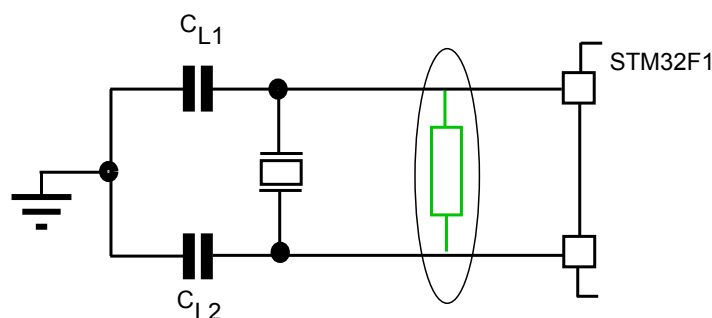
Figure 1. LSE startup using an additional resistor

The LSE (low-speed external) oscillator system has been designed to minimize the overall power consumption of the microcontroller. It is extremely important to take specific care in the design of the PCB to ensure this low power oscillator starts in harsh conditions. In some PCB designs without coating, an induced low leakage may prevent the LSE to startup, regardless of the 32.768 KHz crystal used. This phenomenon is amplified in humid environments that create frost on the OSC32_IN/OSC32_OUT tracks. This unwanted behavior may happen only at the first back-up domain power-on of the device.

It is recommended to mount an additional parallel feedback resistor (from 16 MΩ to 22 MΩ) on board to help the oscillation startup in all cases (see [Figure 1](#)). For more details on compatible crystals and hardware techniques on PCB, refer to application note *Oscillator design guide for STM8AF/AL/S, STM32 MCUs and MPUs* (AN2867).
