MBS KINGMAN

Condition Monitoring Report

SEP - OCT 2023

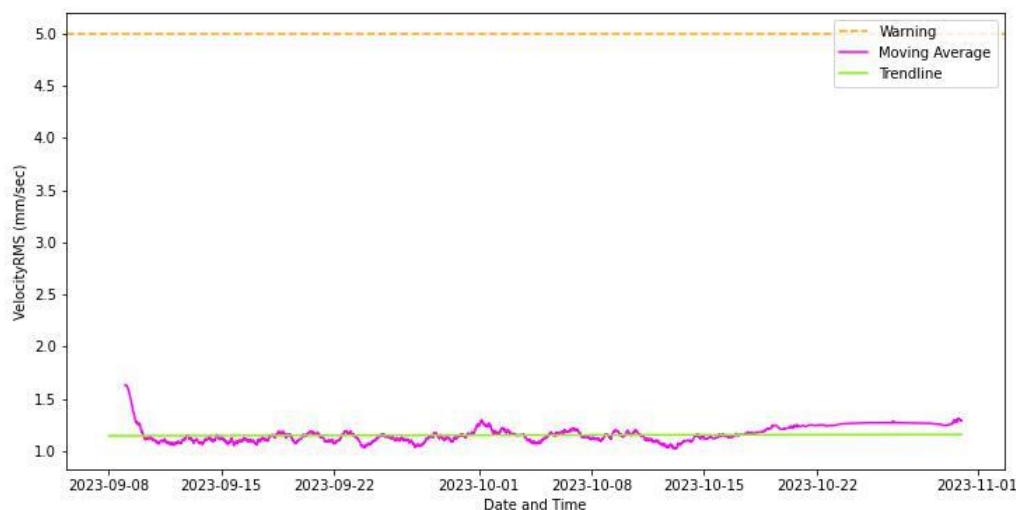
Velocity RMS Data Summary - Radial Horizontal:

- Moving average trend appears to be normal and within ISO threshold limit during the process.
- No clear trend is observed in the VRMS trend rate chart over the period

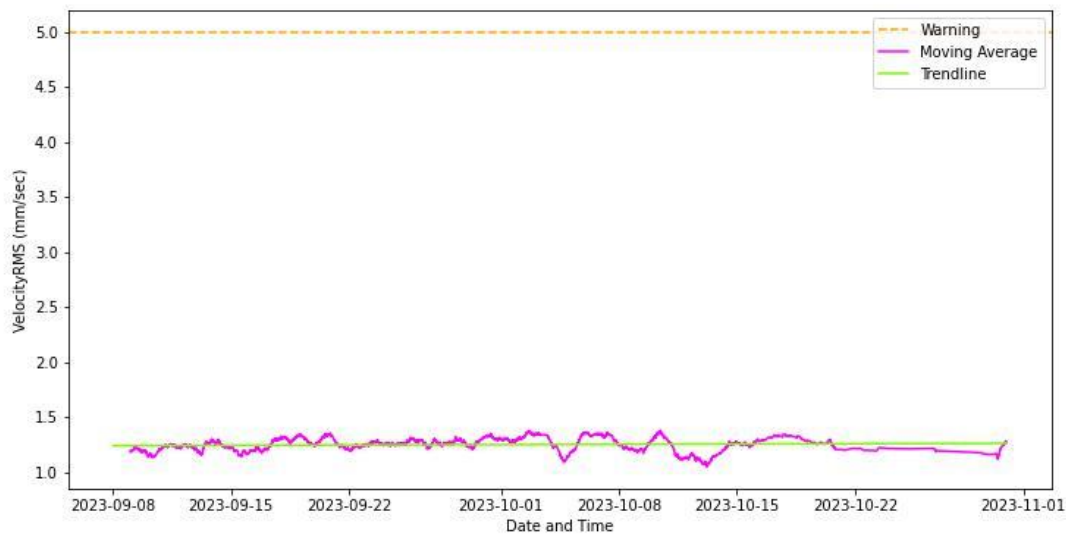
Velocity RMS Data Summary - Axial :

- Moving average trend appears to be normal and within ISO threshold limit during the process.
- No clear trend is observed in the VRMS trend rate chart over the period

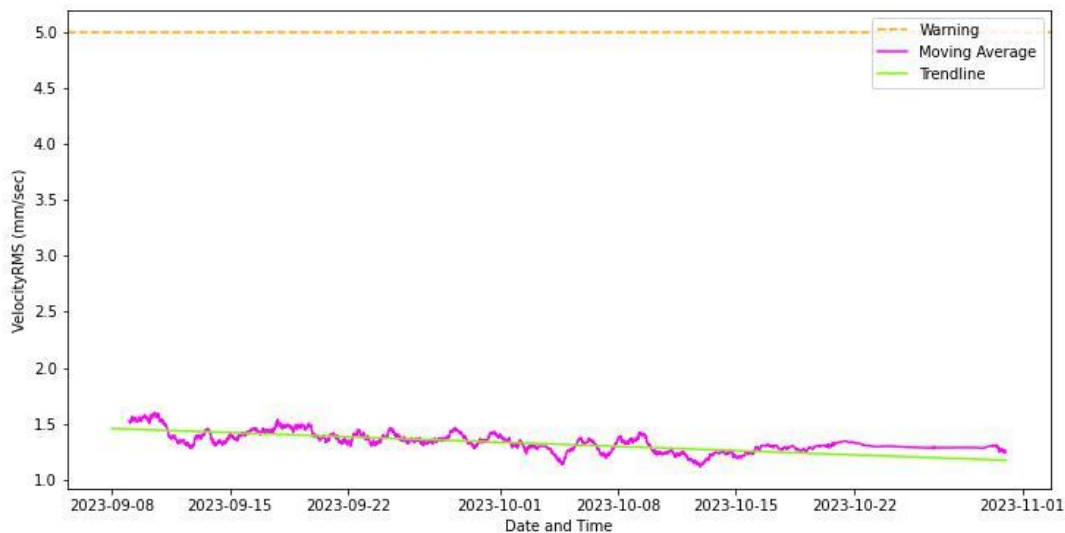
Velocity RMS Data Summary - Radial Vertical:

- Moving average trend appears to be normal and within ISO threshold limit during the process.
- No clear trend is observed in the VRMS trend rate chart over the period

Remarks	<ul style="list-style-type: none"> • Overall condition of the machine/motor's condition is good as the vibration data are observed within ISO threshold limit. • To enable detailed analysis and fault alerts, machine parameters related to rpm, bearing, and gear are required.
---------	---

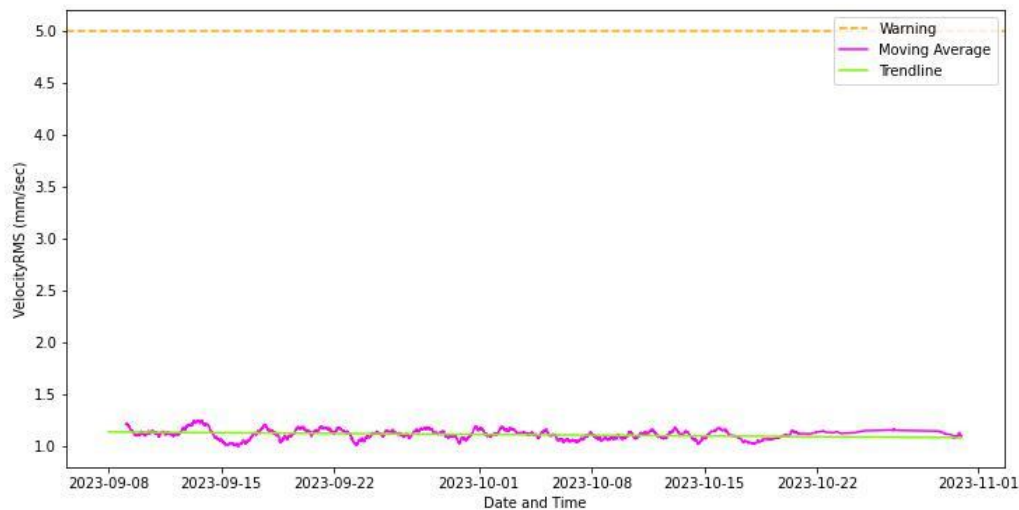
Velocity RMS Data Summary - Radial Horizontal:

- Moving average trend appears to be normal and within ISO threshold limit during the process.
- No clear trend is observed in the VRMS trend rate chart over the period

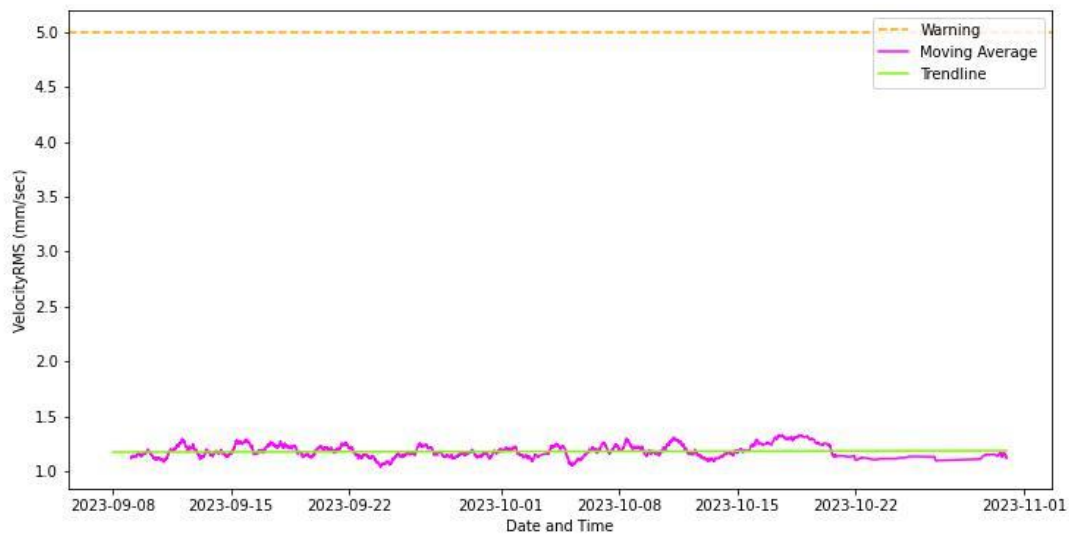
Velocity RMS Data Summary - Axial :

- Moving average trend appears to be normal and within ISO threshold limit during the process.
- No clear trend is observed in the VRMS trend rate chart over the period

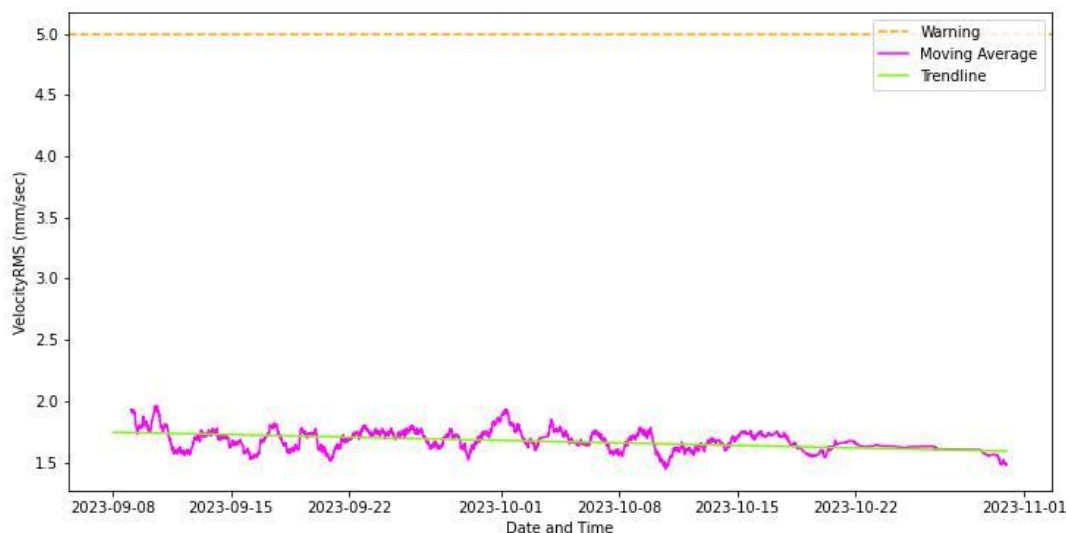
Velocity RMS Data Summary - Radial Vertical:

- Moving average trend appears to be normal and within ISO threshold limit during the process.
- No clear trend is observed in the VRMS trend rate chart over the period

Remarks	<ul style="list-style-type: none"> • Overall condition of the machine/motor's condition is good as the vibration data are observed within ISO threshold limit. • To enable detailed analysis and fault alerts, machine parameters related to rpm, bearing, and gear are required.
---------	---

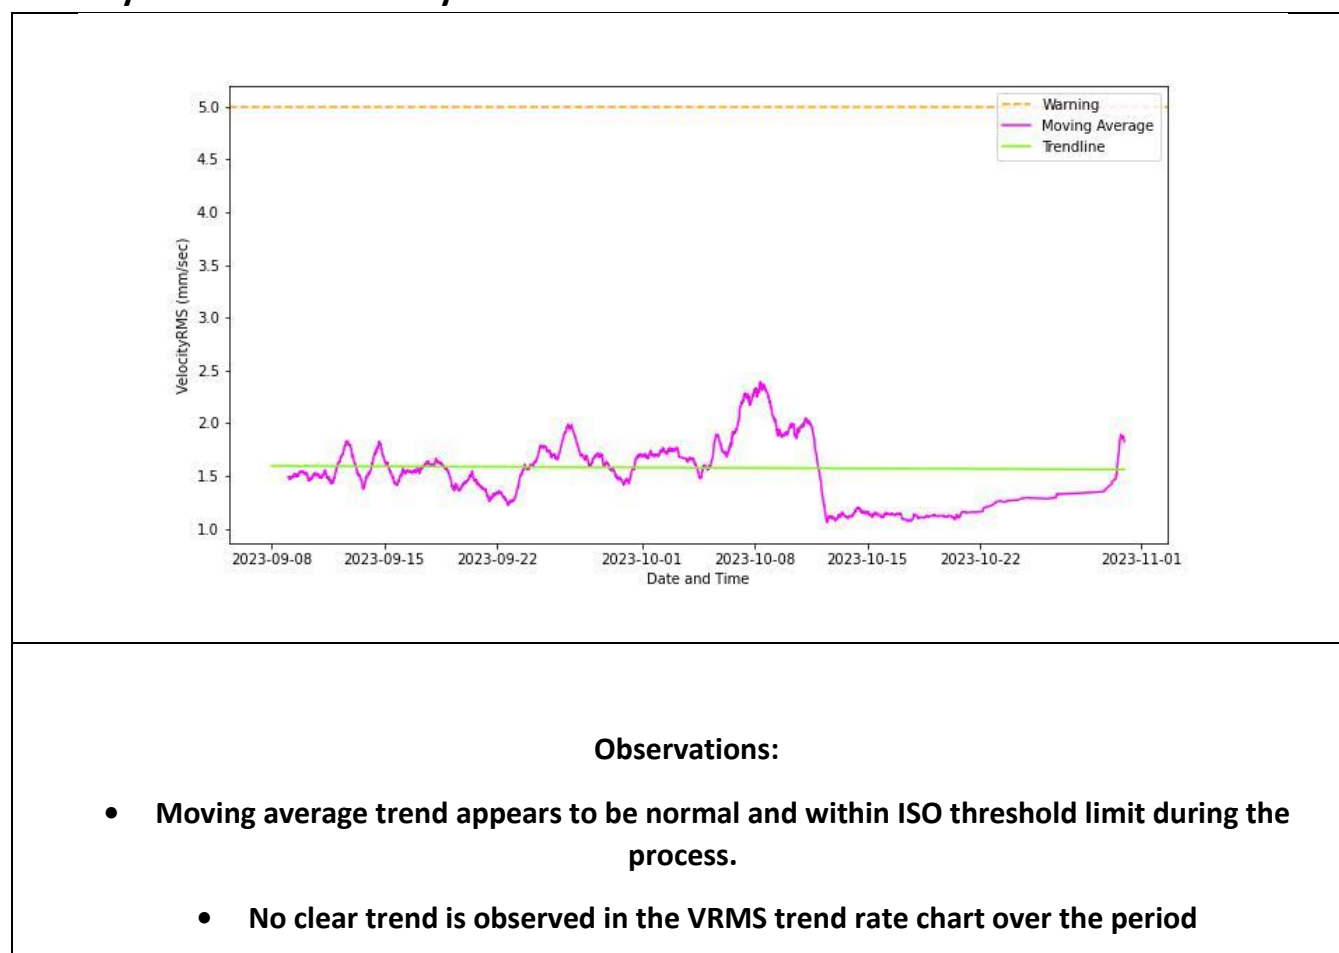
Velocity RMS Data Summary - Radial Horizontal:

Extruder Drive Gear Box 1301, Extruder Drive Gear Box 1201, and Gear pump Drive Gear Box 1202 machine vibration levels are observed within a good range, even though momentary spikes are found due to the process. Godet 1 Gear Box 1401 machine noted with high vibration range & equipment's parameters are required for further fault analysis.

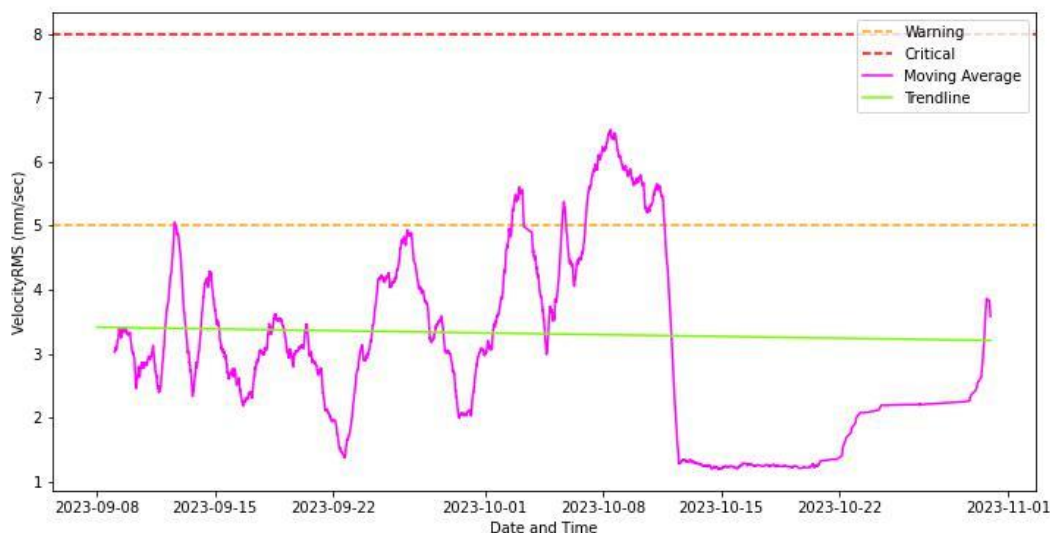
Velocity RMS Data Summary - Axial :

- Moving average trend requires attention as it's beyond the ISO threshold limit during the process.
- No clear trend is observed in the VRMS trend rate chart over the period

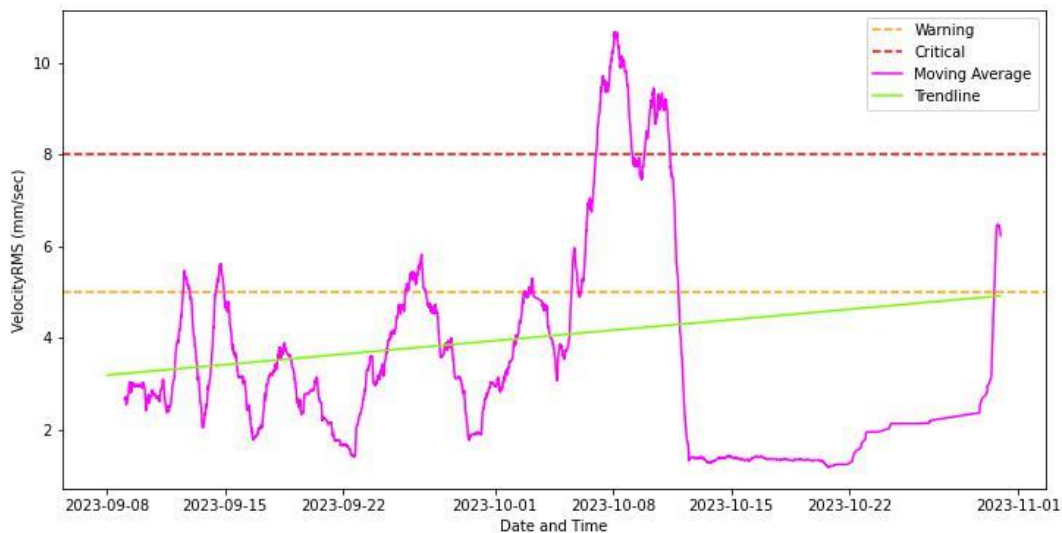
Velocity RMS Data Summary - Radial Vertical:

- Moving average trend requires attention as it's beyond the ISO threshold limit during the process.
- No clear trend is observed in the VRMS trend rate chart over the period

Remarks	<ul style="list-style-type: none"> • Overall condition of the machine/motor's condition is critical as the VRMS data are observed in the Critical range as per the ISO threshold limits. • To enable detailed analysis and fault alerts, machine parameters related to rpm, bearing, and gear are required.
---------	---

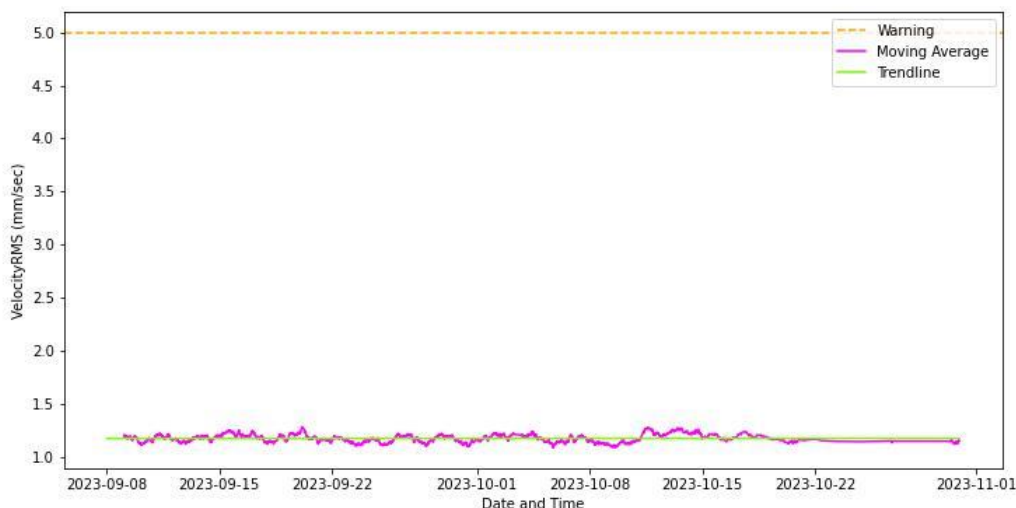
Velocity RMS Data Summary - Axial :

- Moving average trend appears to be normal and within ISO threshold limit during the process.
- No clear trend is observed in the VRMS trend rate chart over the period

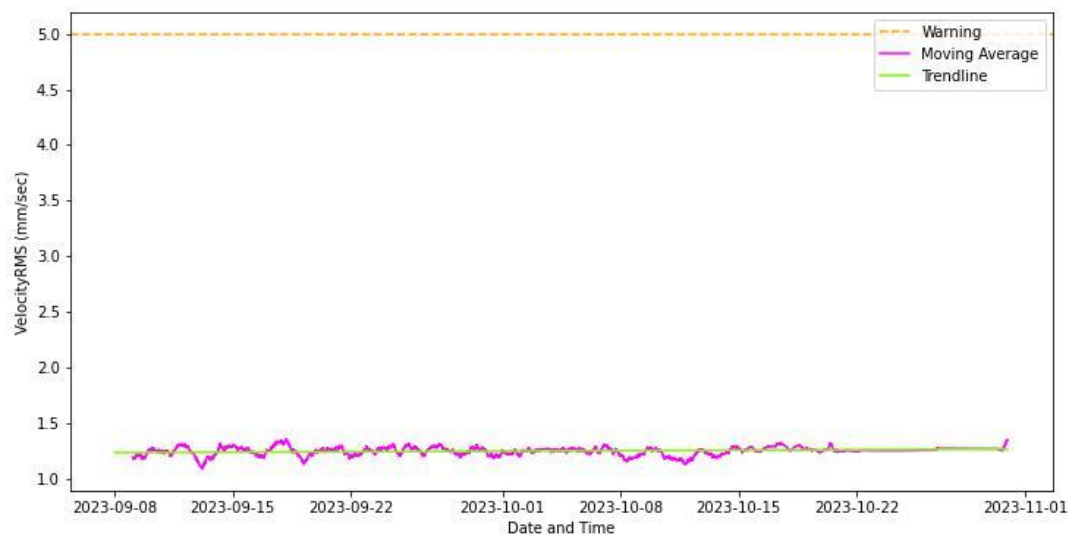
Velocity RMS Data Summary - Radial Vertical:

- Moving average trend appears to be normal and within ISO threshold limit during the process.
- No clear trend is observed in the VRMS trend rate chart over the period

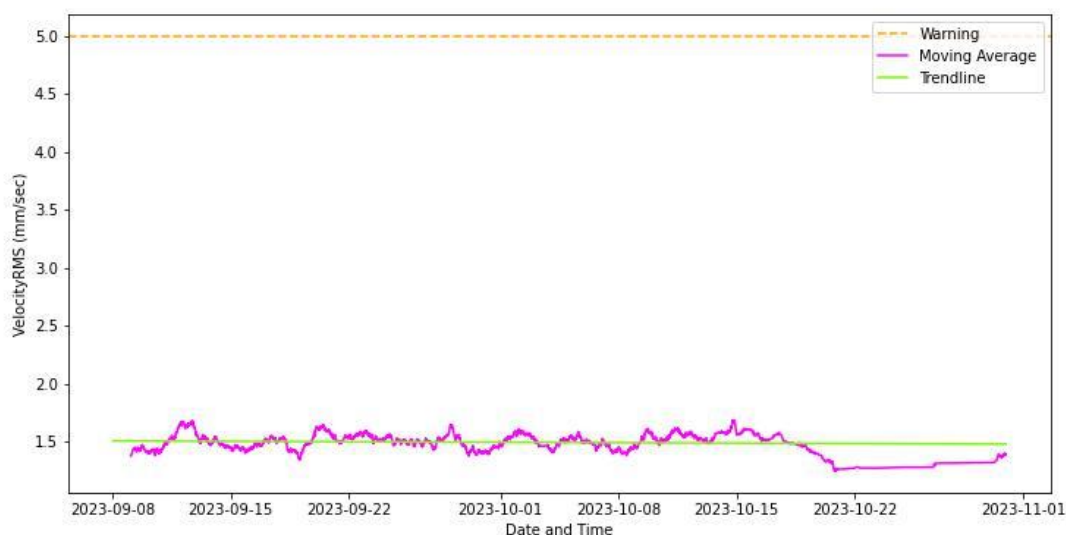
Velocity RMS Data Summary - Radial Horizontal:

- Moving average trend appears to be normal and within ISO threshold limit during the process.
- No clear trend is observed in the VRMS trend rate chart over the period

Remarks	<ul style="list-style-type: none"> • Overall condition of the machine/motor's condition is good as the vibration data are observed within ISO threshold limit. • To enable detailed analysis and fault alerts, machine parameters related to rpm, bearing, and gear are required.
----------------	---
