ARM720T r4pN Errata List

Document number: ARM720T-PRDC-003802 4.0
Date of Issue: 20 March 2009

This document describes the known errata in the ARM720T r4p3 design.

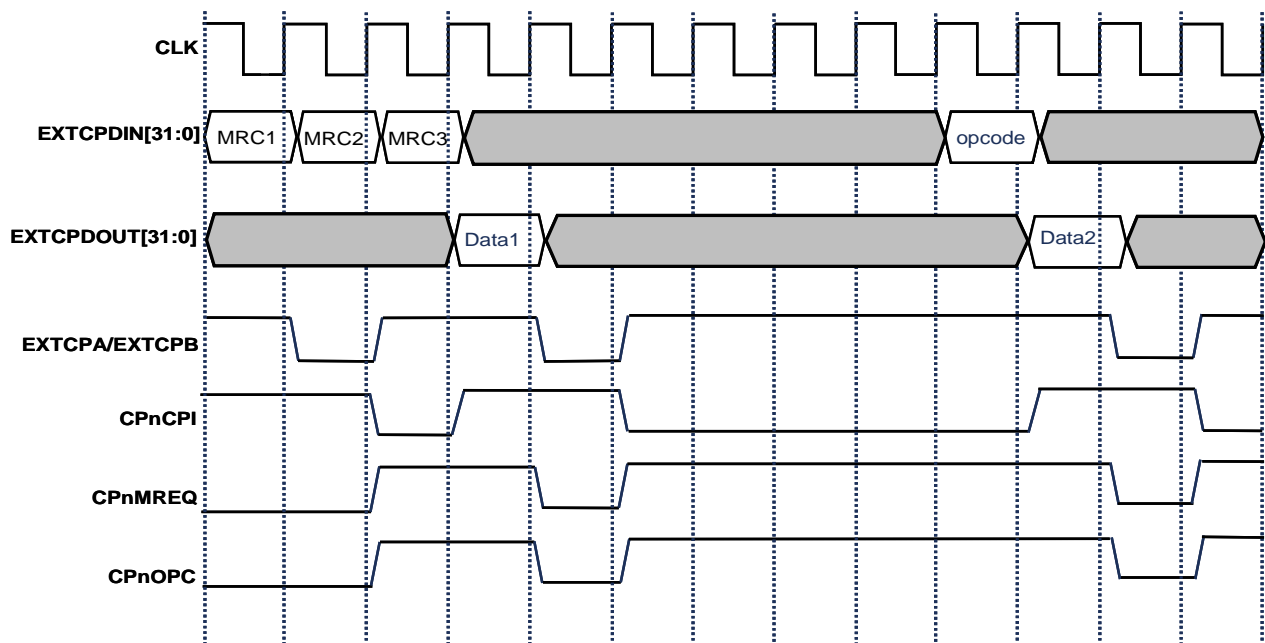
Fig 1: EXTCPA/EXTCPB as driven in the AVS testbench

Figure 1, shows how EXTCPA/EXTCPB are driven in the AVS testbench, causing the bug not to trigger.
