ARM9TDMI Rev 3 Errata List

CPU Cores Division

Document number: ARM9TDMI-PRDC-000577 1.0
Date of Issue: 2nd August 2001
Author: Ian Devereux
Authorised by: Simon Segars

This document describes the known errata in the ARM9TDMI Rev 3 design.

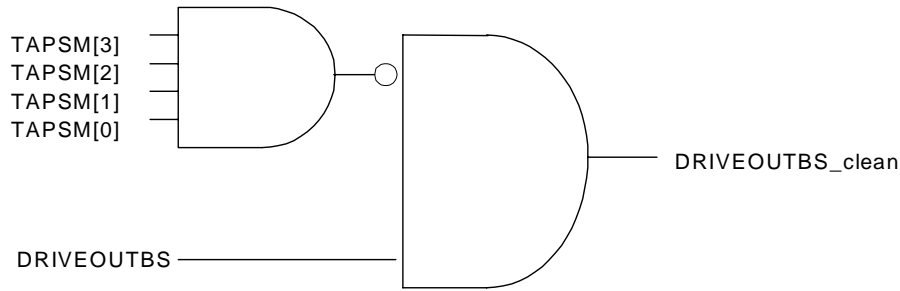
DRIVEOUTBS may be asserted incorrectly during a TAP controller reset.

If the JTAG TAP controller within the ARM9TDMI is reset, DRIVEOUTBS may be asserted incorrectly. If the DRIVEOUTBS signal is used to control the multiplexers in the scan cells of an external boundary scan chain then the boundary scan chain cells may be incorrectly controlled.

If the TAP controller state machine is made to enter the reset state by holding TMS high whilst its current instruction is INTEST, EXTEST, CLAMPZ or CLAMP then DRIVEOUTBS will be asserted for one TCK cycle. If the reset mechanism is nTRST then DRIVEOUTBS is driven correctly.

The following external logic should be added to ensure correct operation of DRIVEOUTBS.

`DRIVEOUTBS_clean = (TAPSM != 4'b1111) & DRIVEOUTBS`
