ARM ETM  
CoreSight™ ETM9™ r0 (TM910)  
**Errata Notice**

This document contains all errata known at the date of issue in CoreSight ETM9 r0 releases up to and including revision r0p1 of CoreSight ETM9

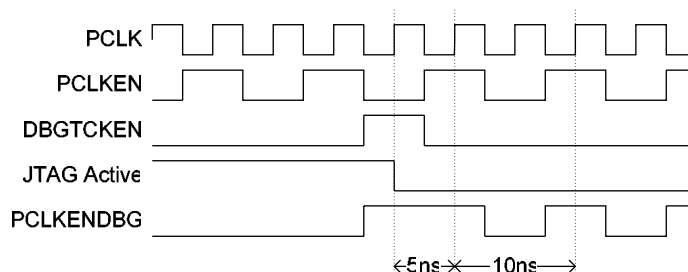
The ETMJTAGPORT in ETM9CSSingle generates PCLKENDBG as an APB clock-enable for the CoreSight ETM9. PCLKENDBG is driven from either PCLKEN (the system APB clock enable) or DBGTCEN from the JTAG synchronising logic in ETM9CSSingle. When the ETMJTAGPORT switches from JTAG to system APB or from system APB to JTAG, the PCLKENDBG input to the CoreSight ETM9 might cause consecutive PCLKENDBG pulses to be closer than synthesis constraints allow.

For example, consider if PCLK is driven at 200MHz and PCLKEN is used to produce an effective system APB clock speed of 100MHz. The time between 2 rising PCLK edges where PCLKEN is high is 10ns. If the ETMJTAGPORT switches while PCLKEN is low, then the time between 2 rising PCLK edges where PCLKENDBG is high might be 5ns. This might violate timing constraints. The timing diagram below shows how PCLKENDBG might behave

Timing constraints might be violated. This might result in failure to achieve timing closure. This is not expected to cause significant functional problems because the signals which are sampled using PCLK and PCLKENDBG in the CoreSight ETM9 will not be changing around the switching point under normal circumstances.
