ARM CoreSight™
DAP Lite (TM940)
Errata Notice

This document contains all errata known at the date of issue for revision r1p2 of CoreSight DAP Lite

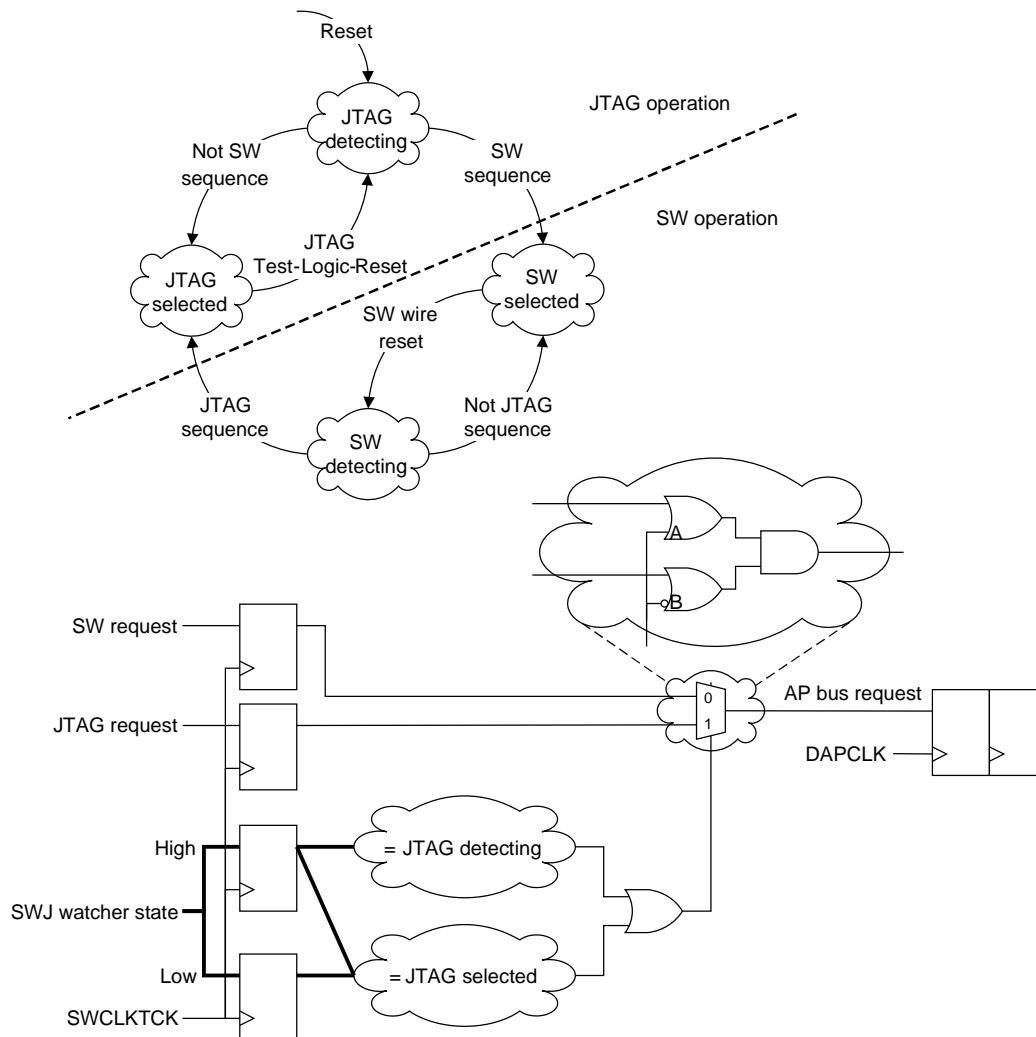
The diagram below illustrates the conditions necessary for this erratum.

If the watcher switches from JTAG operation to SW operation or back again, it can cause a glitch on the AP bus request signal, causing an unexpected access to a DAP Access Port (AP), such as the APB-AP. When the mode of operation switches, both the SW request and JTAG request signals will be Low. However, it is possible for the multiplexer which switches between these two signals to cause a glitch on its output if it is implemented as an AND of ORs structure, with a significant wire delay between points A and B of the select signal shown in the diagram above. The presence of such a delay might cause both OR gates to be asserted simultaneously, causing a glitch on the output of the AND gate.

For this erratum to occur, the glitch on the AP bus request signal must be significantly long for a logic '1' to be sampled in the following register. It is highly unlikely that the skew between points A and B will be sufficient to generate a large enough glitch for this to occur.

Furthermore, it is theoretically possible for such a glitch to be generated when switching between the JTAG detecting state and the JTAG selected state because of the method used to compare against the SWJ watcher state. A glitch can be caused on the following multiplexer, which can in turn cause a glitch on the APB bus request signal as described above. This case is only possible if the implementation includes a significant skew between the data arrival times of the two inputs to the OR gate driving the multiplexer.

- When implementing the SWJ-DP, some of the logic between SWCLKTCK and DAPCLK should be implemented using glitch-free logic to ensure that the implementation does not meet the conditions described above.
