ETM7 Rev 1a Errata

CPU Cores Division

Document number: **ETM7-PRDC-000627 3.0**

Date of Issue: 13 February 2003

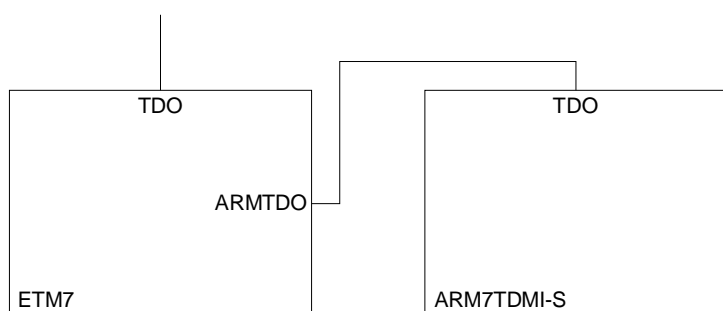
Figure 2: ARM7TDMI-S TDO connections

When the JTAG TAP controller is in the Shift-IR (0xA) state and the BYPASS instruction is selected, serial data is transferred from TDI to TDO through the BYPASS register with a delay of one clock cycle. The instruction register is supposed to be selected as the serial path between DBGTDI and DBGTDO in this situation. If the ETM TDO output is used to connect the TAP controller of another device in series with the ETM/ARM, then during Shift-IR, an undefined instruction can be shifted into the device connected.

This errata can only be observed when the ETM7 is used with an ARM7TDMI-S core, or an ARM7TDMI-S based core such as ARM720T Rev 4.

When connected to the SDOUTBS input of an ARM core, the ETM TDO output is ignored during Shift-IR. However the ARM7TDMI-S core and derivatives (for example ARM720T Rev 4) do not have an SDOUTBS input, so the ARM7TDMI-S TDO output must be connected to the ARMTDO input of the ETM instead.

The device connected in series with the ETM TAP controller but after it in the JTAG scan path will get incorrect instructions if using an ARM7TDMI-S core or derivative (for example ARM720T Rev 4).

- Instead of using BYPASS, use the CLAMP instruction. This causes the ARM7TDMI-S core to behave as if the BYPASS instruction is selected, but causes the ETM7 macrocell to behave as if the INTEST instruction is selected.
- Before using CLAMP, ensure that scan chain 6 has been deselected. This causes the ETM7 macrocell to route the ARM7TDMI-S TDO to its TDO, and in effect selects the core BYPASS register.

- Implement a shadow TAP controller which shares its TDI, TMS, CLK, TCKEN and nTRST inputs with the ETM7 macrocell.
- Implement a multiplexer on the ETM7 and ARM7TDMI-S TDO outputs. When the shadow TAP controller is in BYPASS, select the ARM7TDMI-S TDO output, otherwise select the ETM7 TDO output.
