## ARM940T Rev.2v2 Errata ListARM940T Rev.2v2 Errata List

Document number: ARM940T-PRDC-000610 2.0  
Date of Issue: 17<sup>th</sup> December 2001  
Author: Paul Garden  
Authorized by: Jason Ackroyd

This document describes the known errata in the ARM940T Rev 2 v2 design.

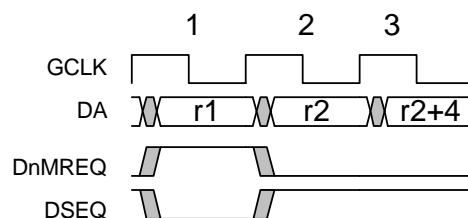
#### Example of a failing instruction sequence

A coprocessor memory transfer instruction (LDC or STC) can incorrectly have its first access (a non-sequential access) marked as being sequential.

For the first memory transfer of any memory instruction the ARM9TDMI should indicate on its data memory request signals that the transfer is non-sequential. This is indicated by DSEQ being low during this first memory access. However there is a particular situation for a LDC or STC instruction where its first memory transfer can incorrectly be marked as sequential. This case can only be invoked if a LDC or STC instruction, which fails its condition codes, is directly followed by a second LDC or STC instruction which passes its condition codes. For the precise conditions required see below.

During cycle (1) in the diagram above, the DnMREQ is high and DSEQ is low, indicating an IDLE cycle. This corresponds to the IDLE cycle generated by the LDC which fails its condition code check. In cycle (2) the first memory transfer for the second LDC occurs. In cycle DSEQ is incorrectly high, marking the transfer as being sequential.

If a coprocessor is attached with can execute LDC or STC instructions then this errata only applies if the coprocessor can execute an LDC or STC without busy-waiting the processor first. Thus a hardware workaround is to ensure all attached coprocessors insert a busy wait cycle before executing a LDC or STC.

A second work around is to ensure that the code does not contain a sequential instruction pair of LDC or STC instructions where it is possible for the first instruction to fail its condition code check and for the second to pass its condition code check.
