Roof Damage Report

3926 Danforth Dr W
Jacksonville, FL 32224

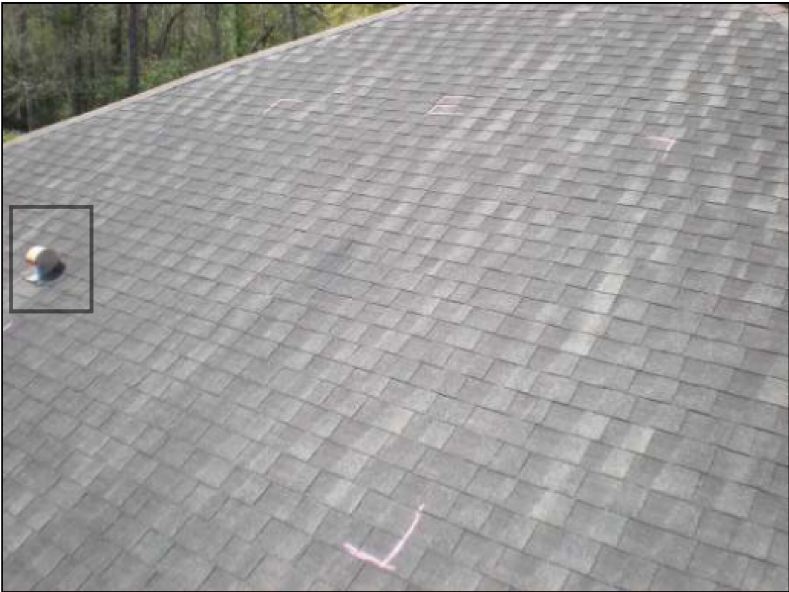
Over View of front slope
