AVR128DA Silicon Errata and Data Sheet Clarification

AVR128DA28/32/48/64

The AVR128DA28/32/48/64 devices you have received conform functionally to the current device data sheet (www.microchip.com/DS40002183), except for the anomalies described in this document. The errata described in this document will likely be addressed in future revisions of the AVR128DA28/32/48/64 devices.

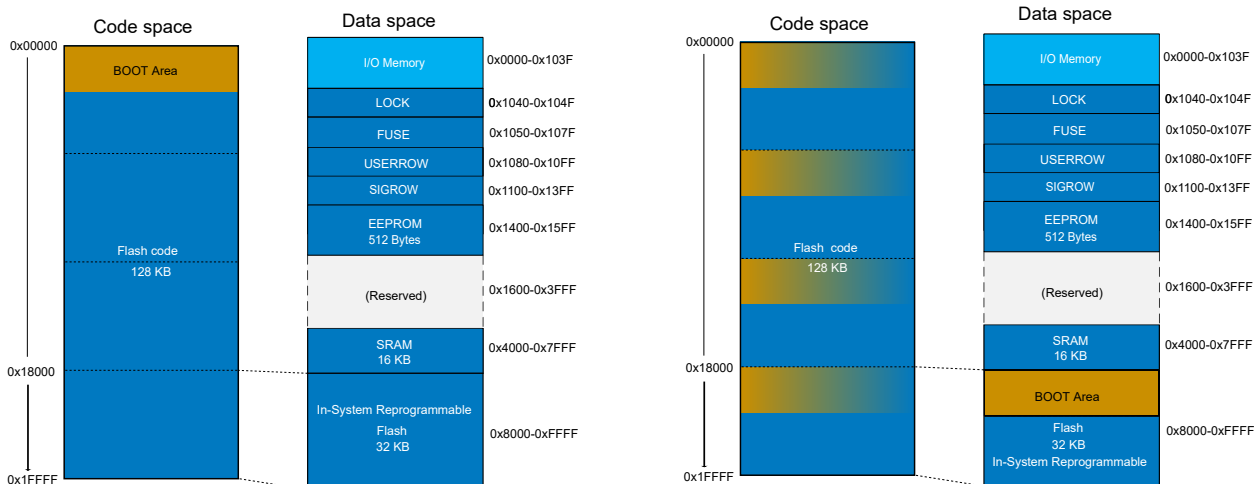
The inter-section Flash protection mechanism does not take into account the FLMAP bit field when checking if the address is in BOOT, APPCODE or APPDATA areas. It uses for comparison only the address offset between Flash start address in data space (0x8000) and the accessed address. This will cause the mirroring of the BOOT area in each Flash section selected by FLMAP (in blocks of 32 KB). Refer to the image below.

BOOT area for devices without issue

BOOT area for devices with issue

For read operations, the FLMAP bits work as documented when the Boot Read Protect (BOOTRP) bit is not enabled. For write operations, the inter-section Flash protection works properly only when FLMAP is set to '0x00'.

Use only store program memory (SPM) instructions to write and load program memory (LPM) instructions to read Flash memory.
