MSP430G2553 Device Erratasheet

1 Revision History

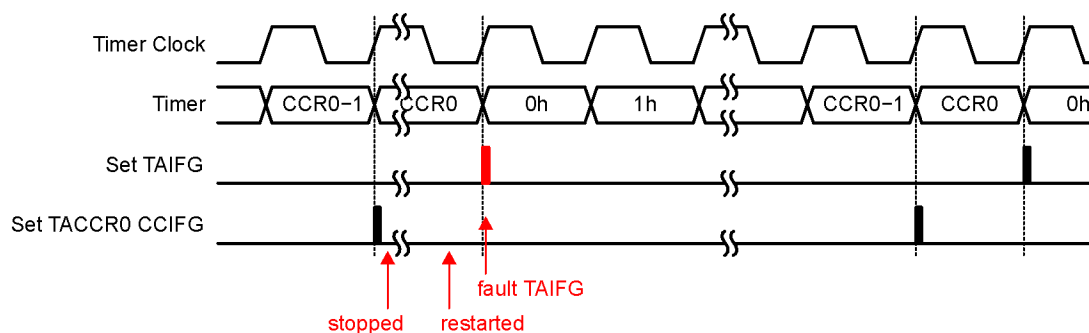
TA21 *TIMER_A Module*

Function TAIFG Flag is erroneously set after Timer A restarts in Up Mode

Description In Up Mode, the TAIFG flag should only be set when the timer counts from TACCR0 to zero. However, if the Timer A is stopped at TAR = TACCR0, then cleared (TAR=0) by setting the TACLR bit, and finally restarted in Up Mode, the next rising edge of the TACLK will erroneously set the TAIFG flag.

Workaround None.
