## Arborist Report

1325 Monterey Road  
South Pasadena, CA 91030

St. James Episcopal Church  
1325 Monterey Road  
South Pasadena, CA 91030

January 17, 2022

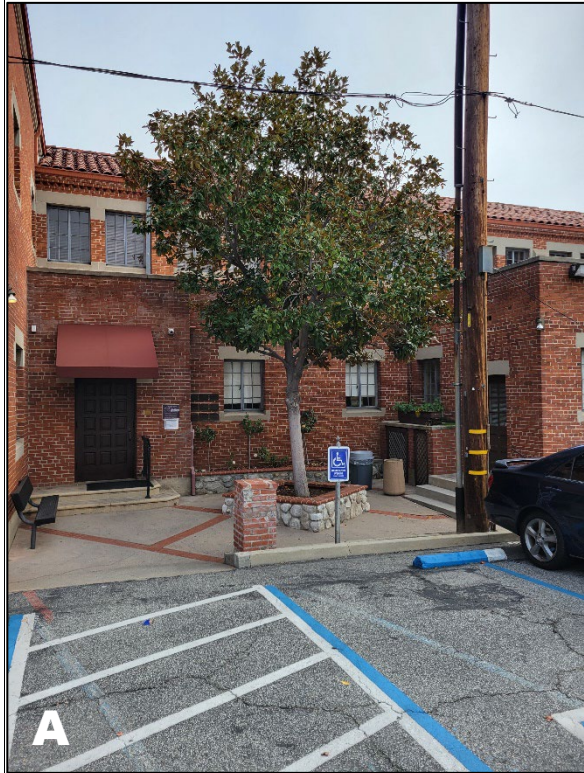
Tree	Photo	Species	Size	Condition	Comments
1	A	Southern magnolia ( <i>Magnolia grandiflora</i> )	DBH: 8" Height: 25' Width: 15'	Fair	Growing in a 4' 6" x 4' 6" planter. Has a buried <b>root crown</b> . Tree located in proposed construction area.
2	B, C	Italian cypress ( <i>Cupressus sempervirens</i> )	DBH: 10" Height: 30' Width: 3'	Poor	Growing in a 2' x 4' planter space. Lower 10' of trunk has no foliage. Tree located in proposed construction area.
3	B, C	Italian cypress ( <i>Cupressus sempervirens</i> )	DBH: 10" Height: 30' Width: 3'	Poor	Growing in a 2' x 4' planter space. Lower 10' of trunk has no foliage. Tree located in proposed construction area.

Photo A, facing east, showing Southern magnolia in a 4' 6" x 4' 6" raised planter.

1. Remove the two Italian cypress and one Southern magnolia.
2. Plant three 24-inch box trees as replacement trees for the trees removed.

1. Remove the the two Italian cypress and retain the Southern magnolia.
2. Plant two 24-inch box trees as replacement trees for the trees removed.
3. Side-box in-place the Southern magnolia under the supervision of the project arborist.

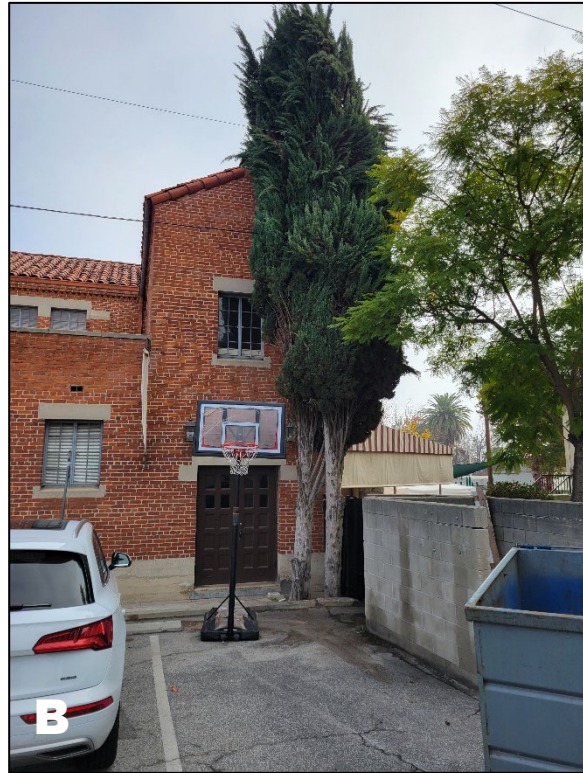
Photo B, facing east, showing two Italian cypress in a small planter with limited space.

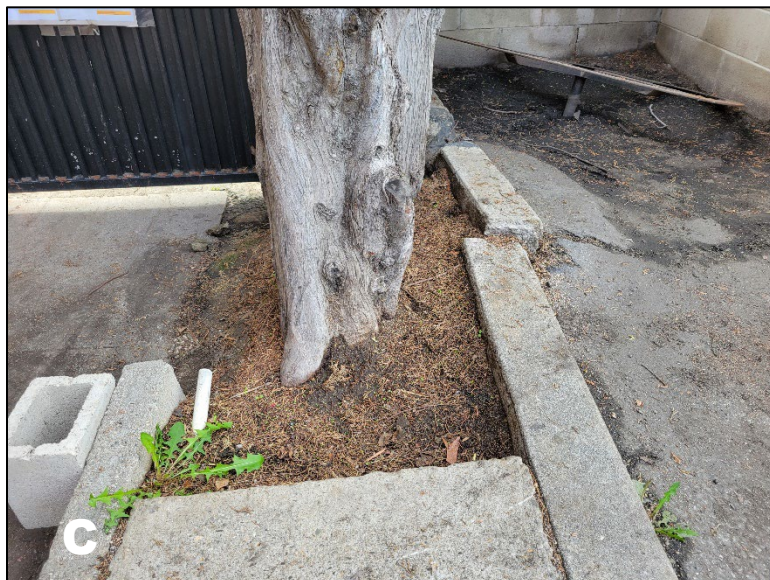
Photo C, facing south, showing detail of 2' x 4' planter with limited space where the Italian cypress are growing.
