City Of South Pasadena  
Tree Removal Request

1040 Orange Grove Ave  
South Pasadena, Ca 91030

**Oct 21<sup>st</sup>**

***Subject: Diseased and Defective Canary Island Palm Removal Request***

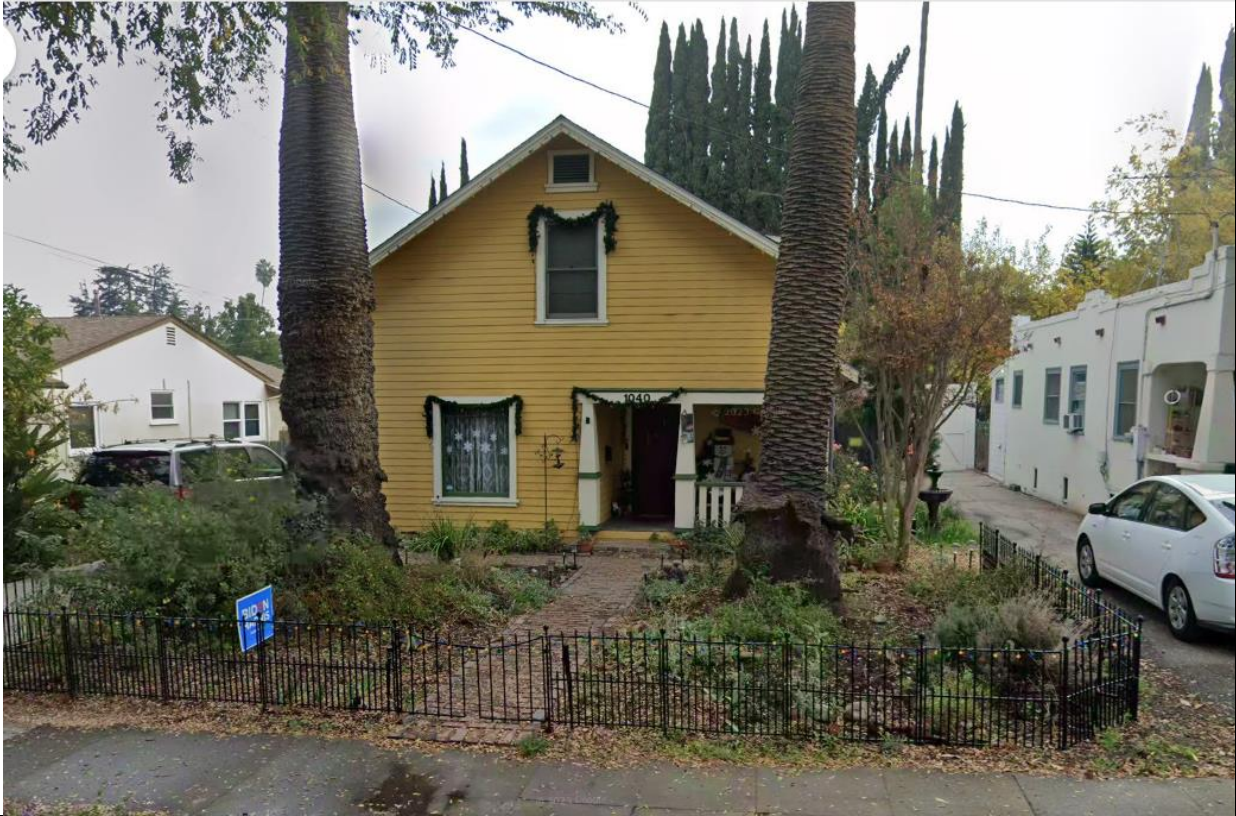
The 2 Palm trees are planted too close together. The crowding has created a lean in their growth. Although the lean is slight, the two trunks are leaning away from each other. This species of Palm is very top heavy and not well adapted to resist leaning.

Street view from Dec 2020 (Notice lean on the trunk of the Palm on the right (Tree #2) (Notice the original grade of the trees seen here)

These trees are not known to withstand leans. While some species like the Mexican fan palm can withstand leans, these slender flexible palms are much different than the stout Phoenix canariensis. These trees have huge buds with enormous weight which needs to be centered over the base of the tree. I'm concerned about the uncorrected lean of these trees. I think that it was caused because the trees are planted too close together and their fronds are overlapping and competing.

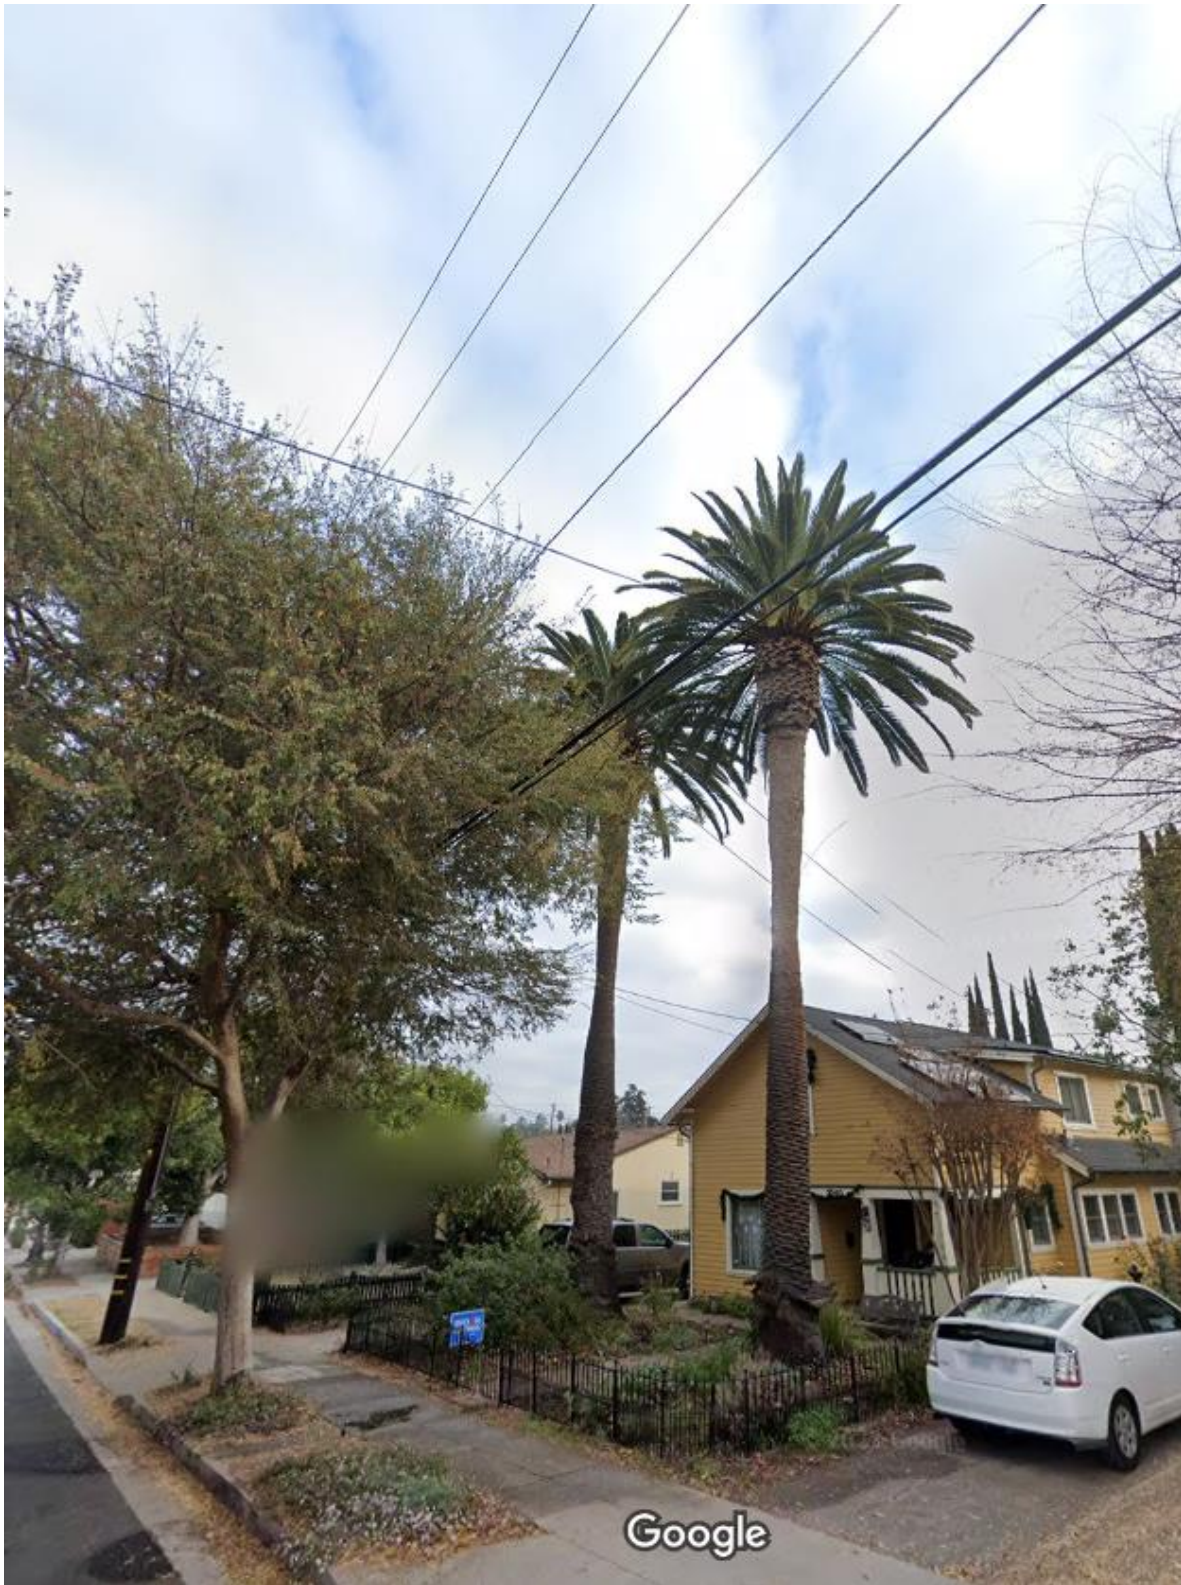
The last concerning condition that I noticed is that while the base of the Palm trees have a diameter of 30" and 36", over-pruning of these trees in the past have led to dangerous and irreversible taper in the trunks to about 18" (approx.) near the middle. From this narrow point upwards, the palm trunks widen again. Allowing these trees to continue getting taller and heavier above this 'pinch' point is unsafe.

These trees are also poised to impact the utility lines as they continue to grow taller. It is the general consensus of Utility companies to remove Palm trees adjacent to high voltage power line due to the hazard posed by falling fronds.

Street View Dec 2020 (Notice trunk taper) (Palms appear to be trimmed and healthy) (Notice the proximity to the high voltage power lines)

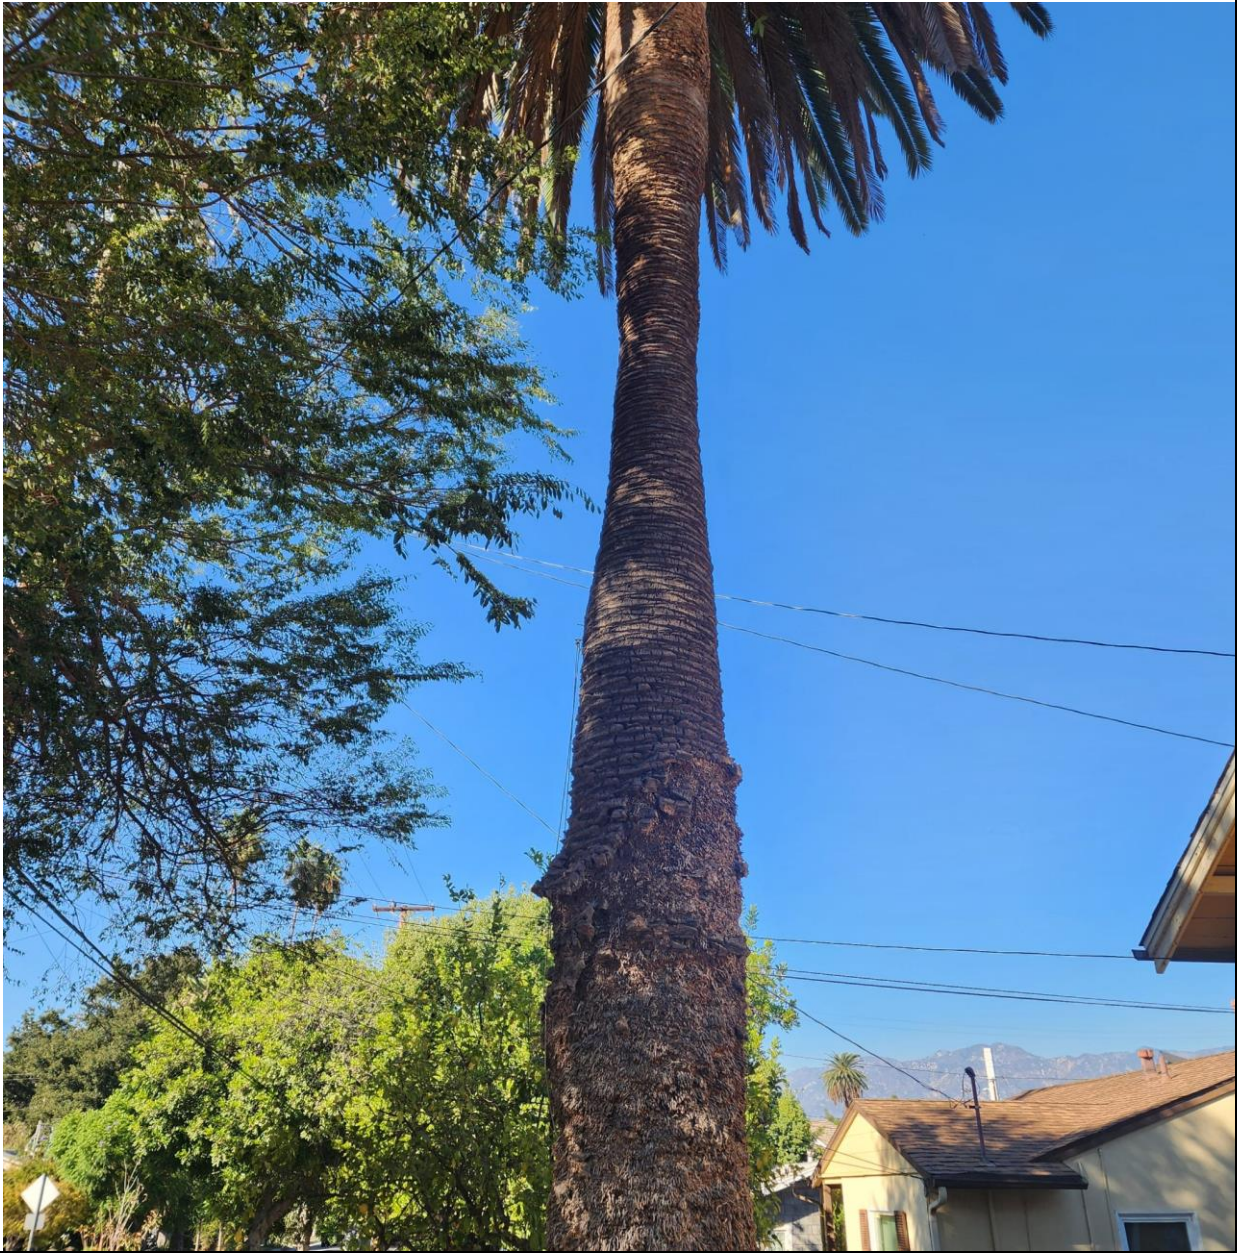
Palm Tree #1 (Notice the significant taper creating a weak point about 20ft up the trunk)

These Palms also develop their trunk size at an early age and maintain a uniform trunk girth as they grow. These trees are not supposed to have fronds removed past the horizontal plane as this creates an unnatural taper that predisposes the tree to poor form. The subject trees are displaying a very significant reduction in taper. This is a serious defect that only become more important as the trees grow taller.

The current recommendation is to remove and stump grind the subject trees and demolish the above ground planters in order to remove the trees completely. Remove as much of the ground up stump shavings and soil in order to remove as much of the diseased soil as possible. Import fill soil to cover the stump locations.

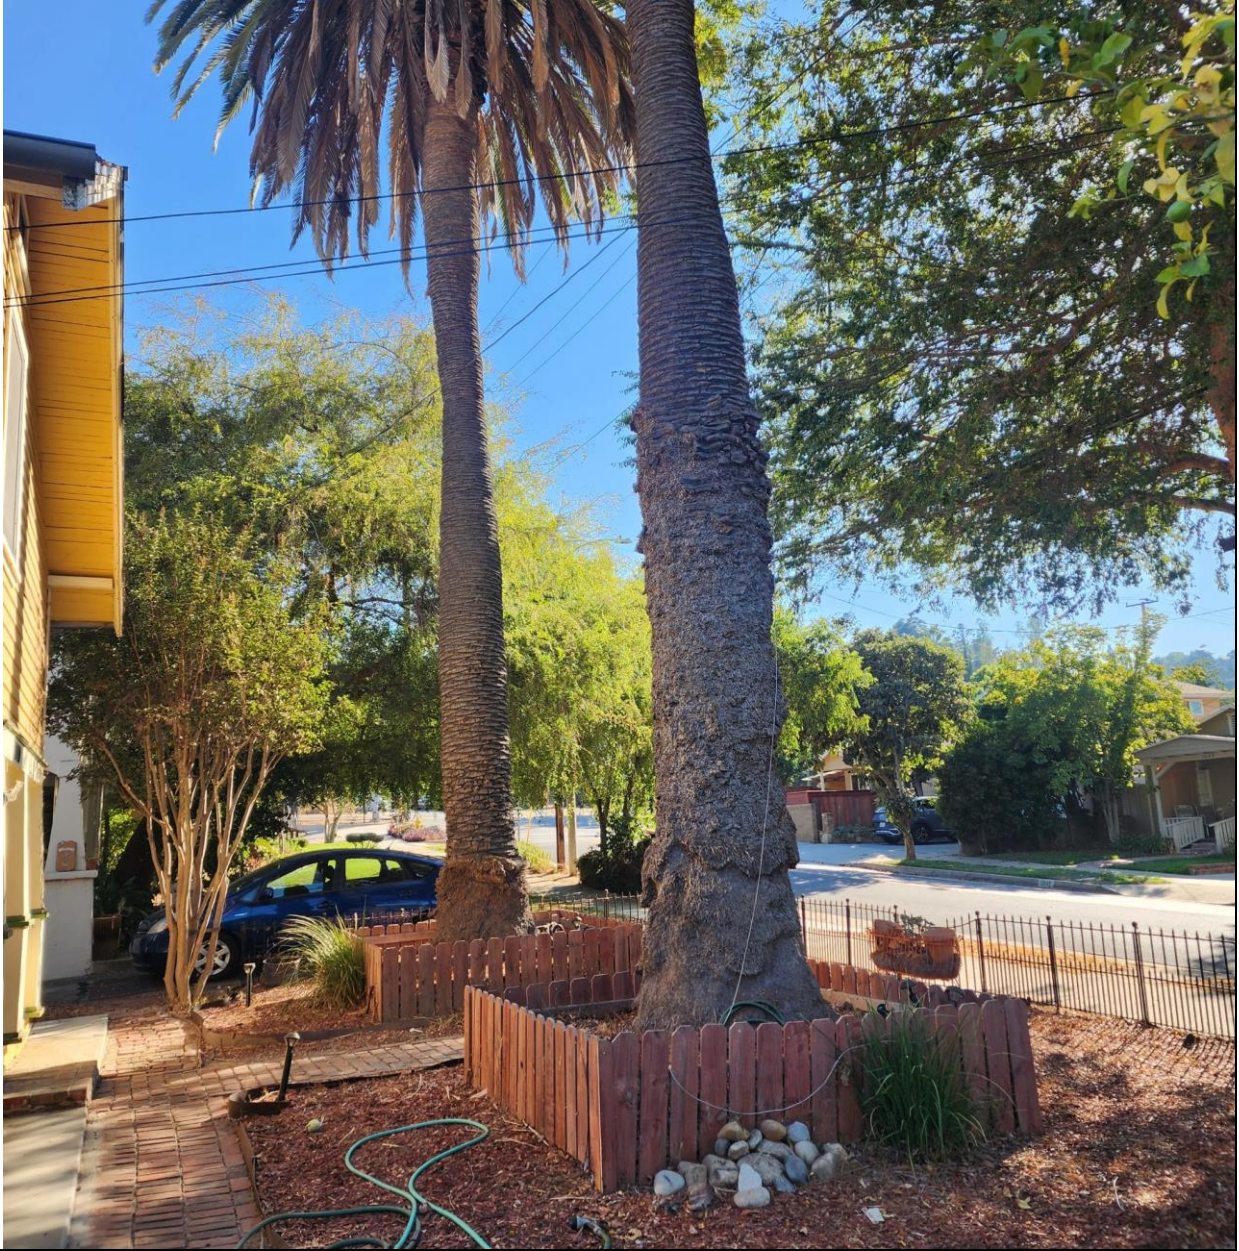
Palm Tree #2 (Background) (Notice the significant taper in the trunk about 20ft up. There is also a 'crook' in the tree where the angle of the trunk changes).

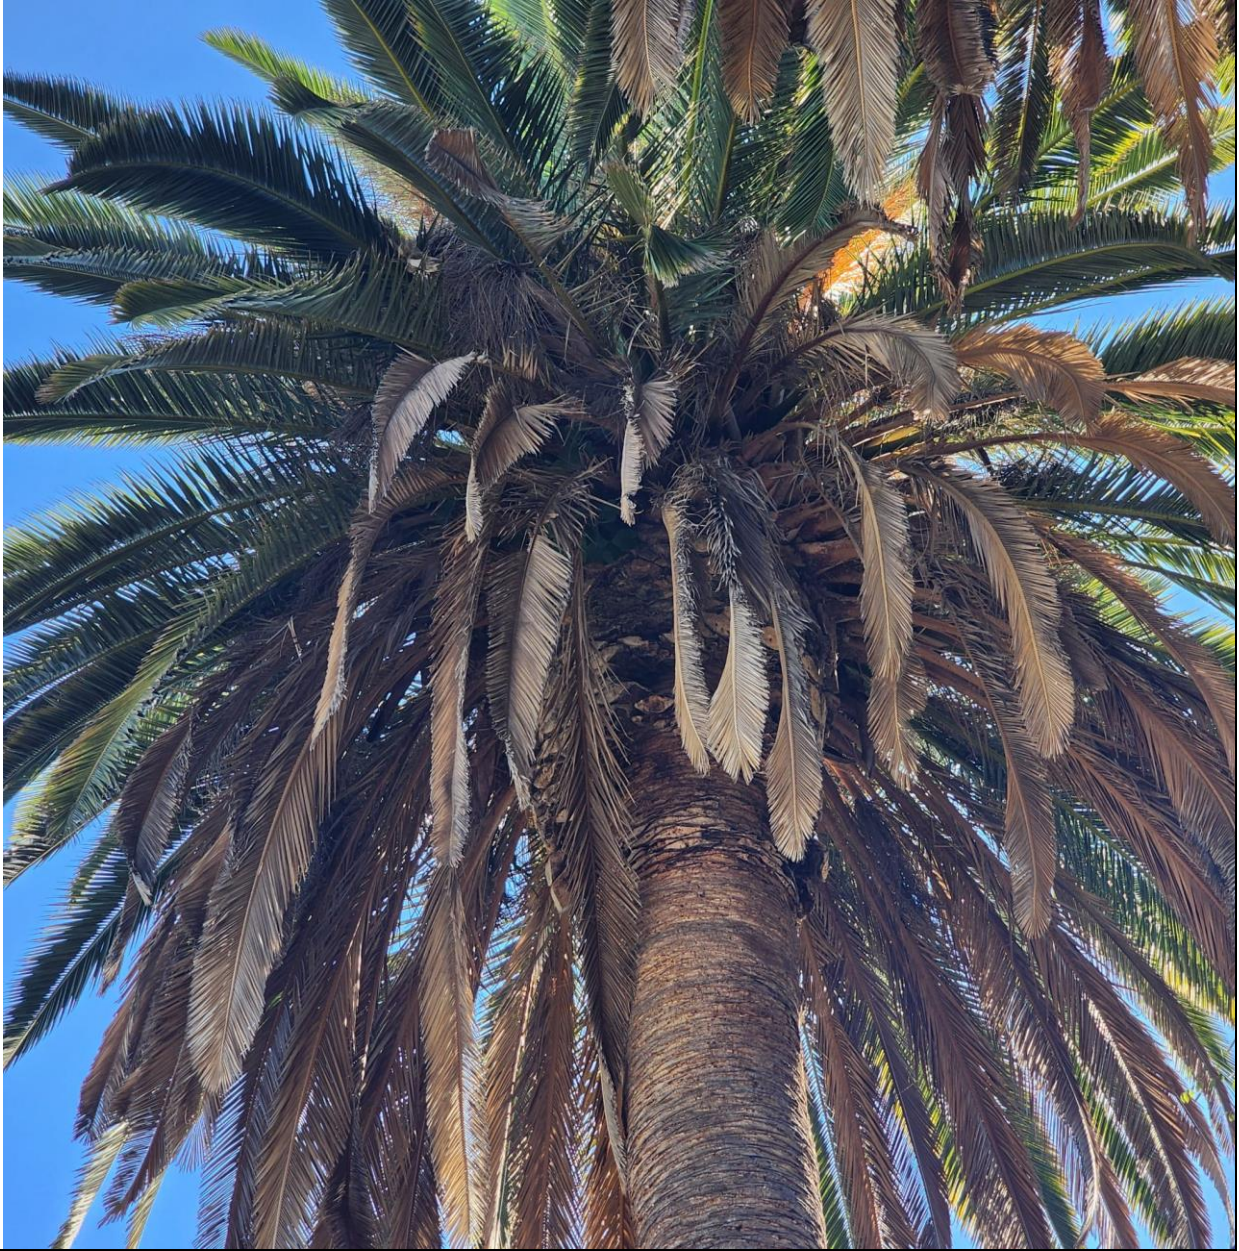
The crown of the trees appear to have Fusarium dieback, a widespread fungal disease that attacks this species. The fungus is a vascular disease meaning that once it has made its way into the vascular bundles of the tree, it will spread throughout all parts. The prognosis for this disease unfortunately is a slow and certain decline. You can see how the tree on the right side has a pocket where the fronds are noticeably discolored (dark) and are falling off the tree prematurely. This disease has no effective cure.

Palm Tree#2 (Notice the diseased canopy showing signs of 'Fusarium dieback')

different airborne pathogens, varying soil types, confined planting spaces, poor pruning practices, climbing spikes, and marine influence + coastal rains. With our back to back rainy years and the gloomy early summer we experienced in 2024, the prevalence of Fusarium wilt has increased significantly. Once a Canary Island Date Palm becomes infected, removal of the tree is recommended to prevent the spread to other nearby healthy trees. The pathogen can lay dormant in the soil and therefore replanting of the same species tree is not recommended as re-infection is likely.

There is evidence that the trees have both fungal issues at the base of the tree from grade disturbance as well as Fusarium dieback clearly evident in the canopy. Fusarium dieback is considered to be untreatable and fatal. Retention of these trees can also spread airborne spores and threaten nearby healthy trees.

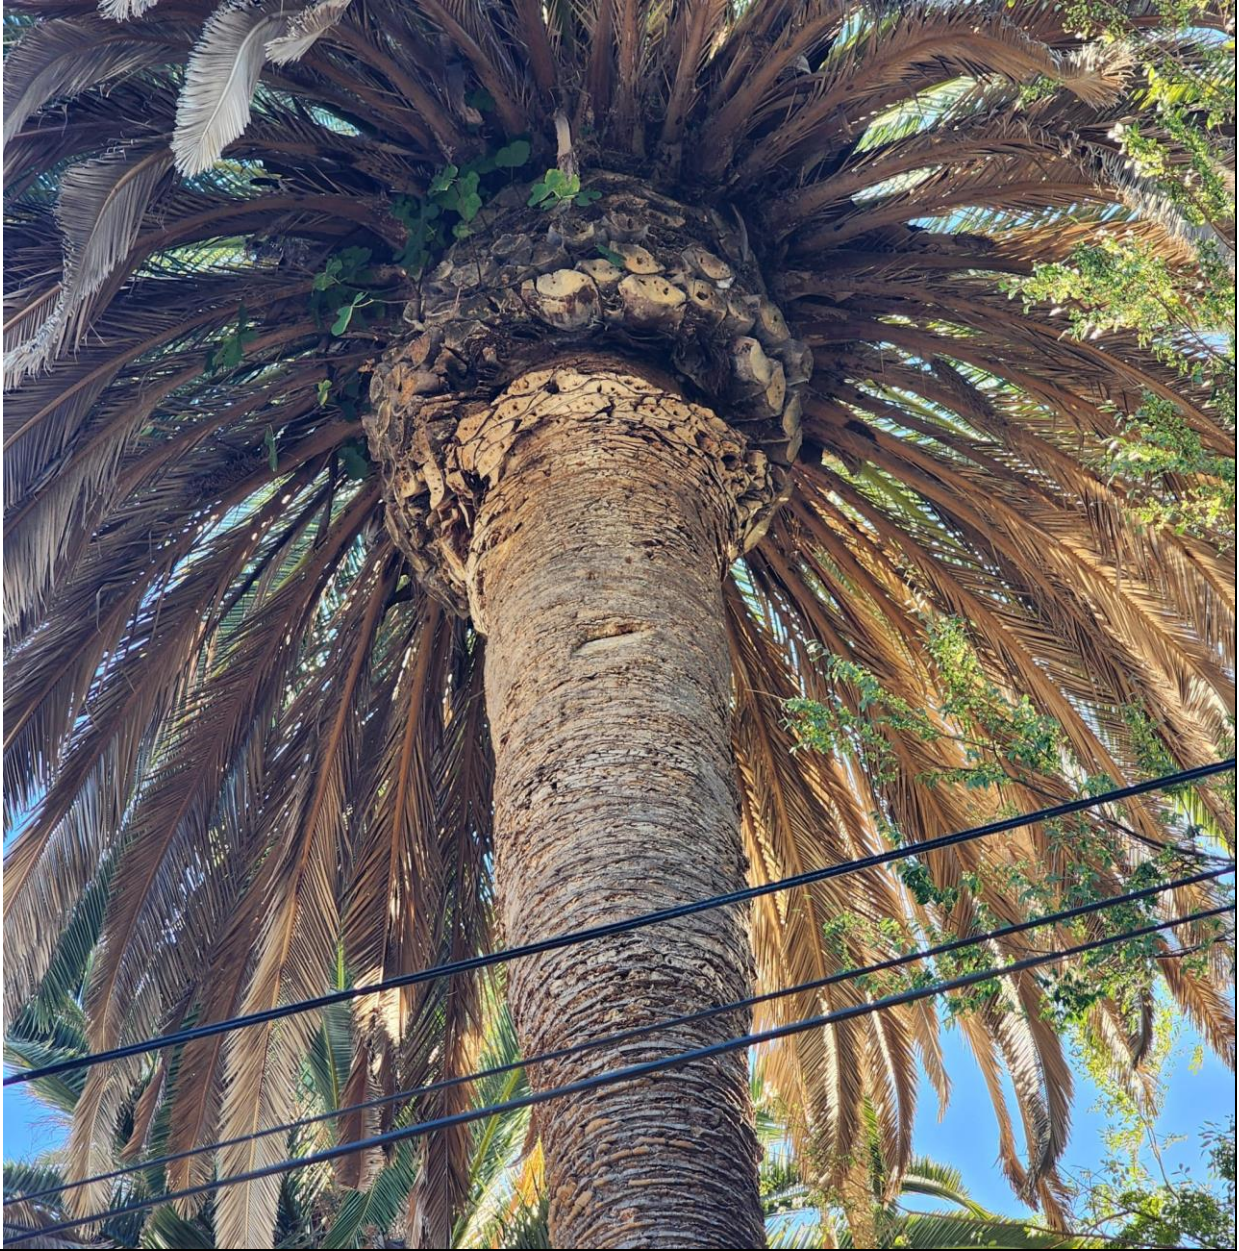
Based on my experience, the 2 Canary Island Palms in your front yard pose a potential hazard due to some unusual and worrying root and trunk characteristics as well as showing symptoms of a fatal fungal disease evident in the bud. These trees are a non-native species that are declining throughout the region. The risk of tree retention is too great to ignore. The potentially severe consequences of these trees failing makes tree removal the only prudent mitigation option.

Palm Tree #1 Canopy (Notice the decaying bud and weeds growing out of the bud)

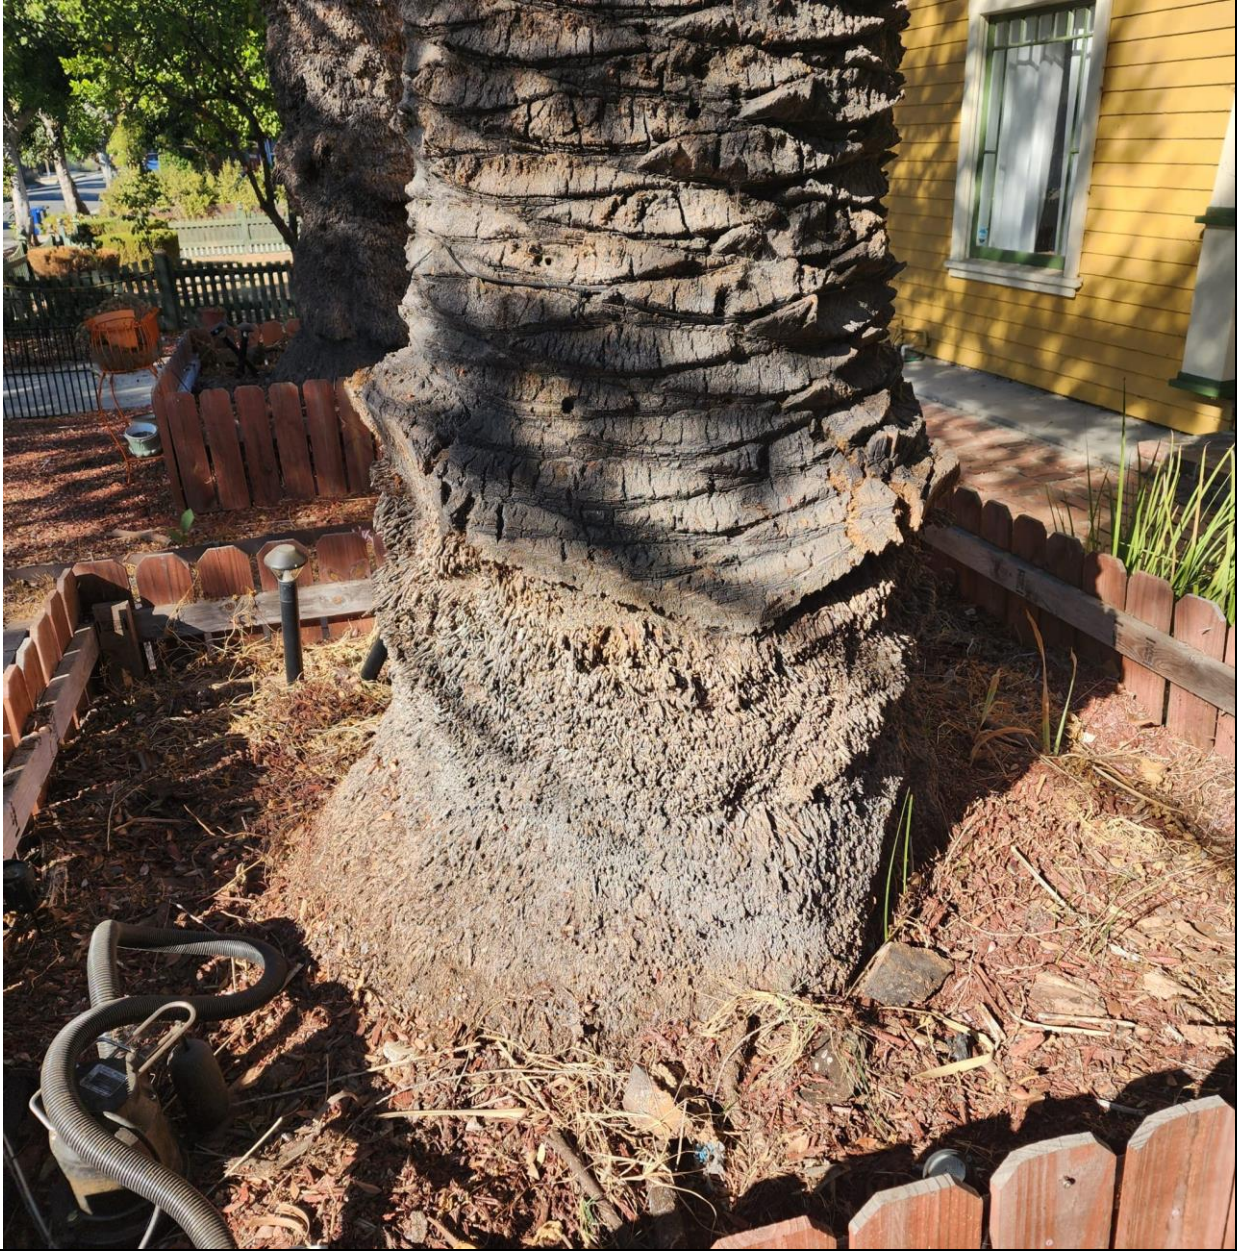
The two palms have built up planters around their base. The planters are full of soil and mulch. Trees do not do well when their natural grades are disturbed. The addition of soil above the original grade is a formula for decay and rot. Upon doing some manual digging at the base of the tree, I discovered areas that has apparently rotten roots and sunken trunk tissue with white fungal mycelia growing on it. This is generally an indicator that a fungal disease has begun digesting the structural tissue of the tree and weakening the trunk.

Palm Tree #2 (Notice the soil grade has been raised around the base of the tree)

Palm trees have fibrous root systems that grow from a root initiation zone. Palms like these are not adapted to disturbed soil grades or erosion. These trees do not need mulch or rich compost and actually become more susceptible to disease when they are exposed to grade changes and thick compost/mulch layers.

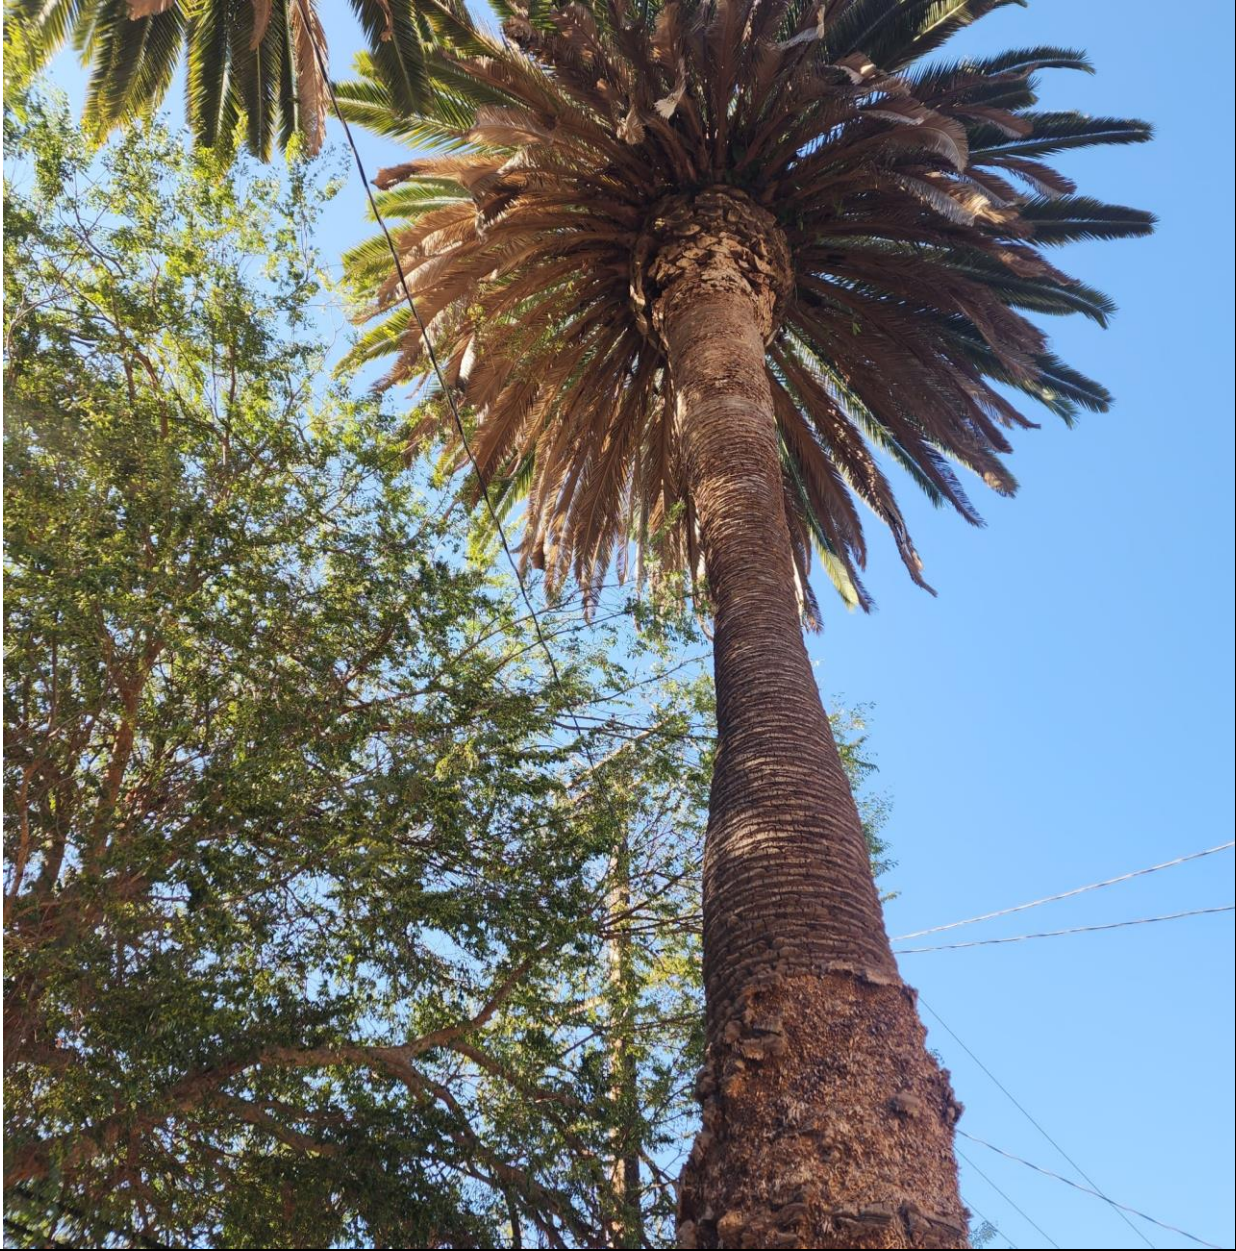
Palm Tree #1 (notice proximity to power lines/service lines)
