PROJECT REPORT STAGE-1

**IMPROVEMENT IN QUALITY PPM IN REJECTION AND REWORK
FOR CUP-MACHINING OPERATIONS ON GILDEMEISTER (AS-48).**

➤ Project Sponsored by- CUMMINS India limited, Kothrud.

- **Gildemeister (AS-48)** is a cam operated- **Multi-spindle** automat machine.
- The machine was procured in **1971** by **Cummins India Limited., Kothrud**
- The machine is used for performing machining operations for diesel-generator-injector **cup**(nozzle).

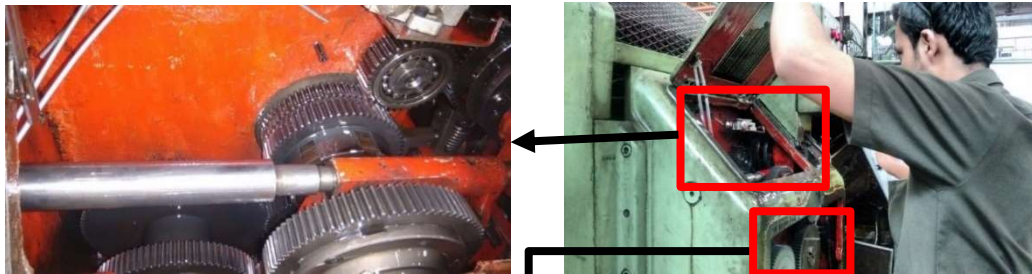
Gear adjustment lever mechanism

1.Jamming of slides

- **Causes:-** Slide lubrication is inadequate and the gear tooth were a bit worn out leading to lag in gear timing.
- **Rejection Frequency :-** Twelve jobs every month.

- There is frequent activation of safety-clutch due to jamming of slides.
- The safety clutch in gear adjustment level disengages if the slides are jammed.

❖ All six jobs on six spindles are rejected.

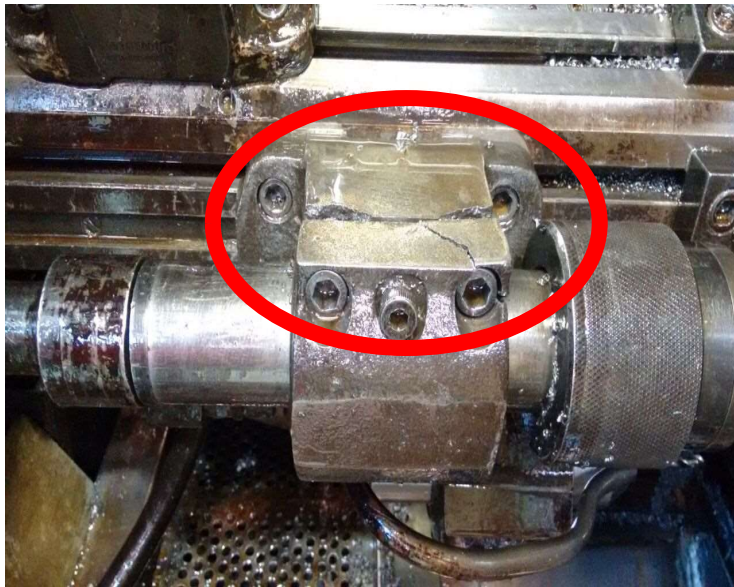
Broken tool holder

2.Tool holder broken

- **Causes:-** Vibrations and stress loading.
- **Rejection Frequency:-** 4-5 jobs were rejected daily for almost a week.

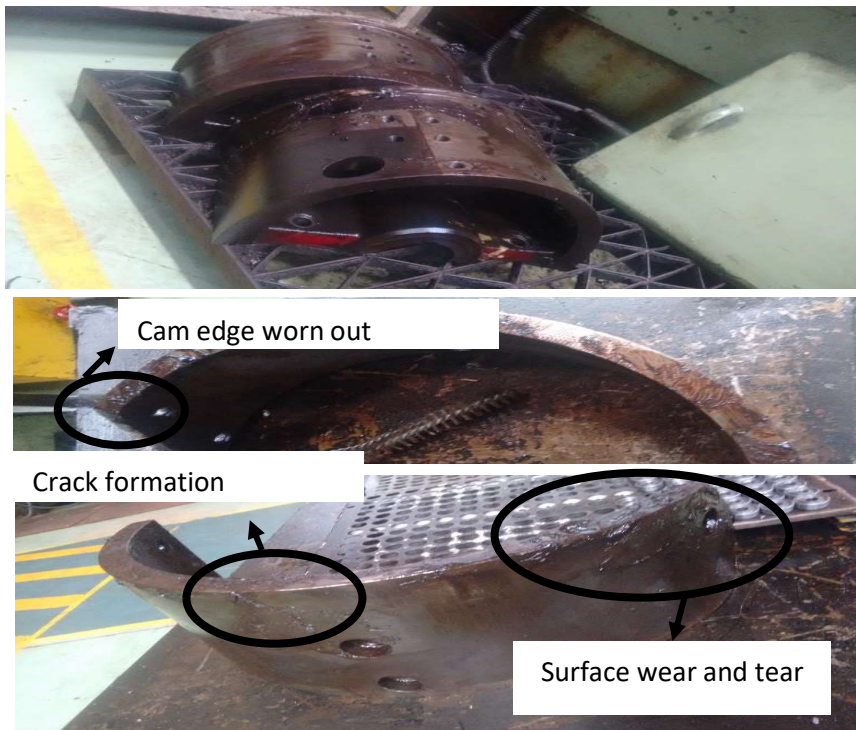
3.Worn out Cam profile

➤ Causes:-

1. Inaccurate cam profile
2. Cam edge worn-out
3. Crack formation
4. Surface wear and tear.

➤ Effects:-

1. Inaccurate central-block motion
2. Wear and tear of gears

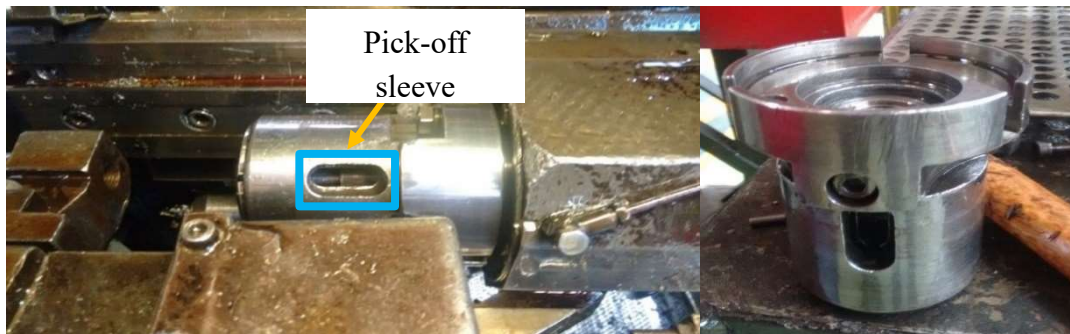
Pick-off collet

4. Pick-off Dysfunctions

➤ Causes:-

1. Pick-off sleeve is worn out.
2. Mandrill bar of pick-off is slightly bend.
3. Cup O.D reduced beyond tolerance.
4. Pick-off spring malfunctioned

➤ Effects:-

1. Cup breakage
2. Surface indentation and scratches on cup.

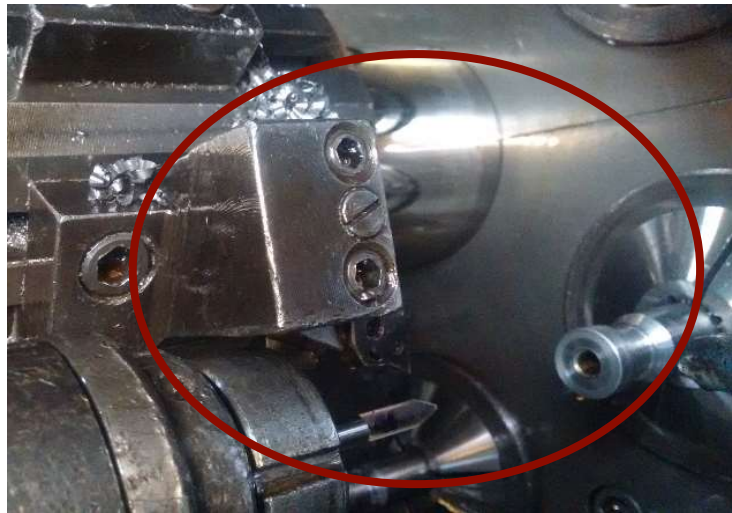
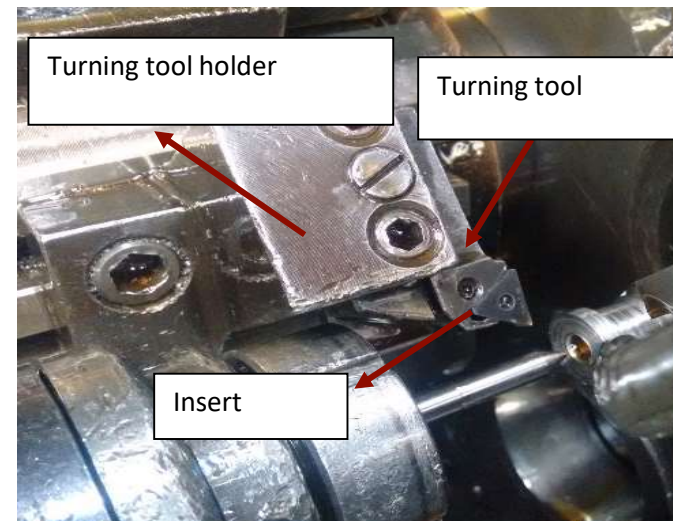
Turning tool mechanism

5. Turning tool positioning problem.

- The Turning tool has to be set for three different cups- K, STC, STD.
- **Causes:-** Turning tool setting done on trial and error method using dial gauges.
- **Rejection Frequency:-** 3 parts per day
- **Effects:-** Faulty plunge profile on cup.

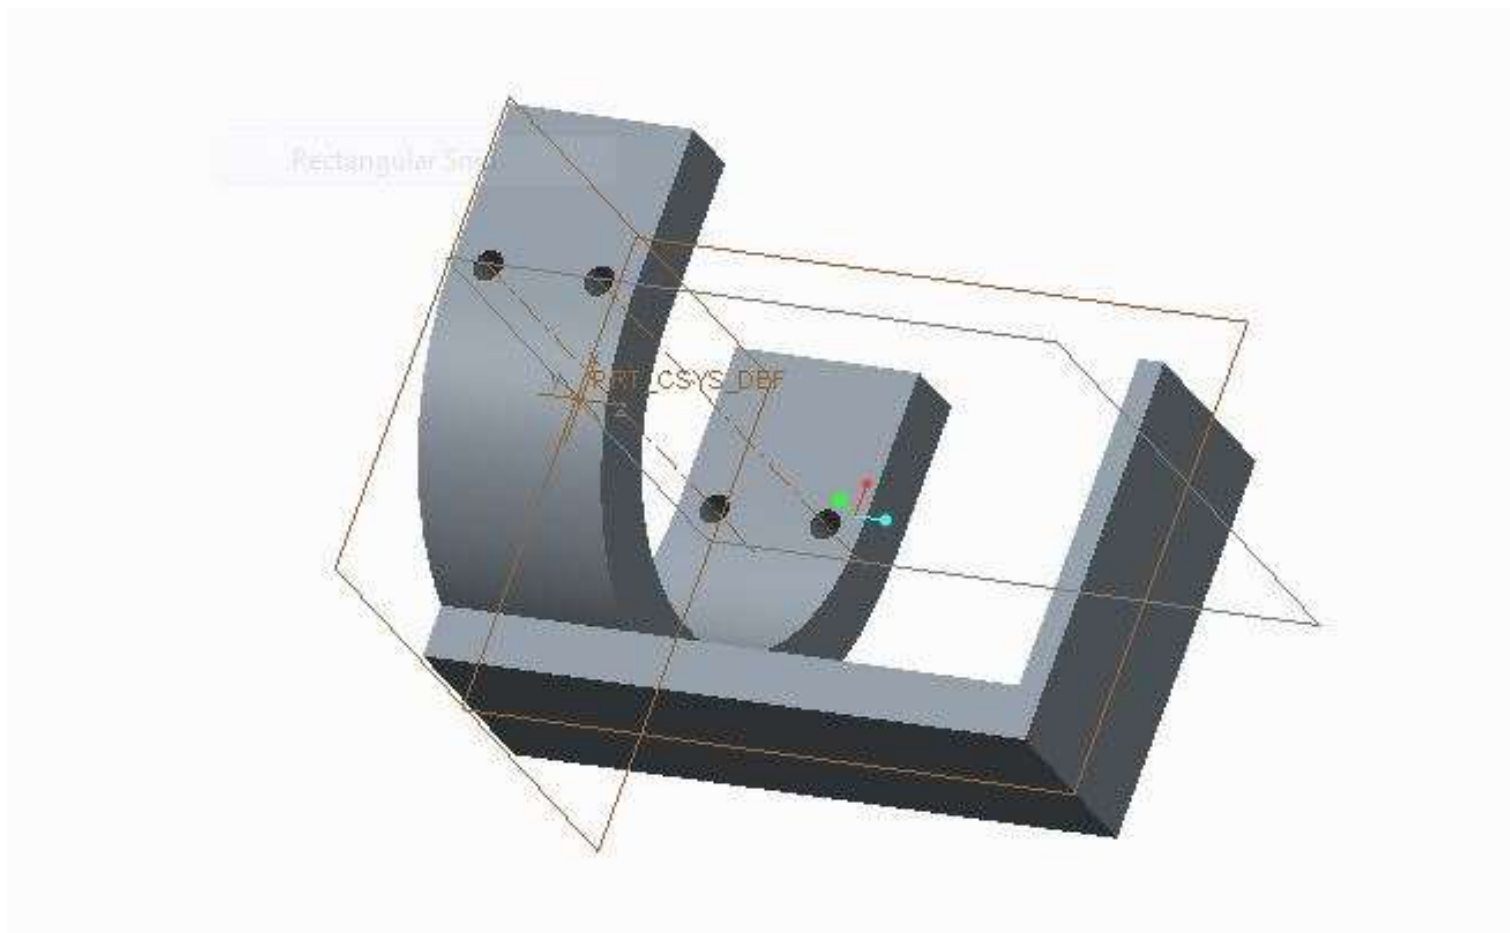
Solution for Cone-drill Problem

Problem Statement – Error in measurement of cone drill length on station 2

➤ Solution –

- We have designed measuring gauge to tackle the arbitrary measurement taken on cone drill .
- The cone drill is 30 degree and the length of the cone drill outside the tool holder is not fixed.
- Thus C- clamp has been designed to accurately measure the length of the tool length outside the tool holder.
- The L shaped scale fabricated on the C – clamp perfectly aligns the tip of the cone drill at accurate length .
- This is an offline operation

PROCEDURE – 1) The C- clamp is fixed on the holder with the help of nuts .

2) The tip of cone drill is aligned as per the L shaped .

3) Once the tool length is fixed the C –clamp is removed .
