Structural Health Monitoring of Wind Turbine Blades

*A Diagnostic Study of Structural Anomalies and Failure
Detection in Rotor Blades*

Raonak Shukla

November 17, 2025

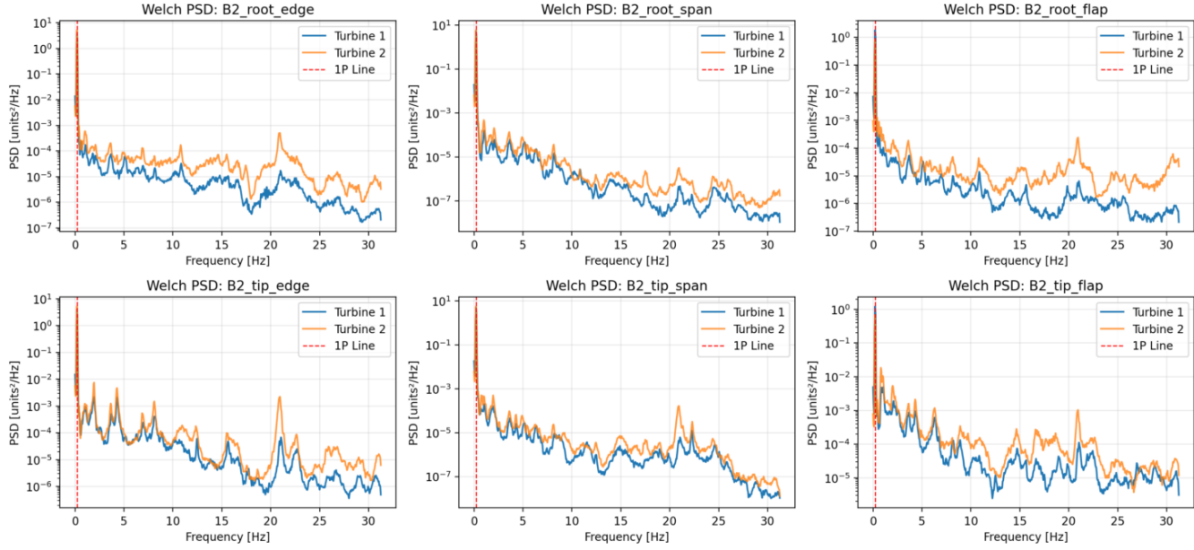
Figure 2: Welch Power Spectral Density Comparison for Blade 2

A comparison of the Welch Power Spectral Density (PSD) plots for Blade 2 on Turbine 1 and Turbine 2 reveals a consistent and systematic increase in vibration energy across all measured directions, edge, span, and flap and at both the root and tip of the blade. Under identical operating conditions, as confirmed by the identical 1P rotor-frequency line, Turbine 2 exhibits broadband PSD amplitudes that are significantly higher than those of Turbine 1 from approximately 1 Hz to 30 Hz. This effect is most pronounced in the flapwise direction, where the PSD levels of Turbine 2 exceed those of Turbine 1 by up to an order of magnitude in the 5–15 Hz band, which is strongly influenced by the blade’s primary bending modes. The tip sensors show these differences even more strongly, suggesting the vibration increases toward the blade tip. This points to a change in overall blade stiffness or mass, not a problem at the root or with a sensor.

The PSD elevation observed in Turbine 2 across all three orthogonal directions, but especially in flapwise bending, provides strong evidence of reduced structural stiffness, increased effective mass, or increased damping relative to Turbine 1. This interpretation directly aligns with the modal analysis results, which showed a 20–25% reduction in the first flapwise natural frequency for all blades on Turbine 2. The combined frequency-domain and modal-domain indicators therefore point toward a turbine-wide change in dynamic characteristics likely arising from blade softening, moisture ingress, or deterioration of load-bearing laminate or pitch-root boundary stiffness. The PSD findings confirm that Turbine 2’s blades are softer and show higher vibrations, suggesting the need for further inspection.

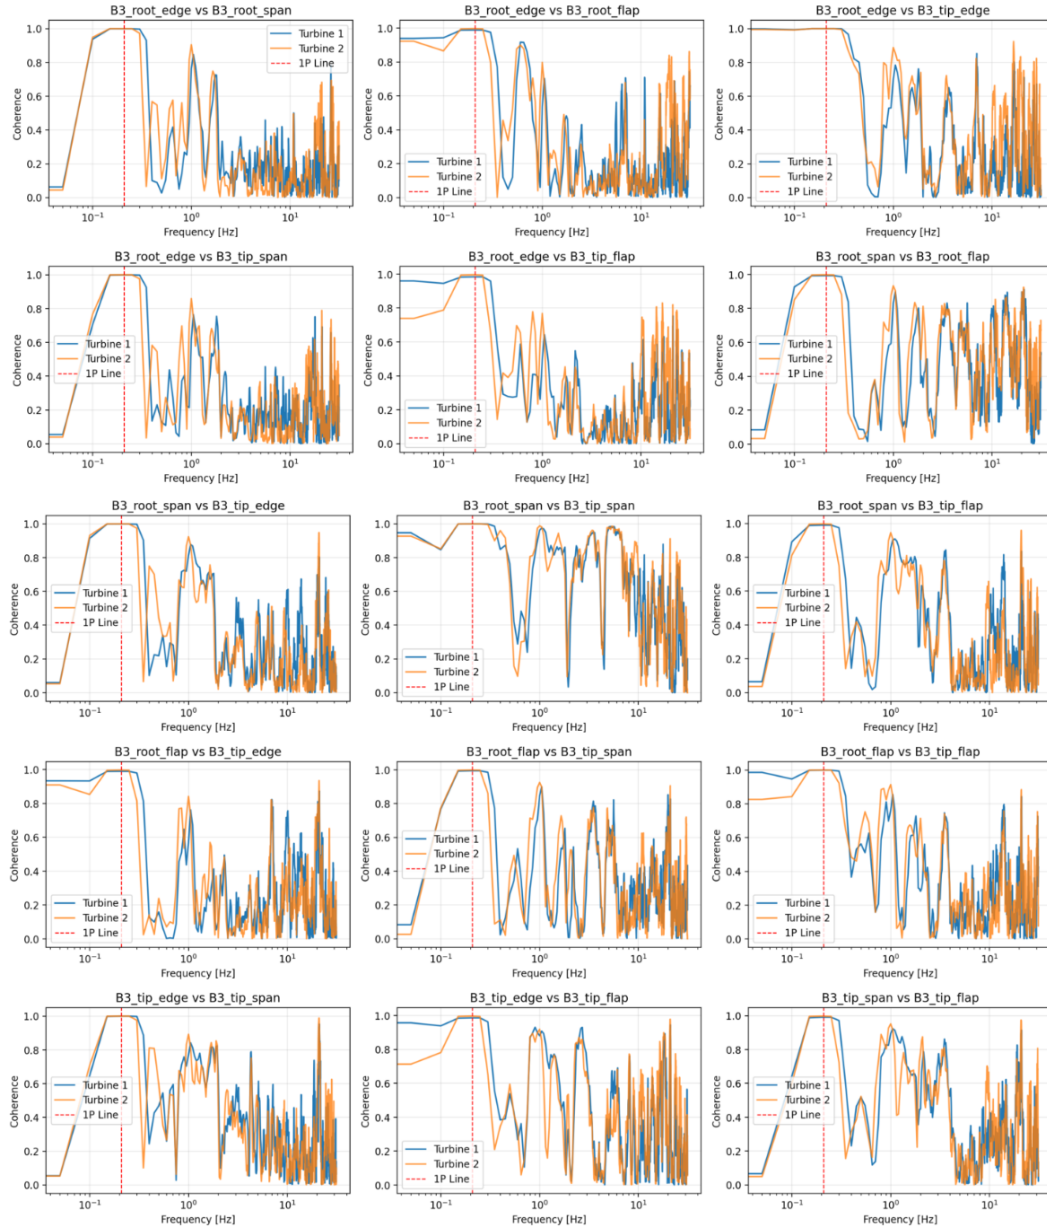
Figure 3: Coherence Analysis for Blade 3

In contrast, Turbine 2 shows consistent structural irregularities across nearly all coherence pairings. Although low-frequency coherence remains high, indicating that global motion is still intact, coherence begins to drop noticeably earlier than in Turbine 1, particularly in root–tip pairs, where the decline often starts before 0.4–0.5 Hz. This early loss of coherence implies that bending waves do not propagate cleanly along the blade, a hallmark of mid-span stiffness reduction often associated with spar-cap cracking or shear-web delamination. Above 1 Hz, Turbine 2 displays irregular, fragmented coherence behaviour rather than the smooth modal structure observed in Turbine 1. These irregular dips and scattered coherence values point to disrupted load transfer along the blade’s length.

The most striking deviations appear in the tip–tip and cross-directional pairings. Turbine 2 shows abnormally high coherence between unrelated degrees of freedom at the tip (e.g., tip-edge vs. tip-flap), particularly in the 10–18 Hz range. Such behaviour does not occur in the healthy blade and strongly indicates increased torsional–bending coupling. This

typically arises when stiffness is locally reduced near the trailing edge or spar cap, causing the tip region to move more uniformly across multiple directions. Additionally, several cross-directional root-tip pairings show elevated coherence only in Turbine 2, suggesting that damage-induced asymmetry or local delamination is altering the dynamic response.

Taken together, the coherence patterns provide robust evidence of structural degradation in Turbine 2’s Blade B3. The early loss of root–tip coherence indicates impaired load-transfer efficiency along the span, while the abnormally high tip-level cross-direction coherence points to localised damage near the tip, characteristics commonly associated with spar-cap cracking, trailing-edge separation, or shear-web delamination. These findings are consistent with the increased transmissibility, PSD elevation, and modal-shape distortions observed in later analyses. Overall, the coherence analysis supports the conclusion that Turbine 2 exhibits significant stiffness loss and emerging structural damage, warranting targeted inspection through UAV imaging, thermography, or tap-testing.

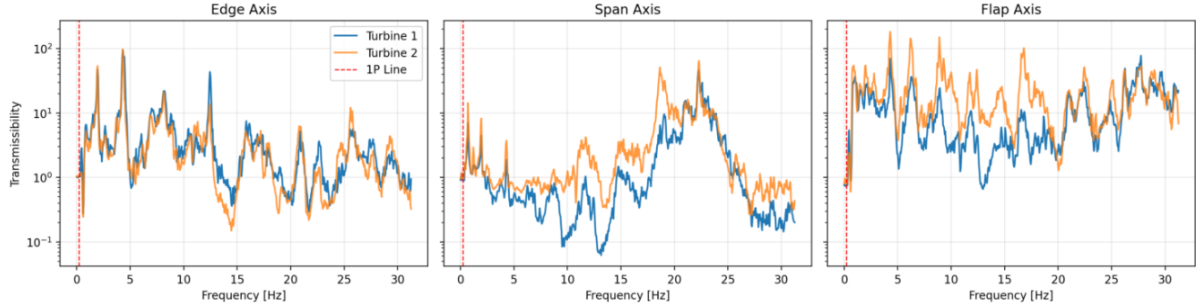
Figure 4: Transmissibility Analysis for Blade 1

Transmissibility quantifies how vibration energy propagates along the blade and is defined as the ratio of the tip PSD to the root PSD for a given axis. It is a key structural health indicator in wind turbine analytics because it is highly sensitive to changes in bending and torsional stiffness, can reveal damage progression, and enables consistent comparison across time, operating conditions, and turbines. In the presented results, the increased vibration amplitude in the spanwise and flapwise directions suggests either higher aerodynamic loading or a reduction in blade stiffness. For Turbine 2, shown in orange, the sharper spectral peaks and changes in higher-mode shapes indicate possible tip-level damage, reflected in significantly elevated transmissibility.

The transmissibility plots also show that the global (first) mode remains relatively unchanged, while higher modes exhibit slight frequency reductions along with shoulder-like distortions or peak splitting, features commonly associated with localised stiffness loss such as foam-core delamination or degradation near the shear web. At the 1P rotational frequency, transmissibility values for the two turbines appear similar across all axes (edge, span, flap), but subtle deviations still imply that their load-transfer behaviour and modal characteristics are not perfectly matched, suggesting early or localized structural changes.

For long-term monitoring, it is recommended that transmissibility be continually compared against an established baseline and that trends be analysed to detect gradual stiffness degradation or the onset of structural damage.
