Raspberry Pi 4 / Z-Stick Gen5 USB electrical test.

This test is done to determine the issues that prevent Z-Stick G5 ZW090 USB enumeration process over Raspberry Pi4.

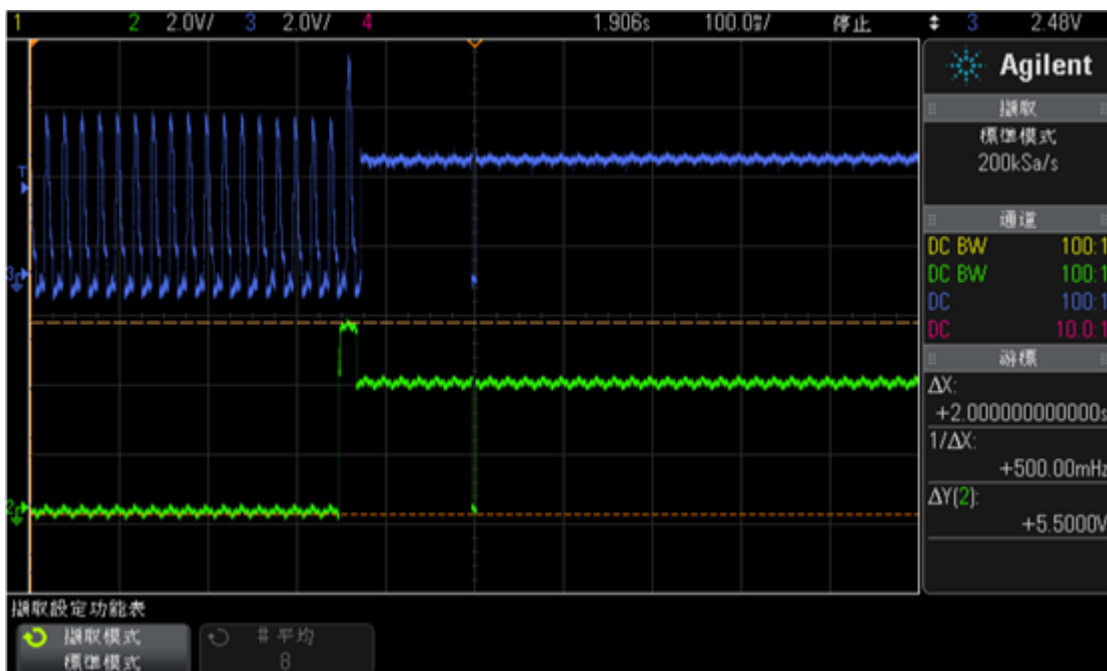
1. D+ voltage is pulled up from 0V to 5.5V.

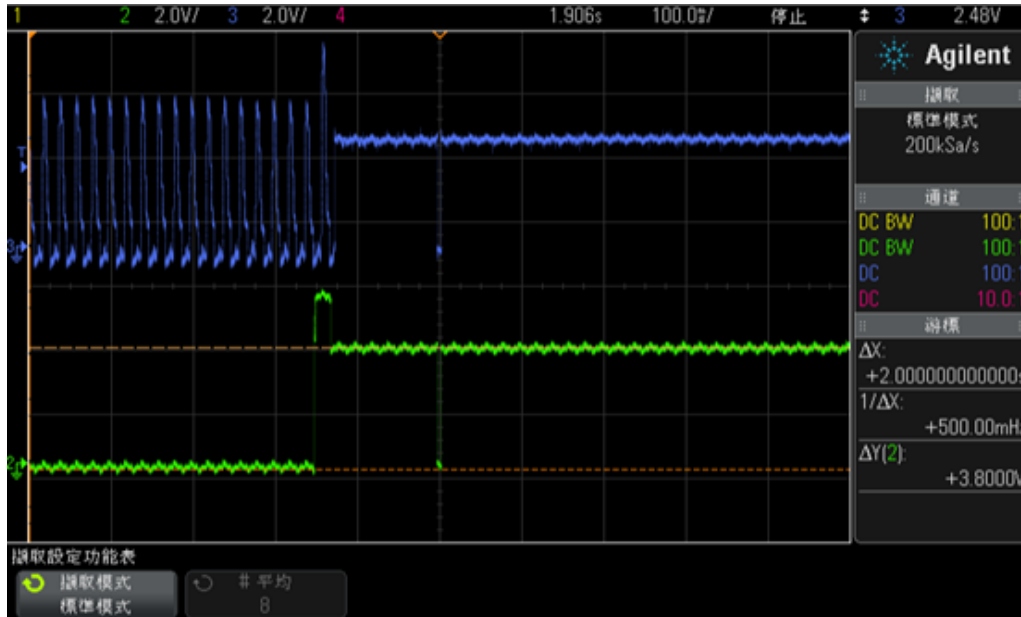
2. After about 300ms, D+ voltage dropped from 5.5V to 3.8V.

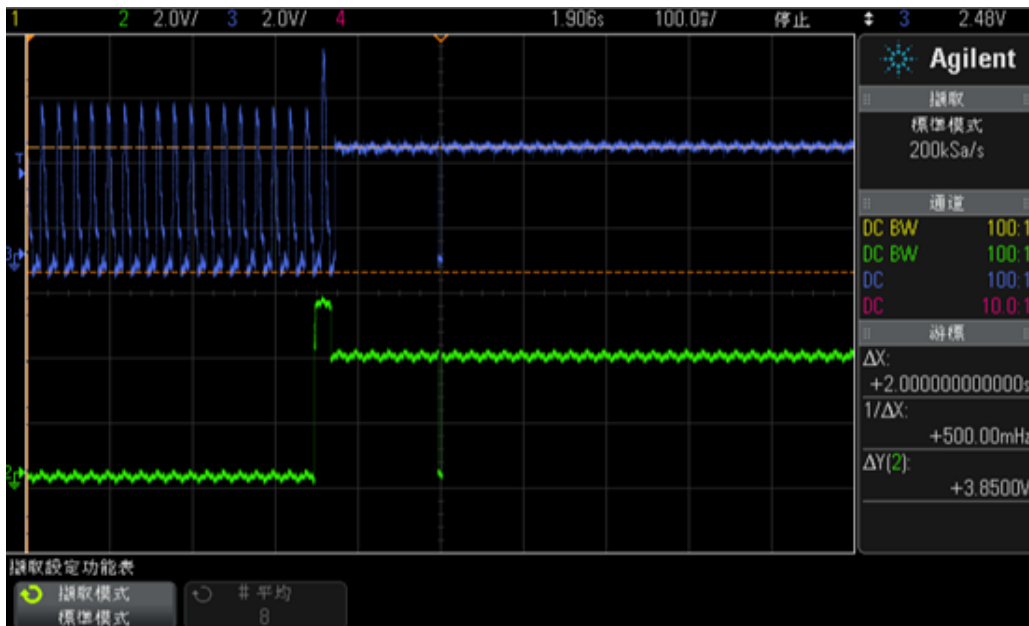
Refer to waveform of D-. When Z-Stick is plugged into the USB port of Rpi4, D- port has obvious noise waves, and voltage is always kept at 3.85V, which is not normal. Normally, the voltage of D- should be 0V initially before the enumeration begins, so in this case, seems the USB enumeration process is not implemented properly.

When Z-Stick is plugged into the USB port of RPi4, it causes the voltage of D- to be non-zero and has large noise; this is the main reason that causes the Z-Stick to be unrecognized by RPi4. By comparing other host device, we can conclude that this specific issue does not happen on other USB iterations.

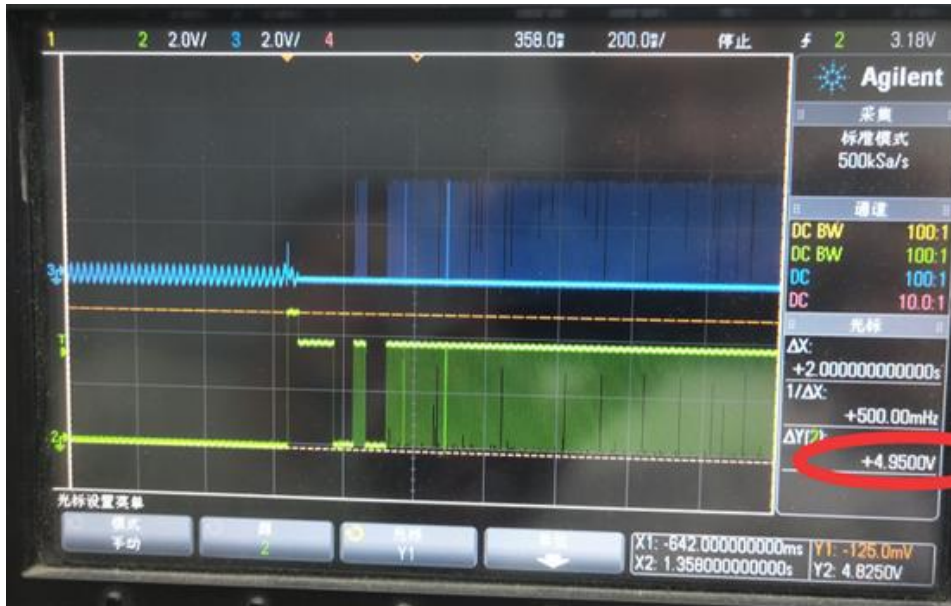
1. When the Z-Stick is plugged into the Laptop's USB port, D+ voltage is pulled up from 0V to 4.95V.

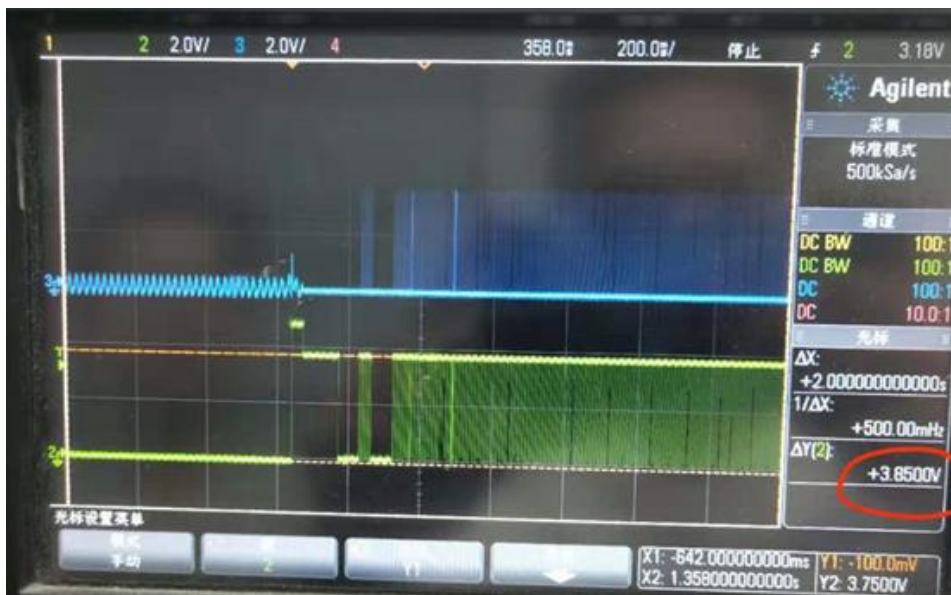
2. After ~300ms, the D+ voltage drops from 4.95V to 3.85V.

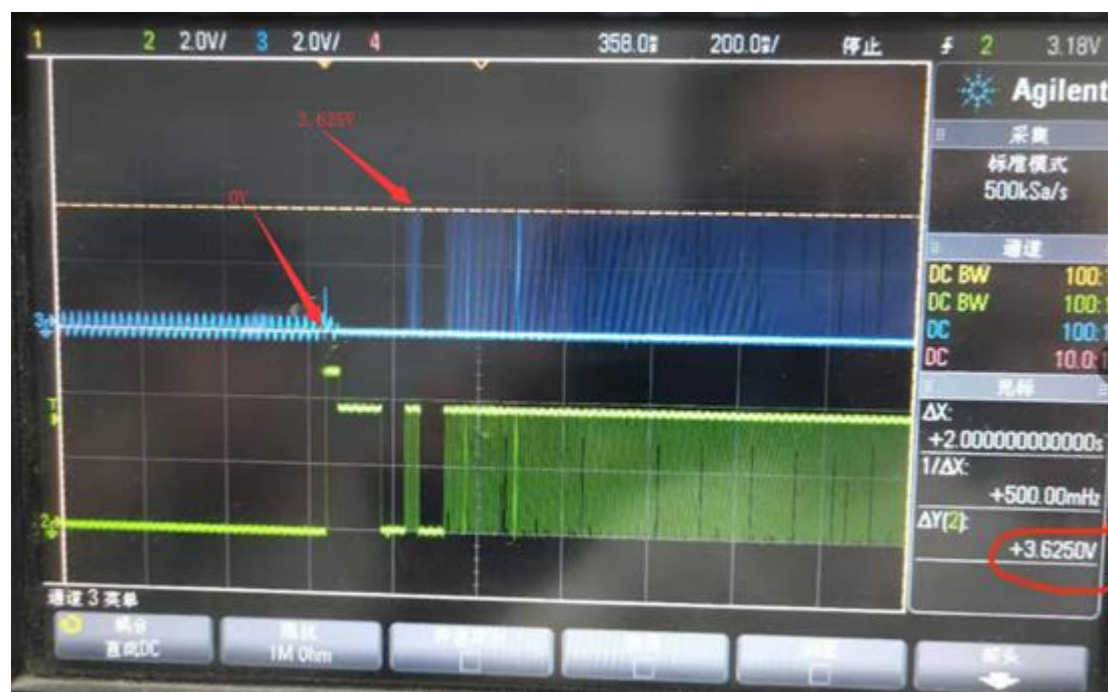
When Z-Stick is plugged into the USB port of a Laptop, the D- voltage is 0V. After about 2 seconds, it rises from 0V to 3.625V, the USB enumeration begins, and all processes seem to be normal.

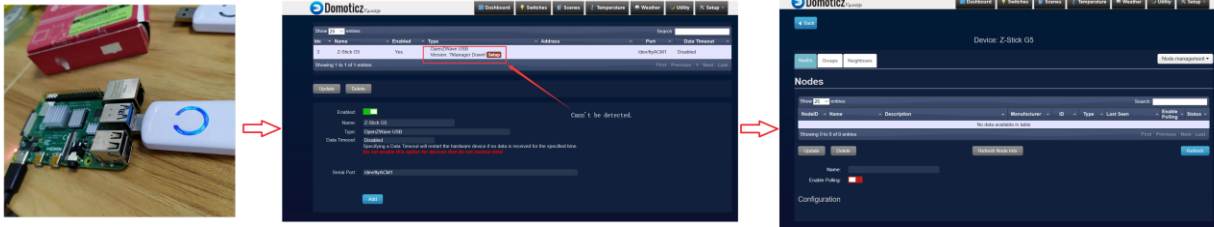
1. When the Pi4's USB 3.0 port is plugged into a Z-Stick G5, the Z-Wave software or Rpi4 cannot detect the UZB device.

The Z-Stick can not be detected by the USB 3.0 port.

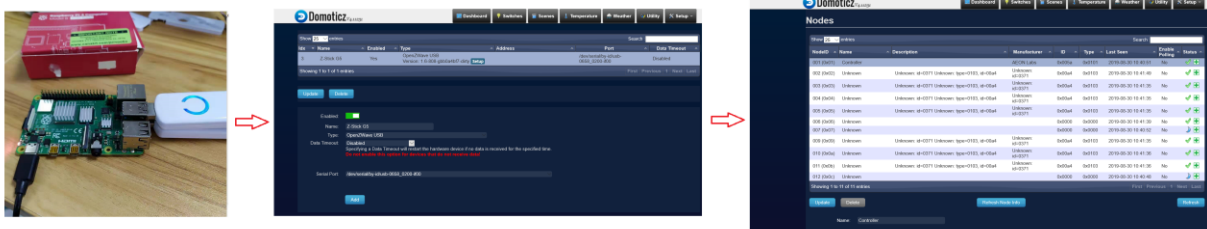
2. When plugging 2 Z-Stick G5 into the Pi4's 2 USB 3.0 ports, then one of the 2 Sticks can be detected, see attached photo 2.

The Z-Stick can be detected by the USB 3.0 port.
