Property Inspection Report

17860 Windflower Way, #1801, Dallas, TX 75252

Date of Inspection: 3/13/2019 Time: 11:00 am

Inspector: Clint Carpenter

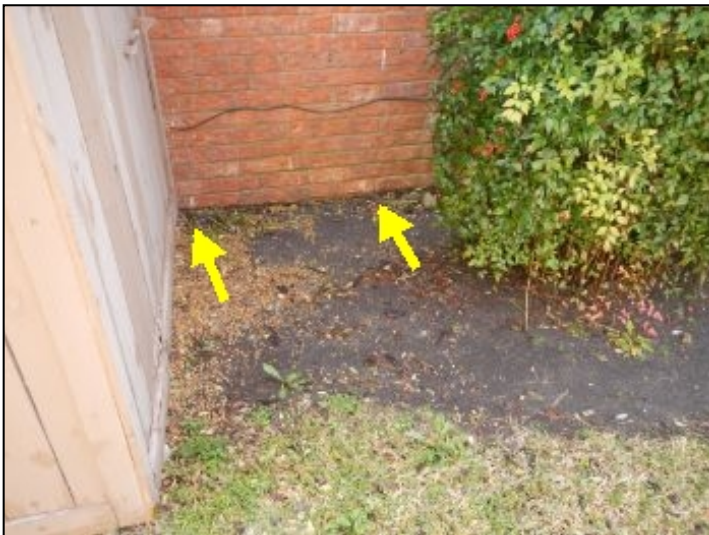
B.1. The soil levels are high along the sides of this unit. High soil levels may allow water and/or insect intrusion into the home. I recommend consulting with a landscape irrigation technician for a resolution.

High soil levels - Side and front of home

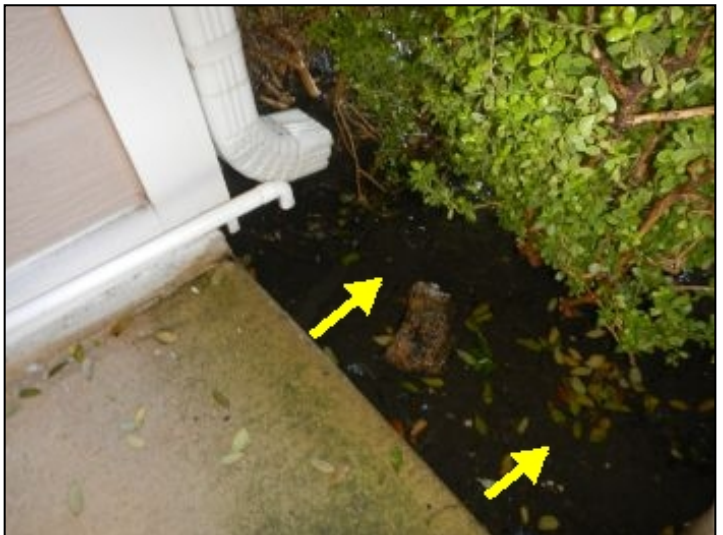
B.2. The front side of the home (at the front porch) has an area of neutral drainage at grade which may route runoff from precipitation to the foundation walls. Excessive moisture content in soil supporting the foundation can cause foundation and other structural damage from undermining, heaving or settling, depending on soil composition, moisture content and other conditions. The ground should slope away from the home 1/4-inch per foot for a distance of at least six feet from the foundation. I recommend re-grading or adding drains to improve drainage near the foundation.

Standing water - At front porch (SW side)

I also recommend redirecting the gutter, at the front porch, away from the foundation or adding an appropriate drain.

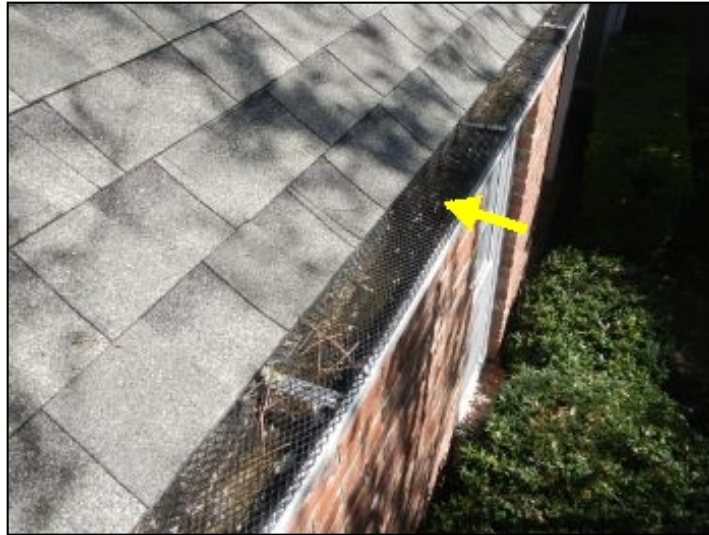
B.3. Standing water was found to the gutters along the front South face of the home. The gutters may not be properly sloped preventing water from draining properly or the down spouts may be clogged. I recommend having the gutters evaluated for repair by a qualified contractor.

Water not draining from front gutters

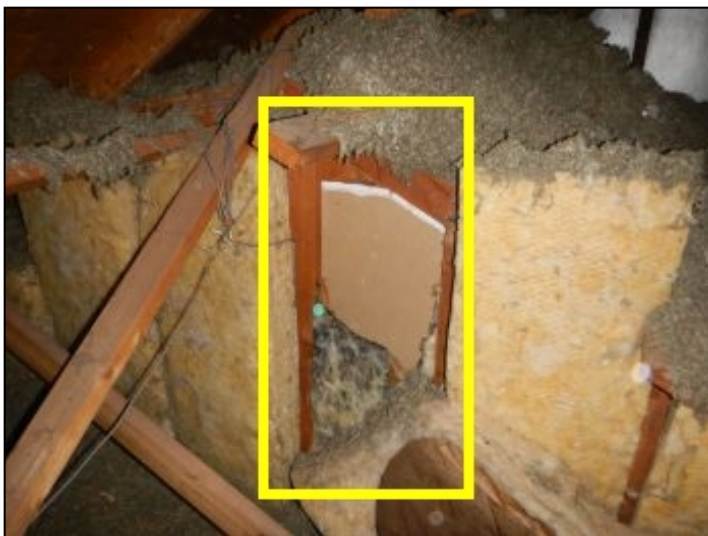
D.2. Wall insulation was found to be torn away from the wall near the attic opening. The insulation should be re-installed properly, as intended.

Insulation torn away from wall - In attic space

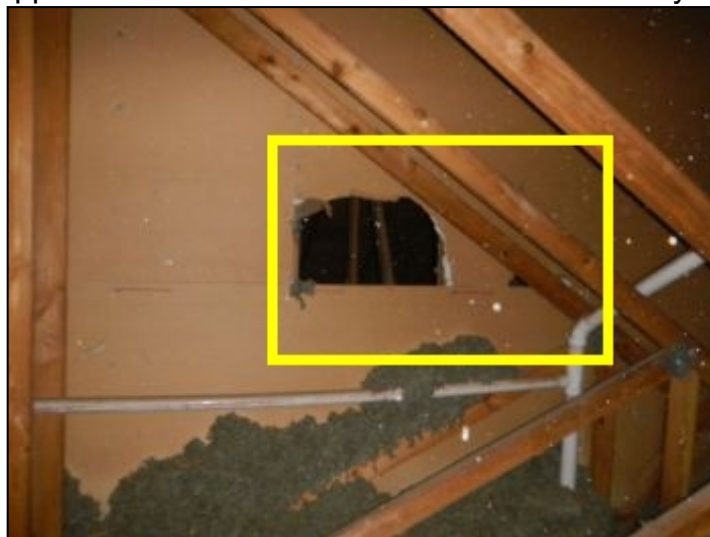
D.3. The North wall in the attic space has holes. These areas are fire breaks and should remain intact. I recommend repairs be made to these holes and any other holes found in the attic space for proper fire breaking, by a qualified contractor.

Hole in fire wall - Attic space

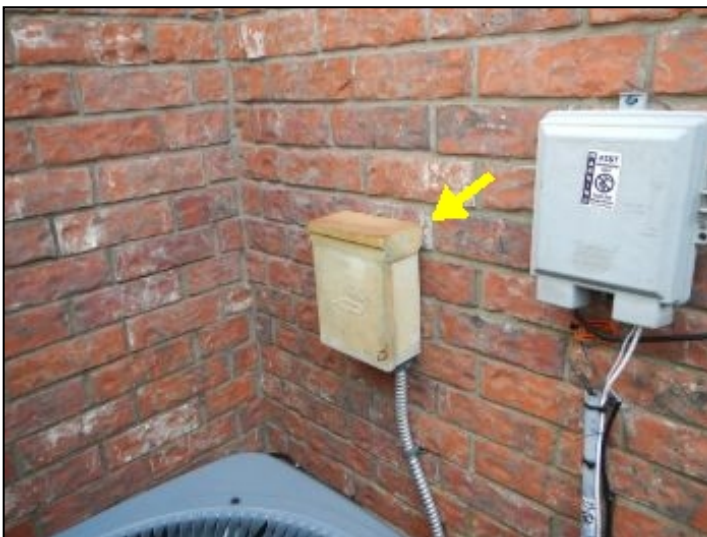
E.3. No sealant (caulking) was found around the AC breaker box. I recommend sealing the area to prevent water intrusion into the wall spaces.

Seal around AC breaker box

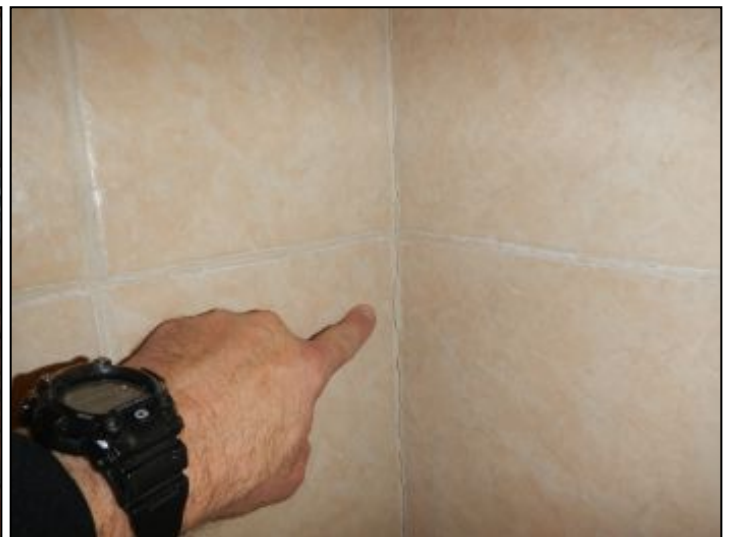
E.4. Cracked sealant (caulking) was found to some of the shower walls in the upstairs bathrooms. These areas should be re-sealed to prevent any water intrusion into the wall spaces.

Cracked caulking - Upstairs shower walls

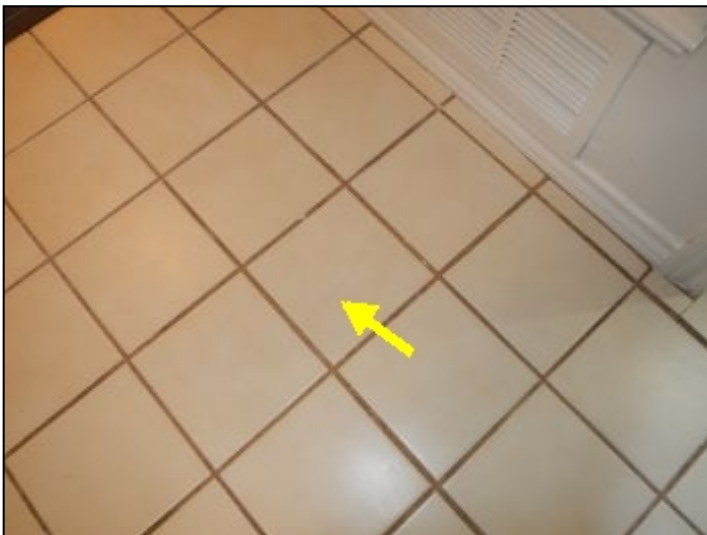
F.2. Several floor tile cracks were found to one tile in the Kitchen and several tiles in the upstairs North bathroom (See pictures for exact locations). It is unknown how the cracks occurred. I recommend replacing or repairing all cracked tiles as needed. Also consider having the cause of cracking determined and corrected by a qualified contractor.

Crack to tile (Kitchen)

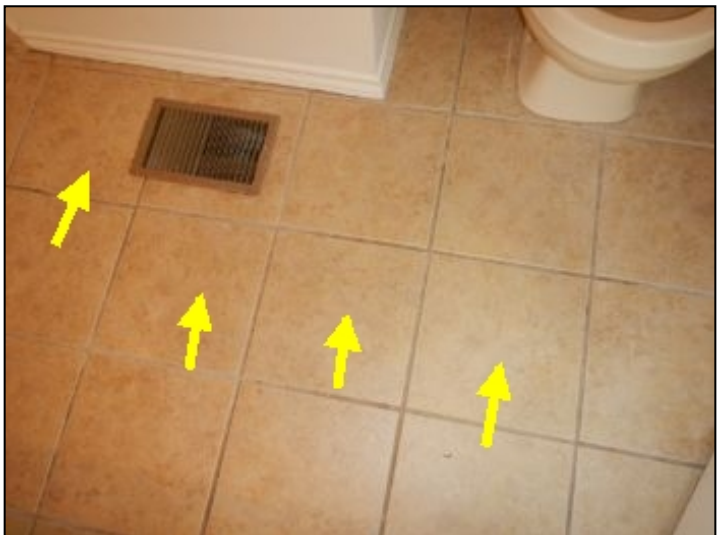
Cracks to tile floors - Upstairs North bathroom (4)

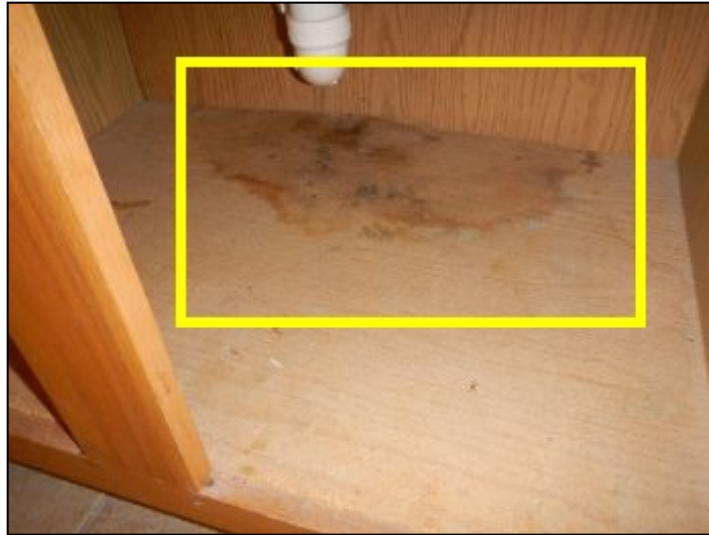
F.3. Minor damage and water/chemical staining is noted to cabinet flooring under the upstairs North bathroom sink. No major damage was found where visible.

Damaged cabinet floor - Upstairs North Bathroom

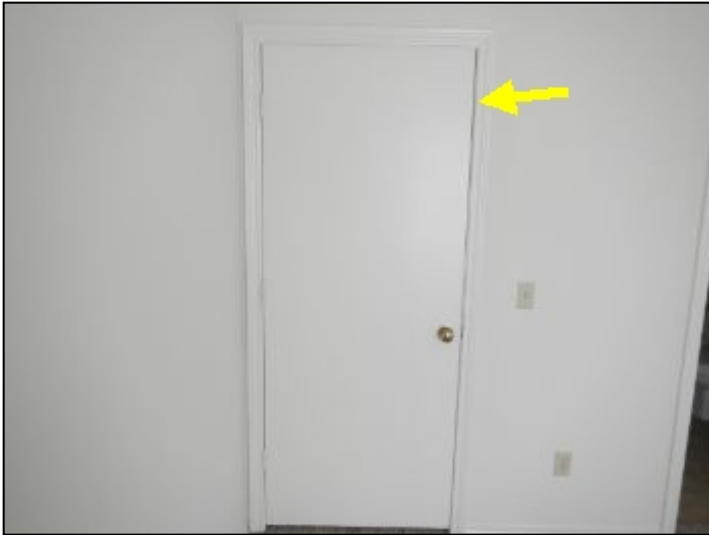
G.1. The upstairs North bedroom door hits the top door frame upon closing and does not shut properly. I recommend having the door or frame adjusted accordingly. I recommend evaluation be done by a qualified contractor for any other damage that may have occurred causing the issue at hand.

Door hits frame - Upstairs North Bedroom

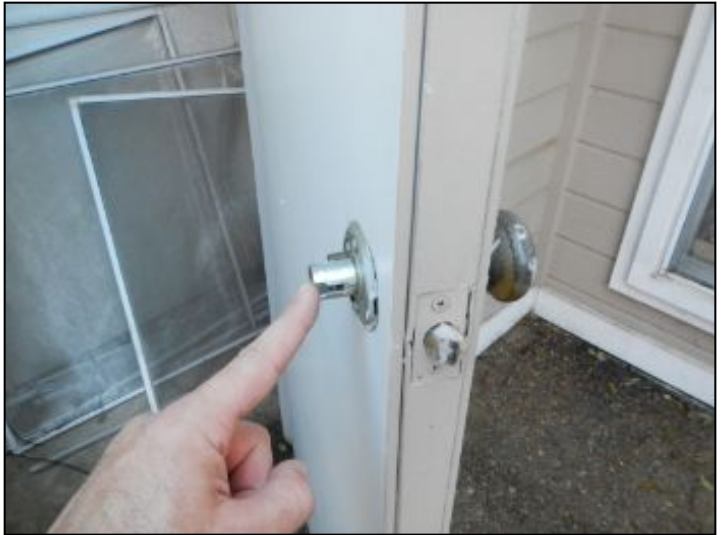
G.2. The exterior storage closet is missing its interior door knob.

Missing interior door knob - Exterior storage closet

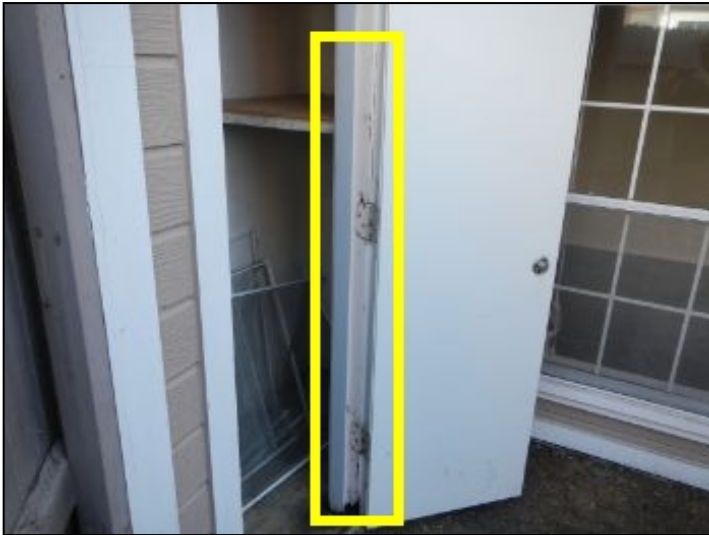
G.3. Moderate wood rot was found to the door frame of the exterior storage closet. All wood rot should be repaired or replaced and then painted to match current color schemes.

Moderate wood rot - Door frame to exterior storage closet

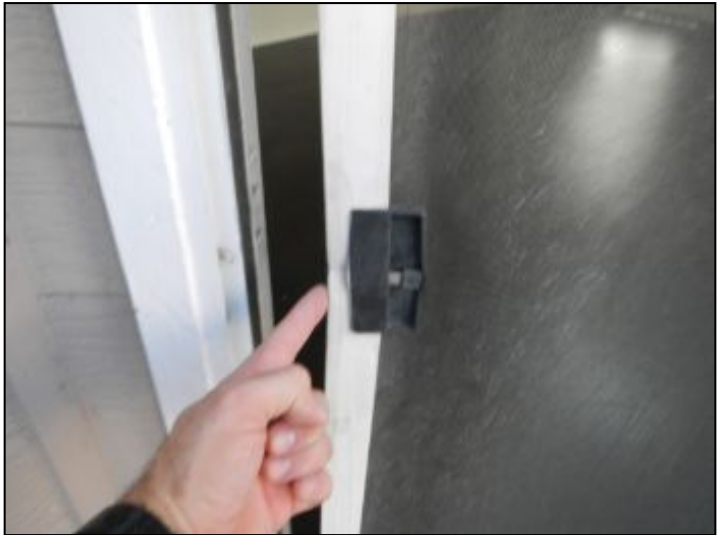
G.4. The sliding glass screen door frame is damaged.

Minor damage to sliding door screen

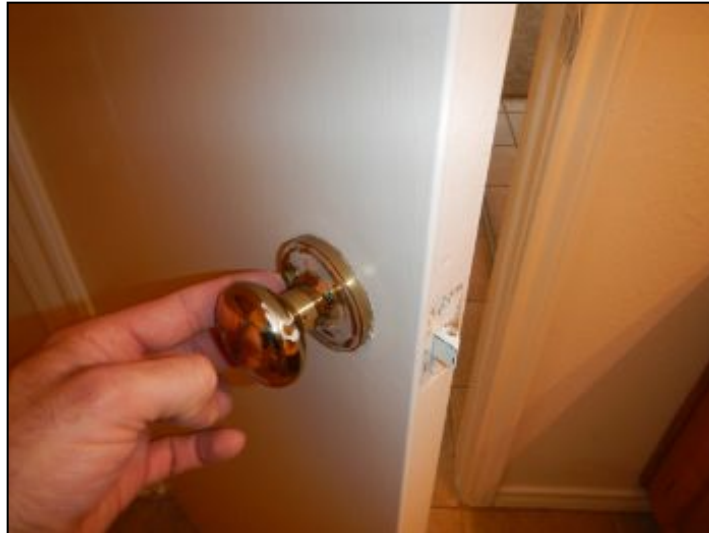
G.5. The upstairs North bathroom door lock is inoperable. I recommend repair or replacement by a qualified contractor.

Inoperable door lock - Upstairs North Bathroom

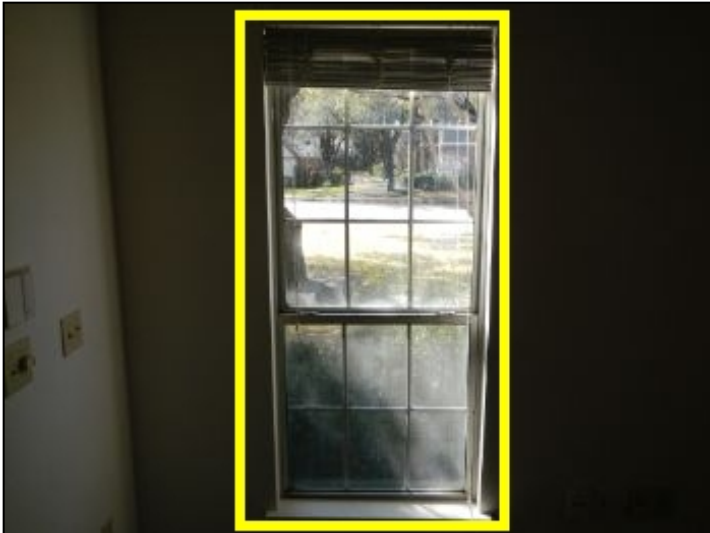
H.1. Several windows, throughout the home, were found to have moderate dried-up condensation and staining between the double-panes (See pictures for locations). Double-pane windows are windows which each have two panes of glass. The air space between the inner and outer panes acts as insulation, reducing heat loss, saving on heating costs and increasing home comfort levels. This space is often filled with a type of inert gas which increases the window's resistance to heat flow. The inner and outer panes are separated by a perimeter strip filled with a desiccant which absorbs moisture so that no condensation forms on the glass. The two panes and desiccant strip form a single assembly which is held within the window frame. Over time, desiccant strips can become saturated, will no longer absorb moisture and when this happens, condensation will become visible under certain conditions. Double-pane assemblies which have only recently failed can often be repaired. Window glazing which has been exhibiting condensation problems for long periods and which show a white haze often cannot be repaired and must be replaced. It is sometimes more cost effective to replace the entire affected window. Consult with a Window technician to evaluate the windows for possible repairs or replacement.

Condensation in between glass panes - Den (SW Window)

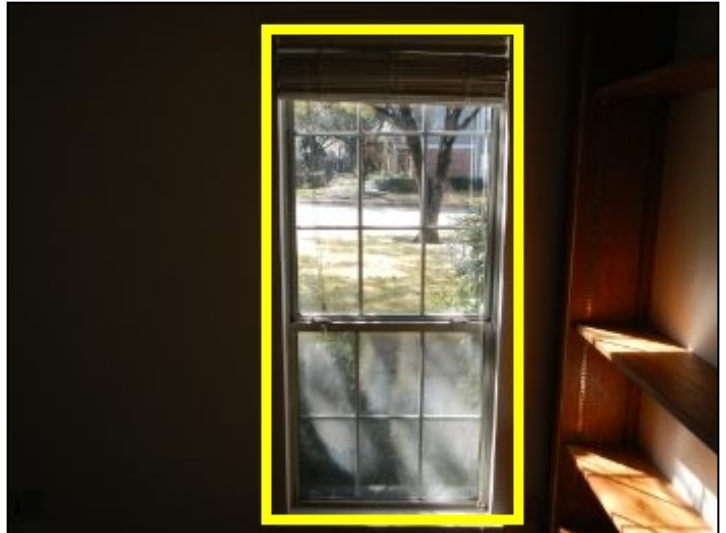
Condensation in between glass panes - Den (NW Window)

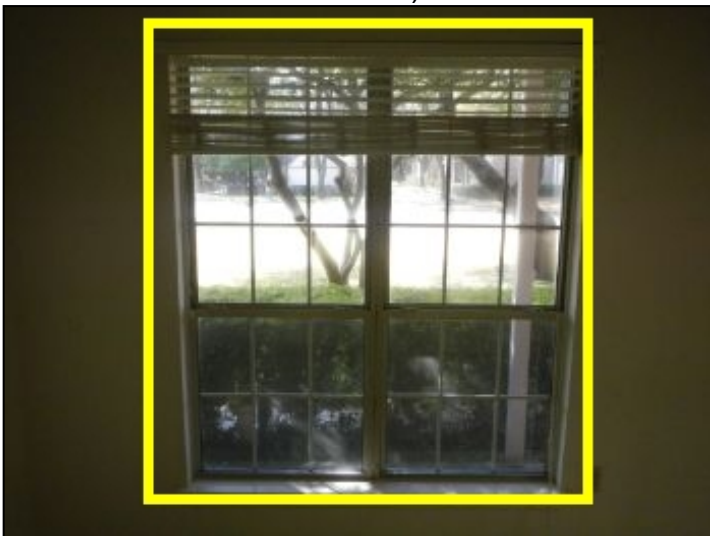
Condensation in between glass panes - Dining

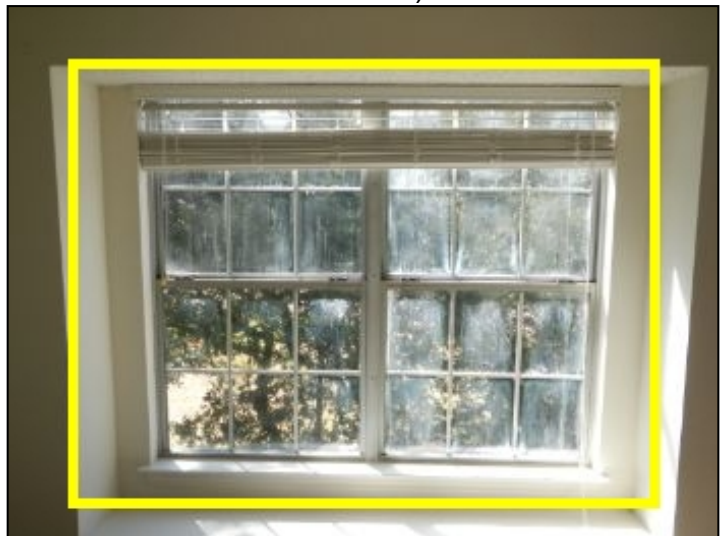
Condensation in between glass panes - Upstairs South Bedroom

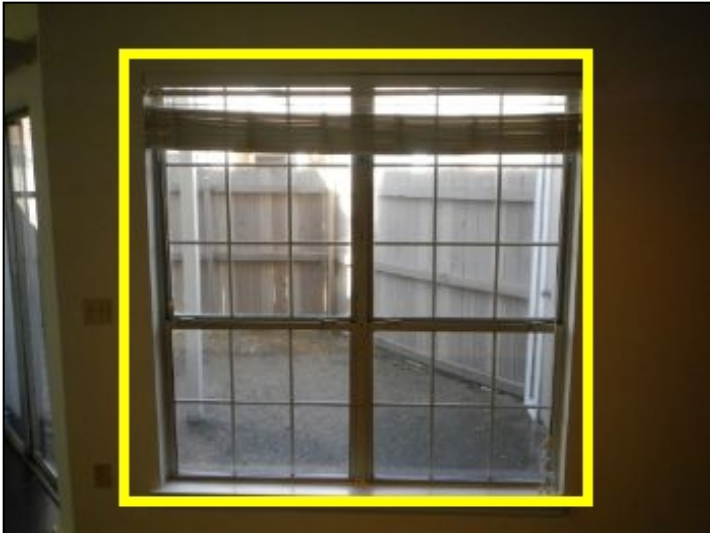
Condensation in between glass panes - East Den

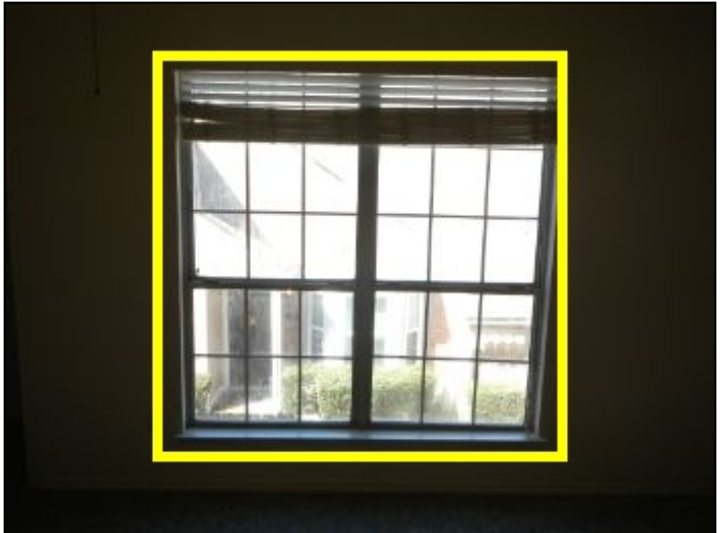
Condensation in between glass panes - Upstairs North Bedroom

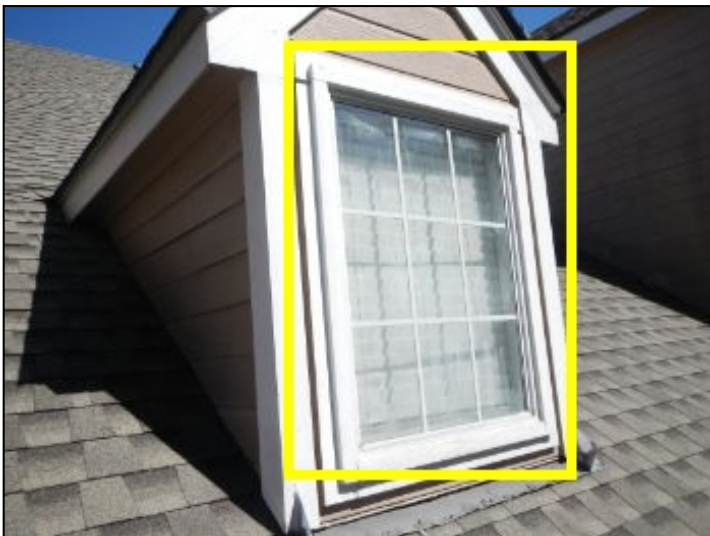
Condensation in between glass panes - Top Den window

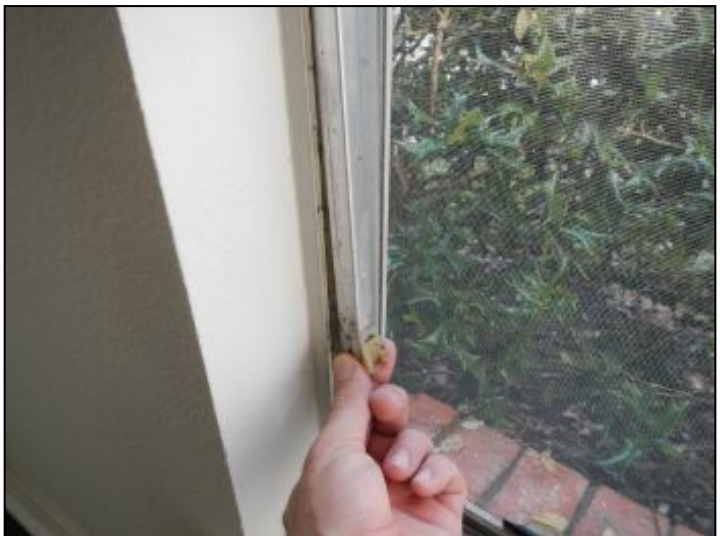
H.2. Several windows were found to have loose side springs (See pictures for exact location). I recommend having the windows evaluated for repair by a qualified Window technician.

Loose side spring - Den (SW window)

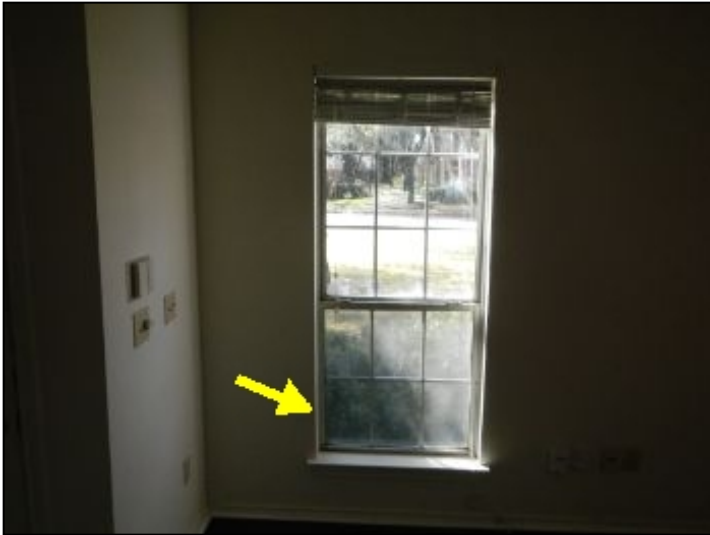
Loose side spring - Den (SW window)

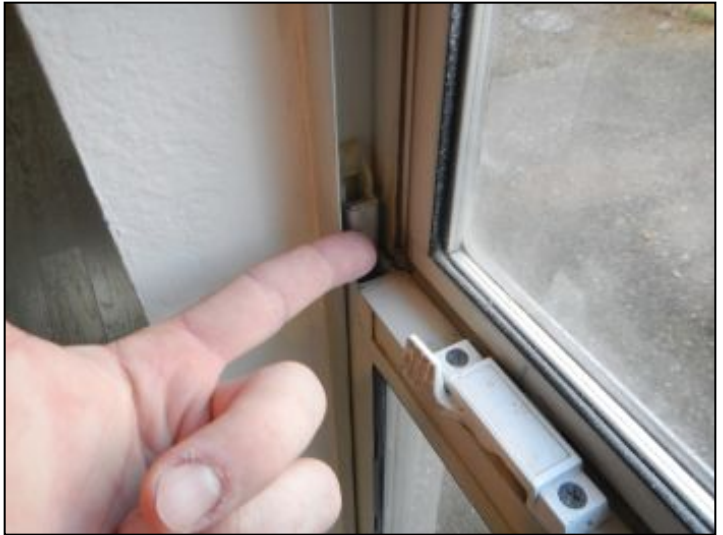
Loose side spring - East Den (Patio window)

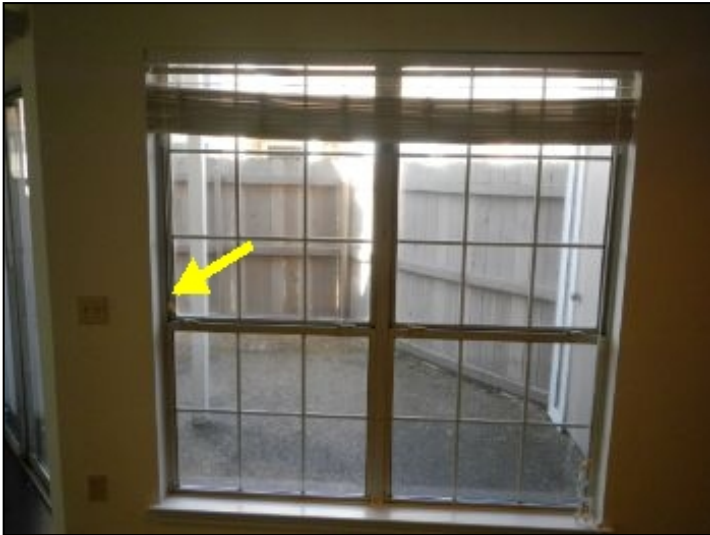
Loose side spring - East Den (Patio window)

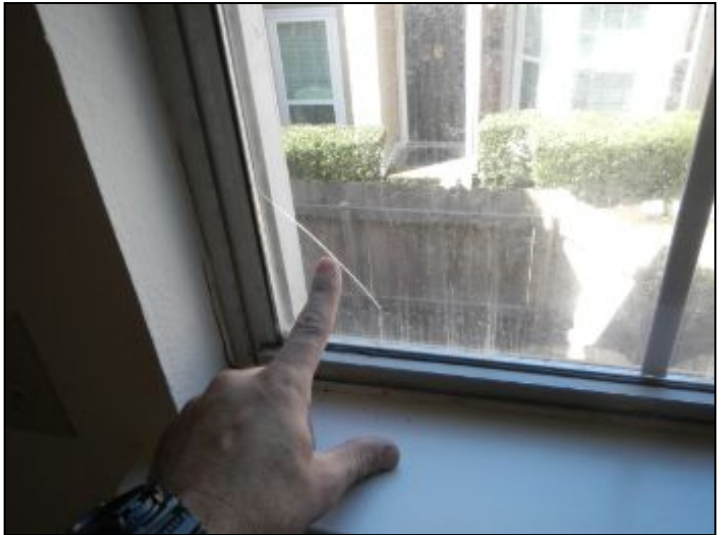
H.3. A cracked glass pane was found to two windows (See pictures for location). I recommend having the windows evaluated for replacement by a qualified Window technician.

Cracks to glass panes - Upstairs North Bedroom

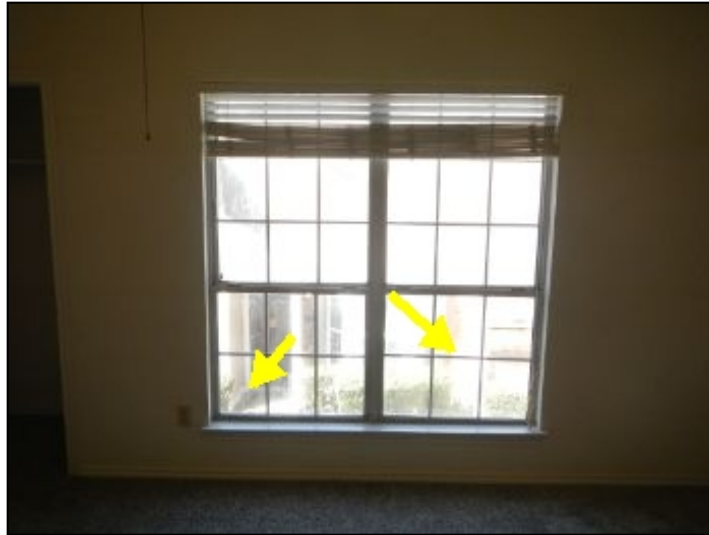
Cracks to glass panes - Upstairs North Bedroom

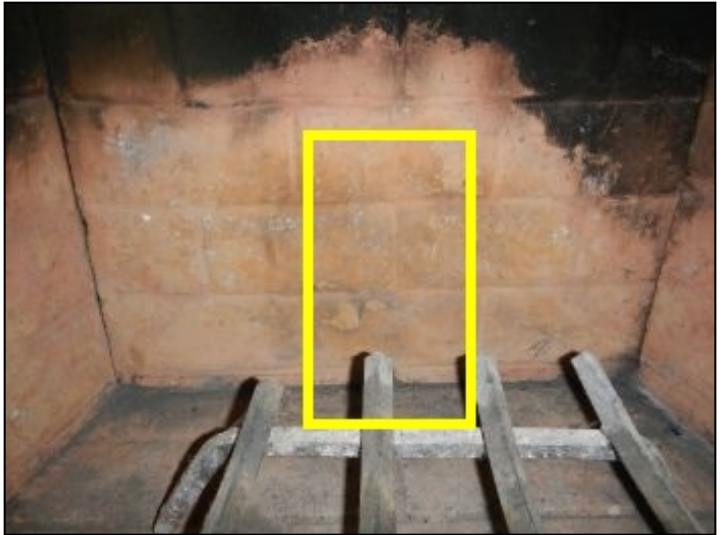
J.2. The interior firebox back wall of the fireplace has minor cracking. I recommend consultation with a qualified Chimney Technician for sealing or repair.

Minor cracks in back firebox wall

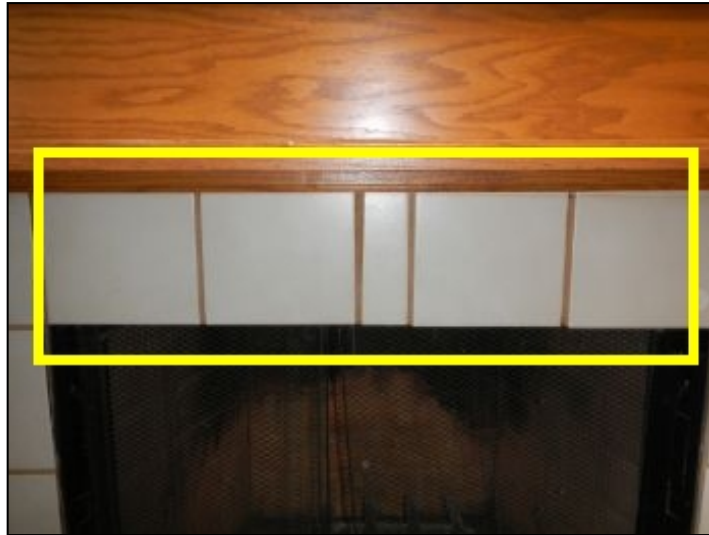
J.3. The upper portion of the fireplace mantle, has loose tiles. I recommend repairs be made by a qualified contractor.

Loose tiles above fireplace

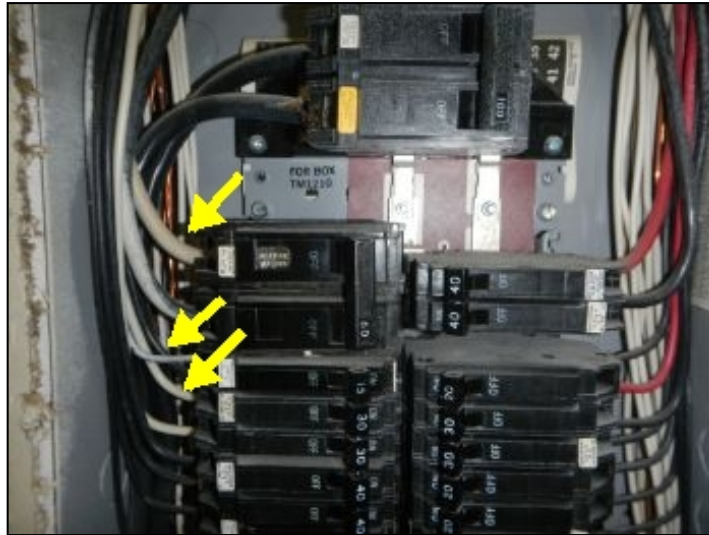
A.2. Three wires, within the breaker box, were improperly color-coded using white instead of black or red. The wires are not properly coded with black markings to indicate whether or not they are ungrounded conductors.

Wrong color-coded wires

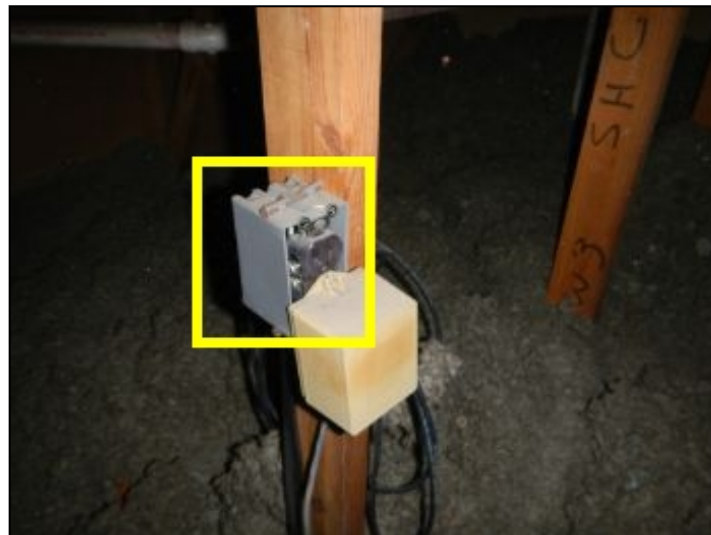
B.1. One outlet, in the attic space, is missing a cover plate. This condition has left energized electrical components exposed to touch and are a shock/electrocution hazard. I recommend installing a cover for prevention.

Missing outlet cover - Attic space

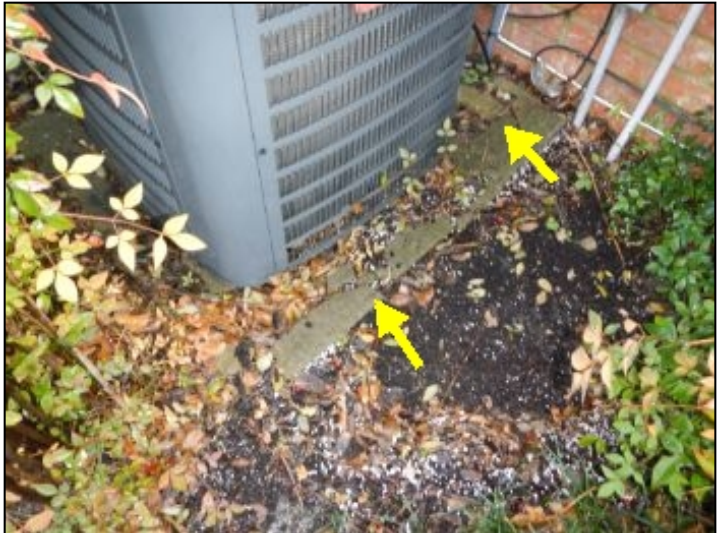
B.4. The AC condenser concrete pad is damaged and should be replaced.

Broken AC pad

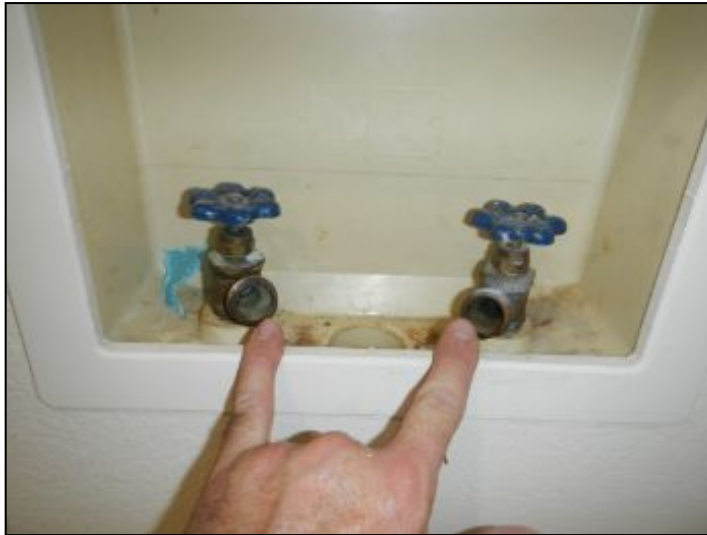
A.3. The hot and cold valves in the Laundry room were found to have a minor leak. I recommend having the valves evaluated and repaired by a qualified Plumber.

Minor leaks at both washer connections - Laundry room

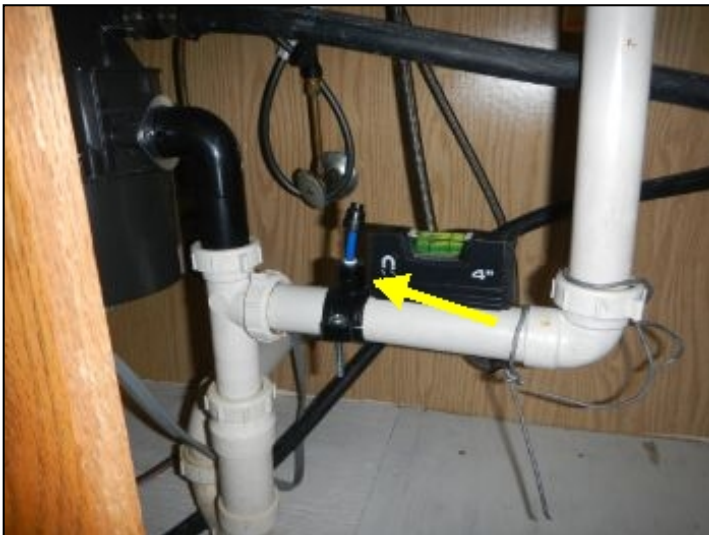
B.2. The drain plumbing, coming from the kitchen sink should have a negative slope to allow for proper drainage. The plumbing is not sloping towards the drain. This may cause water to back-up into the sink. I recommend having the drain pipe corrected accordingly.

No slope to drain - Kitchen sink

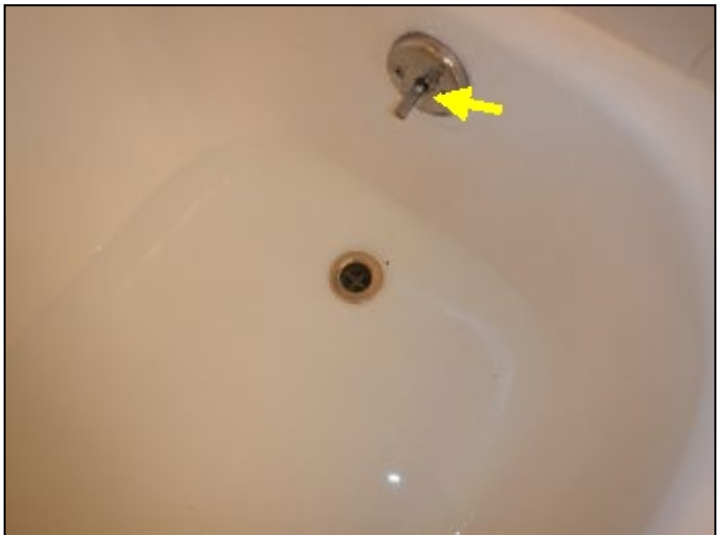
Loose drain lever - Upstairs South Bathroom tub

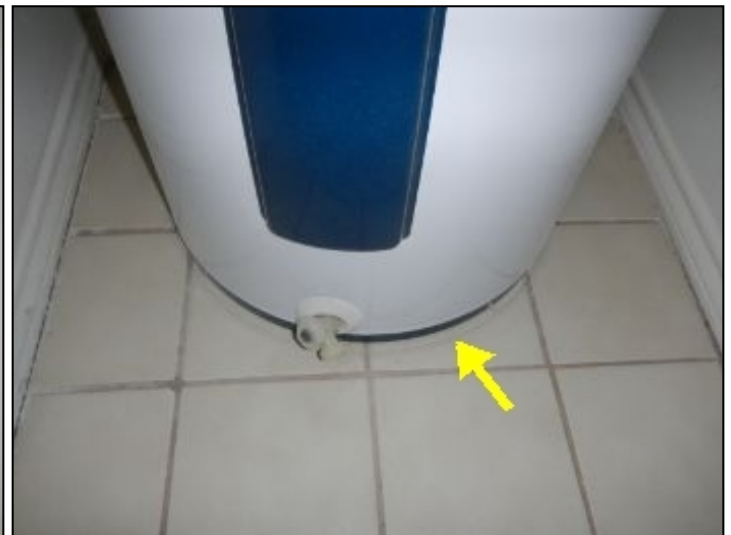
C.1. Drip pan is missing from under the water heater. I recommend having a drip pan installed to prevent any water damage.

Missing drip pan

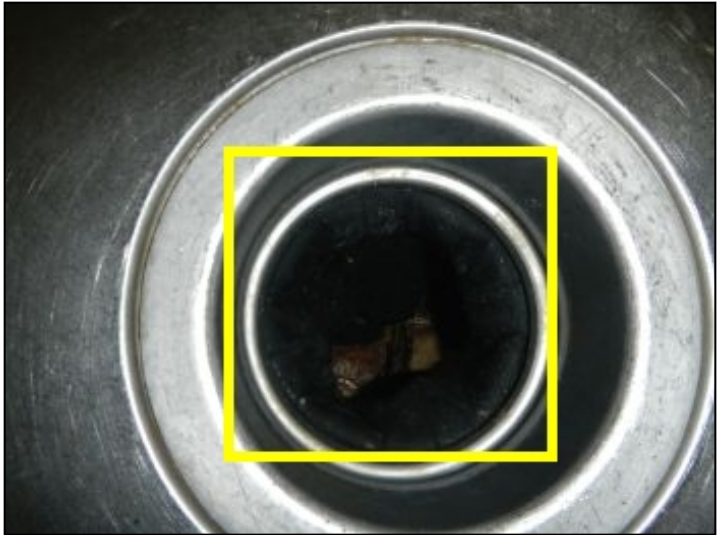
Damaged splash guard

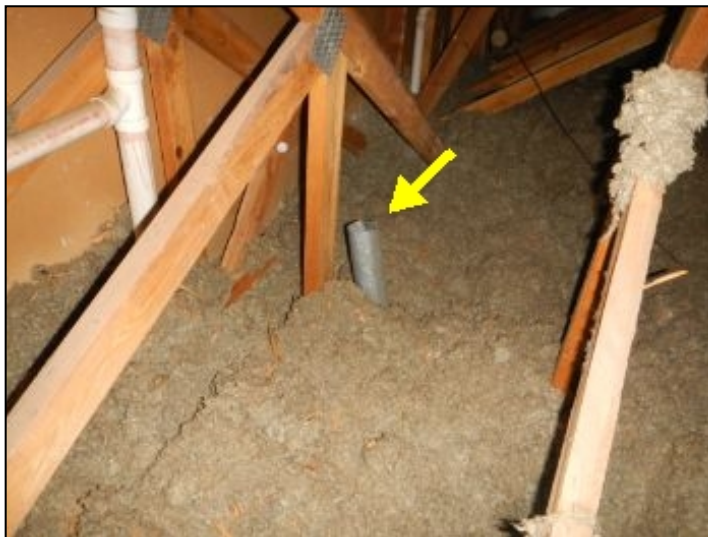
F.2. It appears that most bathroom exhaust vents terminate improperly into the attic space. This can create excessive moisture. I recommend directing the vent towards the exterior to allow for proper ventilation. I did not see any exhaust vents terminating to the exterior of the home.

Bathroom fans exhaust into attic space

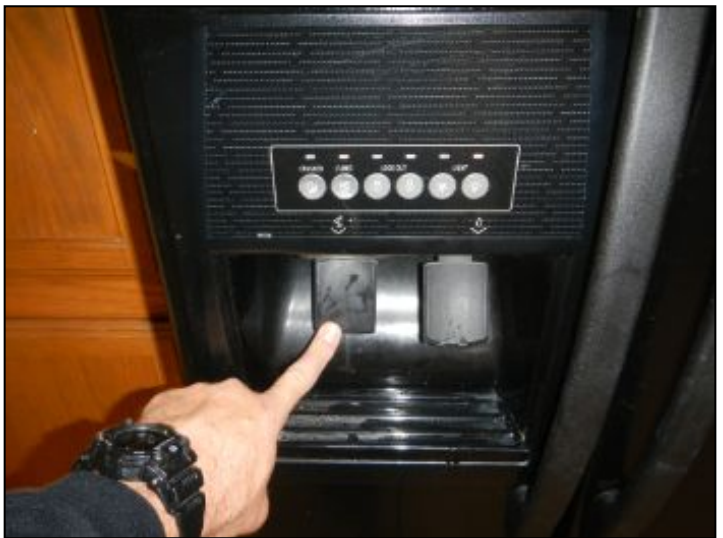
I.2. I was unable to retrieve any ice from the ice dispenser. It appears to be inoperable.

Inoperable ice dispenser

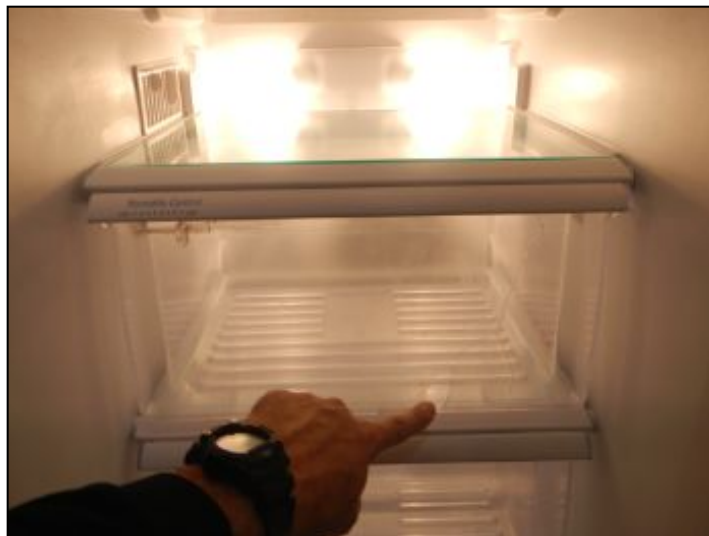
I.3. One of the pull-out drawers was cracked.

Cracked middle drawer

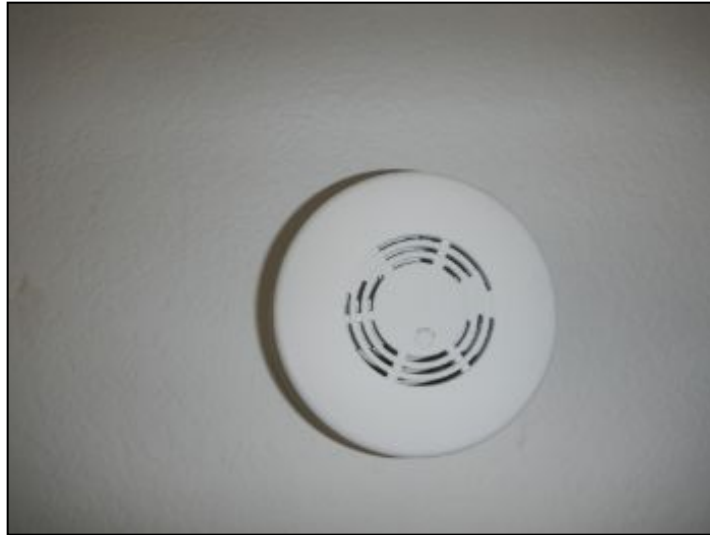
Out-dated smoke detectors
