# Installation of the new electronics for the Helix array 2 (Malargue December 2016)

## Abstract

We present here a first report on the installation of the helix antennas with the new electronics. We show also onsite measurements. 6

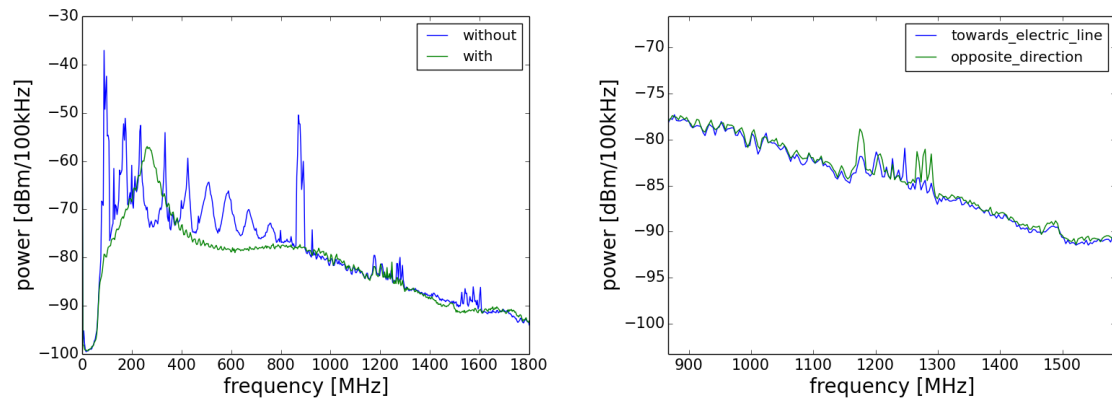
The first day we went for a survey of the helix hexagon to be sure all the tanks were easy to access. We also made measurements to answer the questions listed above. Figure 1 (left) shows a spectrum recorded on the road close to the tank Santy, one is taken without filter (blue) and the other with (green). The spectrum without filter shows a ringing behavior with peaks at regular intervals. These intervals are  $\simeq 100\text{MHz}$  long, so the ringing could be caused by the FM band. Even if the spectrum in our band of interest seem unchanged with or without filter, we cannot operate with a saturated amplifier. We choose the filtered version, even if we know the noise temperature is higher.

As for the electric line, we recorded spectra with the antenna pointed either toward the line (in blue in Figure 1 (right) ) or facing the opposite direction (in green). No significant change is observed, so the line does not produce noise on our setup.

Figure 1 spectra with and without filter close to the tank Santy

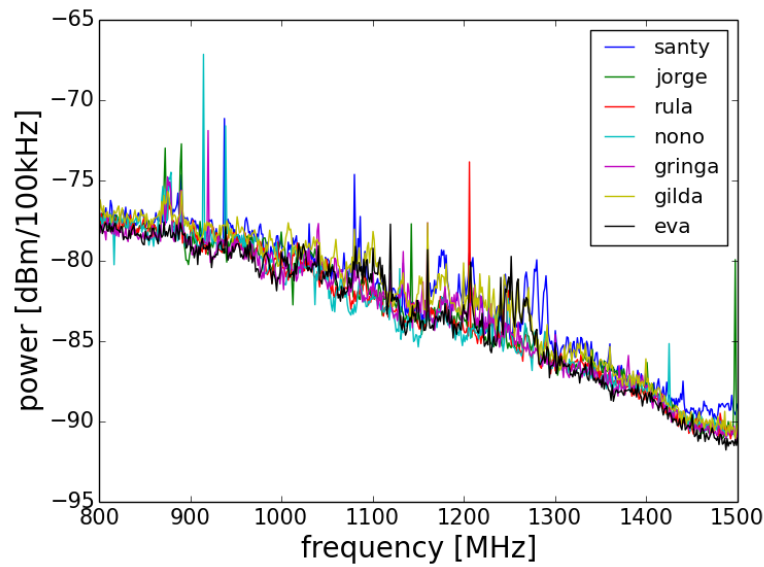
On all the tanks we recorded a spectrum, in RMS mode, to measure the noise floor . They are all presented on the Figure 4. We see already on this spectra that there are peaks inside

Figure 4 spectra in RMS mode on all the 7 detectors installed

not obvious when spectra are taken in RMS mode (Figure 4) but appear consistently when spectra are acquired in peak mode.

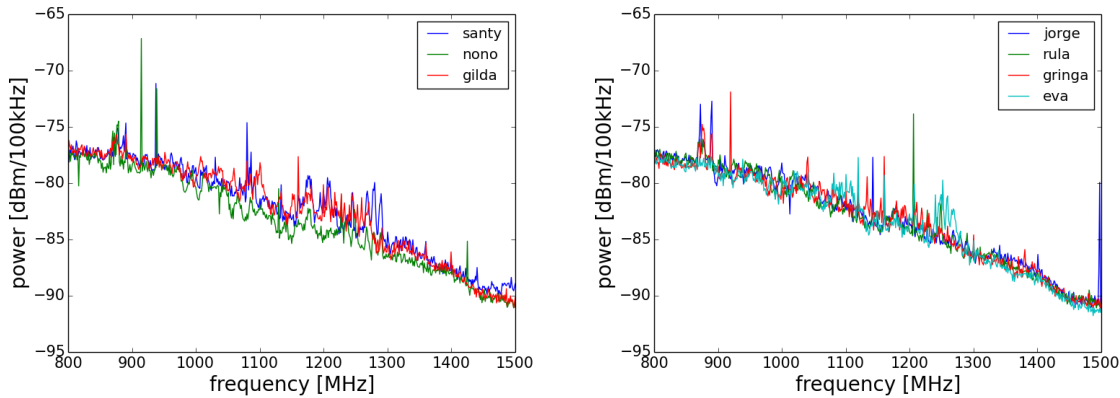
Figure 5 spectra of detectors close to the line (left) and further away (right)

our band. With the same data we can also check that the noise is not significantly larger in

the detectors close to the electric line (cf Figure 5).

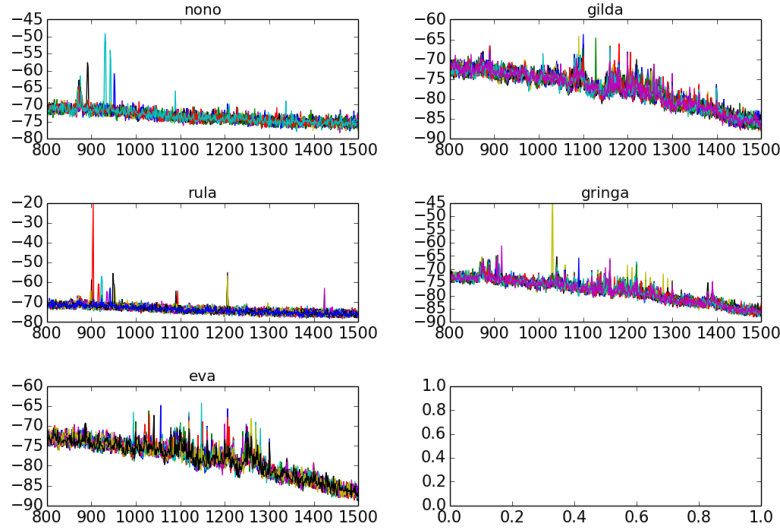
We also recorded spectra in peak mode but only for the five detectors installed on the second day. We show in Figure 6 for each detector approximately 15 to 30 spectra recorded consecutively. The spectra recorded on Rula and Nono were taken with 20dB of attenuation because the peak from the Auger radio (940MHz) was too large and was causing the saturation of the spectrum analyser. As a result, on those two detectors we see less peaks but this is probably due to the spectrum analyzer attenuation. It seems that there are peaks in our band, they are

Figure 6 spectra taken in peak mode

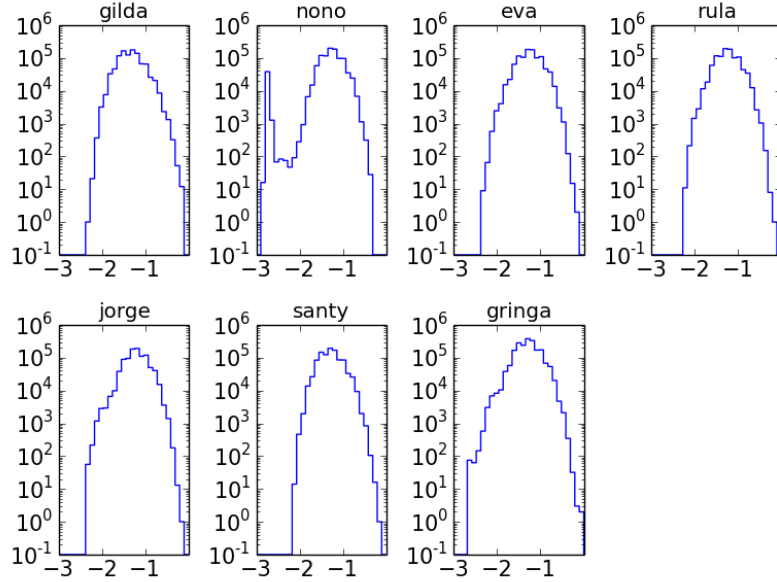
For all the antennas, the baseline is around -1.3V but their amplitude distributions have

Figure 8 distribution of amplitudes, voltage in x axis and entries in y axis

a different shape. Especially Nono has a large contribution at around -3V, Gringa or Jorge 84  
have also a tail at large negative value. The tail in the distribution can be explained by the  
presence of transient noise. This is confirmed by the triggered traces we recorded on Jorge. 86  
Some examples of these waveforms are shown in Figure 9.

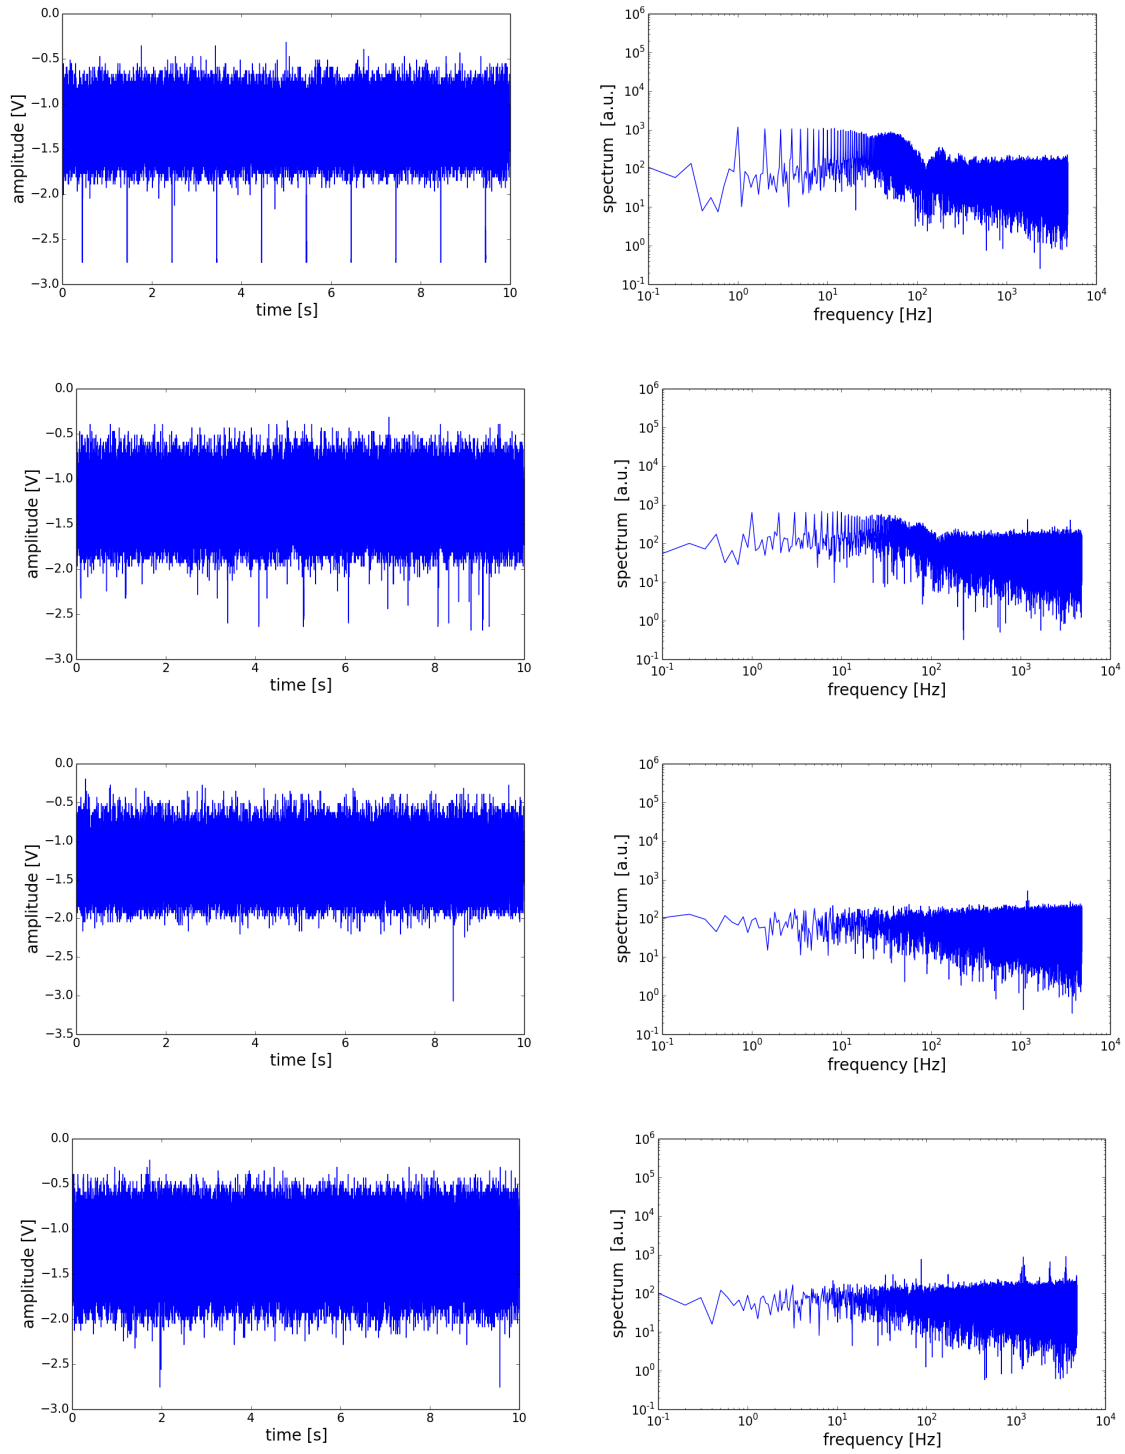
see a strong transient noise every second in the case of Nono. It appears also in Gringa, and  
 probably in Rula (but I lost the file...). This peak appears every second and is 10ms long. 90  
 This noise is very likely coming from the Auger comms. The waveform and spectra of Gilda  
 and Eva are much cleaner. 92

Figure 10 from top to bottom: Nono, Gringa, Gilda, Eva

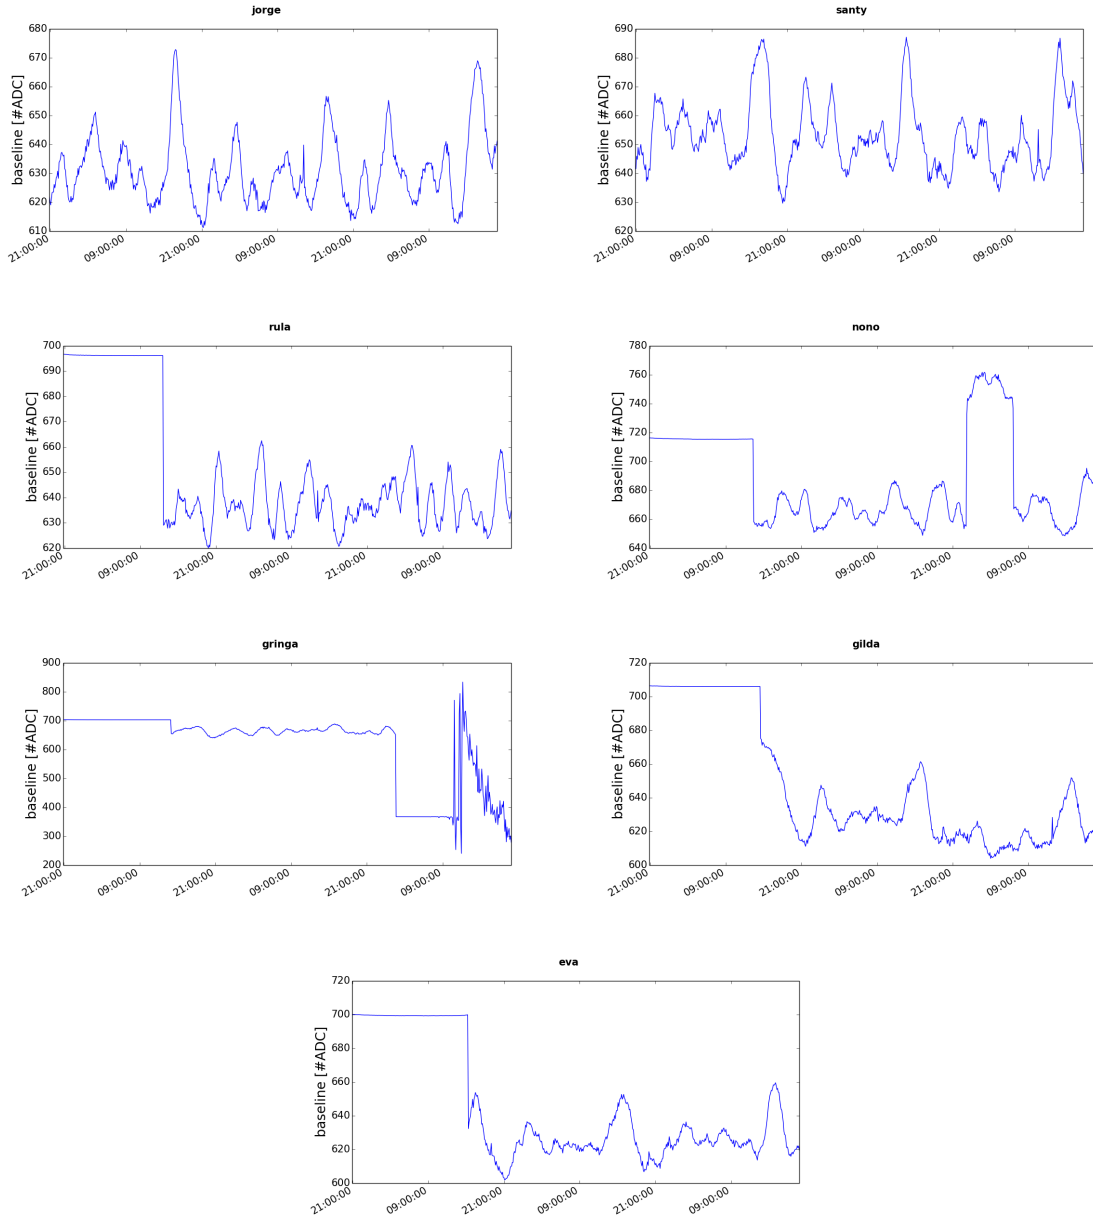
The helix antennas are tilted toward the center of the hexagon, only the central detector points  
toward the zenith. So we expect different signal from the sun depending on the antenna. In 102  
this season, we expect to see a bump from the sun in five antennas (all of them except the  
two pointing toward the south: Rula and Gringa). The sun is very clearly visible in Eva and 104  
Gilda. It is also visible, but less clearly, in Jorge and Santy, however it is really not obvious  
in Nono. This means that Nono is less sensitive than the other antenna. It can be due to the 106  
larger transient noise it receives.

Figure 11 from top to bottom: Nono, Gringa, Gilda, Eva

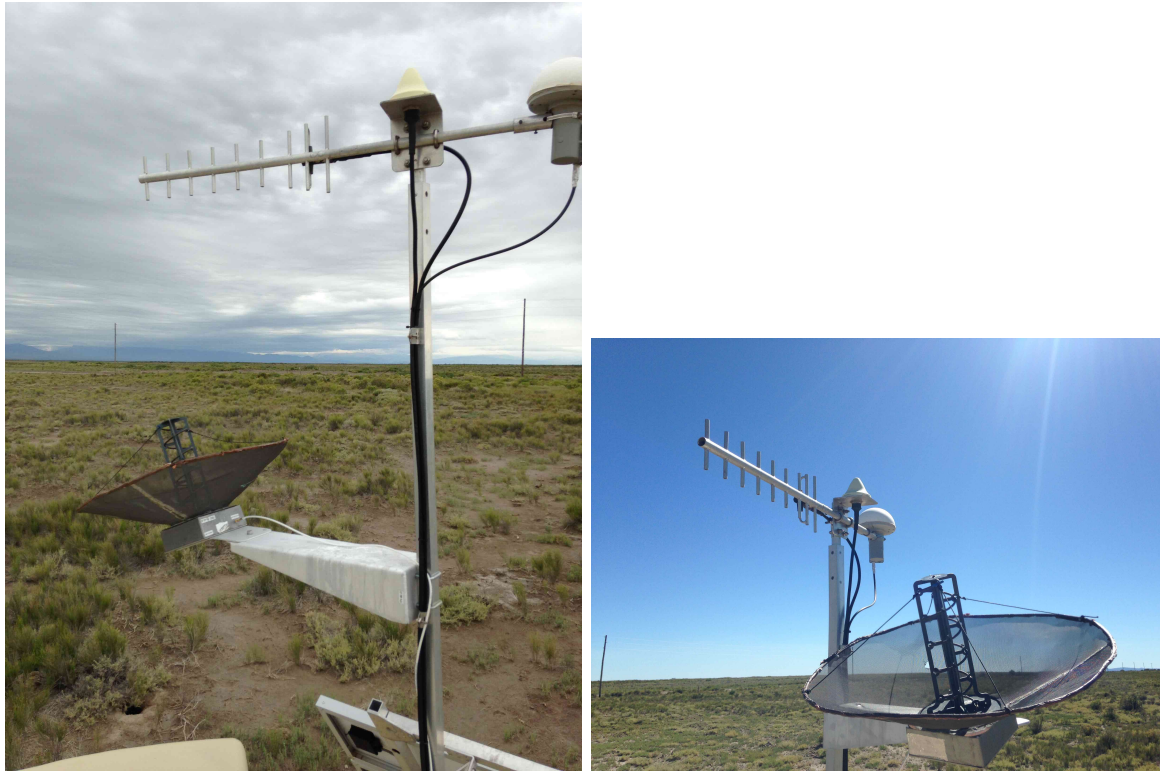
Figure 12 old and new antenna position on Nono tank

**Nono** We also noticed that Nono seemed to be less sensitive than other antenna, especially on the sun signal. One of the possible explanation is the noise produced by the communication antenna which is just above the antenna on this tank. We modified the position of the antenna but we kept the designed orientation (see photo in the Figure 12). From the data we collected on site and the first monitoring data, no clear improvement is observed.
