Helix detector status: May 2016

This note presents the status of the helix detectors. At the end of May 2016 they were all removed from the field and tested in the assembly building lab. We present the status in terms of mechanics and electronics.

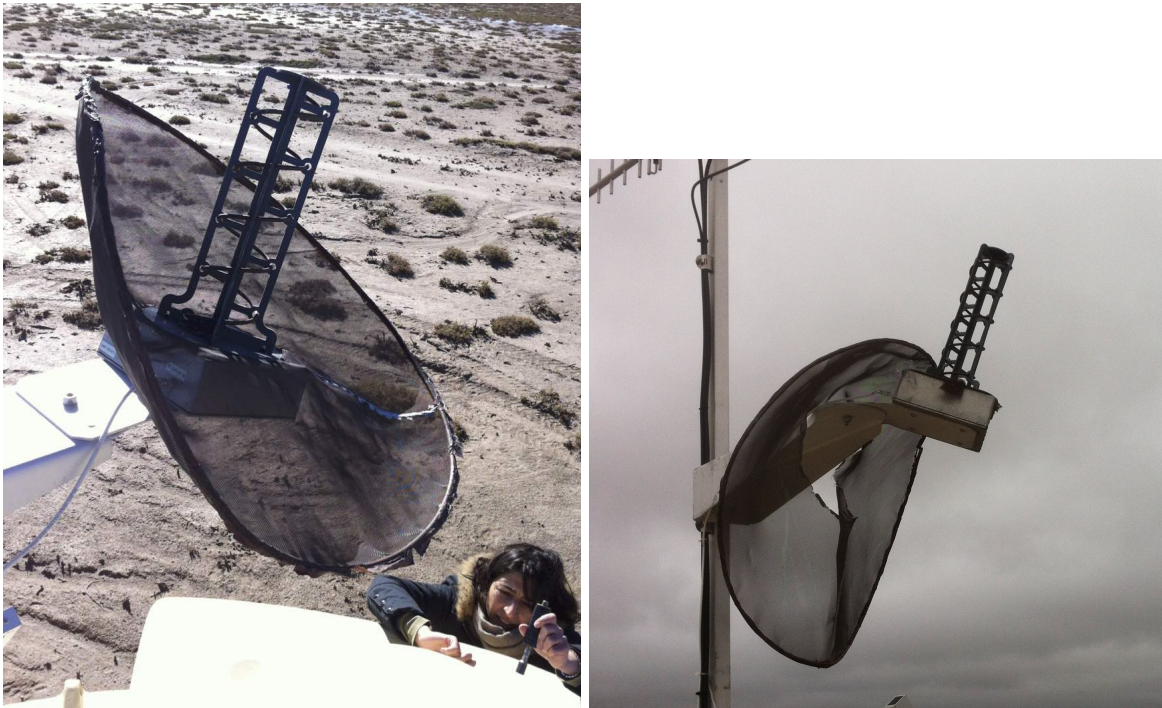
All of the antennas had their metallic cone at least partly distorted. Pictures in the figure 1 show two extreme cases: Nono detector's cone (shown on the left) is distorted, in the case of Eva (shown on the right) the cone is no longer attached to the electronics box.

All the antennas are in a similar state. The mechanics has to be improved.

Figure 1 Left: Nono, Right: Eva

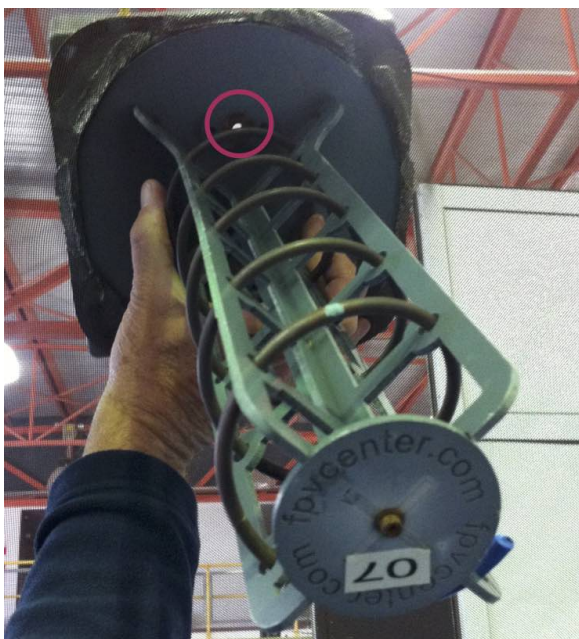
The second problem encountered was that water flooded inside all of the LNA boxes. Water went inside the box through the hole on top of the box (see figure 2 left). Some boxes had still 1-2 cm of water in them and rust started to grow inside the box (figure 2 right).

Figure 2 Left: helix antenna, circled the hole where water went into the LNA box. Right: rust in Santy's LNA box

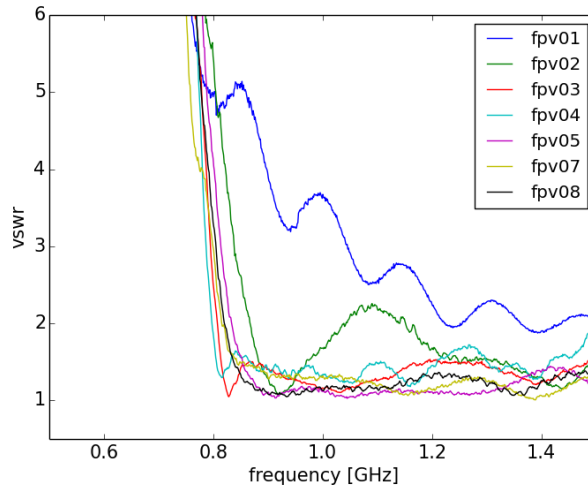
Here we show the characteristics of the RF parts. We show in the figure 3 the VSWR of the antennas. Jacques identified a bad contact on the antenna FPV01. All of the other antennas 26 have a low VSWR (close to 1 in our frequency bandwidth as we expect for an impedance match).

Figure 3 antenna VSWR, measured in lab

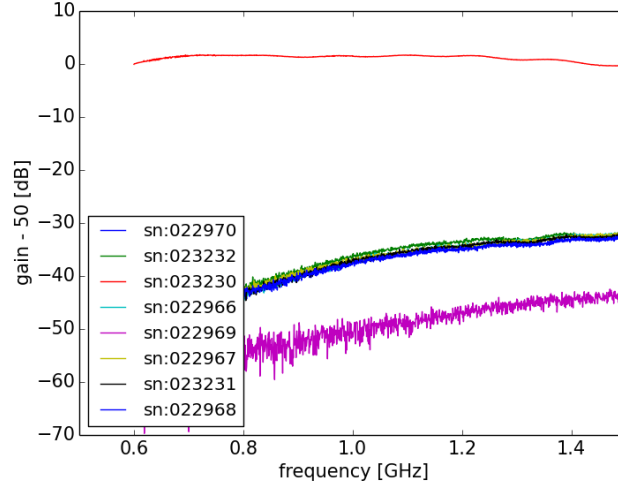
On the figure 5 it is clear that only one LNA is still working, the sn023230, that is the one that was installed on Nono. It has the expected gain (50dB) and a low VSWR. All of the 32

Figure 5 LNA gain. The measurement of the gain was done with a 50dB attenuator.

other ones are broken and almost all have the same characteristics.

So the LNA is the main failure of the system. The LNAs broke for an unknown reason. 34

- a power surge at the LNA input (for instance an electro static discharge or an over 36
voltage due to a thunderstorm)
- the humid/water environment (for instance if the LNA was flooded inside the box) 38

A possible solution to the power surge could be to install a transformer (with coil), or a diode system before the LNA. We need to evaluate the effect of these devices on the noise 40
figure (since they need to be placed before the LNA).

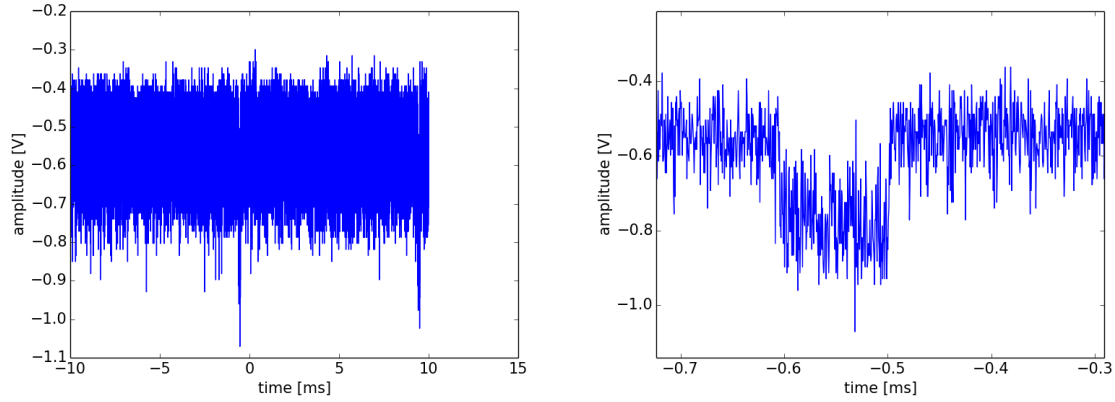
Figure 7 example of trace of the box 4 (left) and zoomed (right)

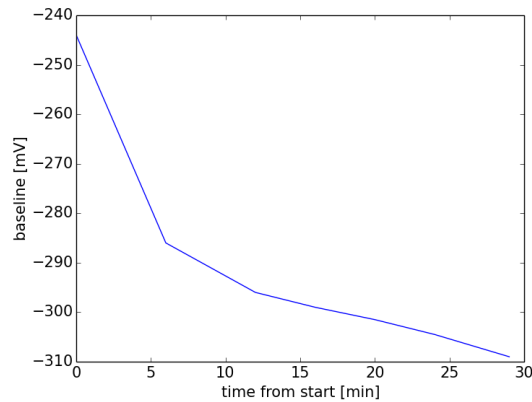
4. As for the time varying baseline, this could be explained by the warm up time of the electronics. Mari did a longer measurement of box9. The results are plotted in the fig 8, the baseline drops by a few tens of mV in 30 minutes. The decrease rate gets smaller with time (the derivative gets close to zero).

Figure 8 baseline versus time for the box number 9
