The Loma Prieta Earthquake: Implications of Structural Damage

S. A. Mahin

University of California, Berkeley, California

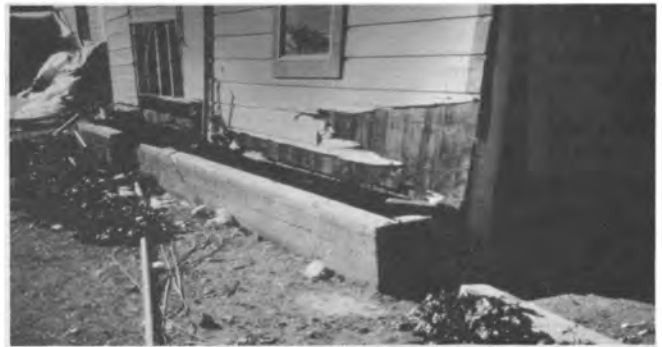
As indicated previously nearly 20,000 dwelling units were damaged during the Loma Prieta earthquake and 10,000 individuals were forced to relocate as a result. A majority of these displaced people lived in wood frame houses and apartments. Many homes located in the Santa Cruz mountains, in the immediate epicentral region, were damaged. Damages ranged from fallen chimneys and porches to partial or complete collapse. Many wood frame buildings in the hardest hit areas were overwhelmed by the seismically induced inertia forces. Sadly, the majority of the damage occurred in older wood frame buildings where the structures were simply not connected to their foundations. During the earthquake, as they have in innumerable past earthquakes, the structures simply shifted off their foundation with resultant vertical dislocation (Fig. 2).

Fig. 2 Damage to House Not Bolted to Foundation

The unfortunate aspect of both of these forms of damage is that simple and economical retrofit procedures, if implemented prior to the earthquake, could have prevented or significantly reduced the severity of the observed damages. Repair following the earthquake was generally extremely expensive as a result of not only the required structural repairs, but because of wide spread damages to architectural, electrical and mechanical features. Pre-earthquake retrofits to these walls and foundations were seen to be effective in several instances in Santa Cruz and elsewhere.

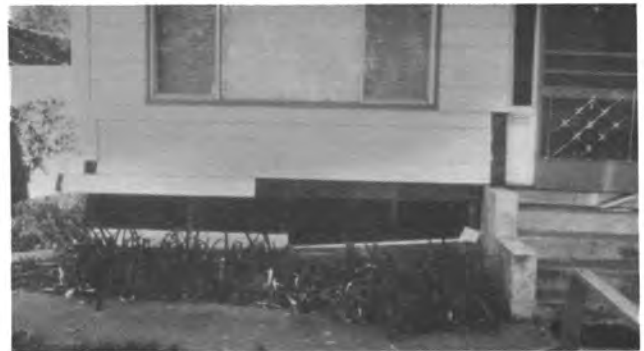
Another common type of failure that was observed related wood frame dwellings built upon short pony or cripple walls. These short walls provided a two to four foot tall access space that was used for storage, ventilation and to accommodate sloped sites. In many older buildings the framing between the ground floor and the foundation consisted of vertical studs and horizontal siding. Even though diagonal braces were provided in the upper levels to resist lateral loads, the braces were typically omitted from the pony walls. In addition, the horizontal siding covering these walls in most cases had badly deteriorated and effectively provided little or no lateral resistance (Fig. 3). The failure of these short support walls resulted in large vertical and lateral displacements of the supported structures (Fig. 4).

Fig. 3 Damage to "Pony" Wall

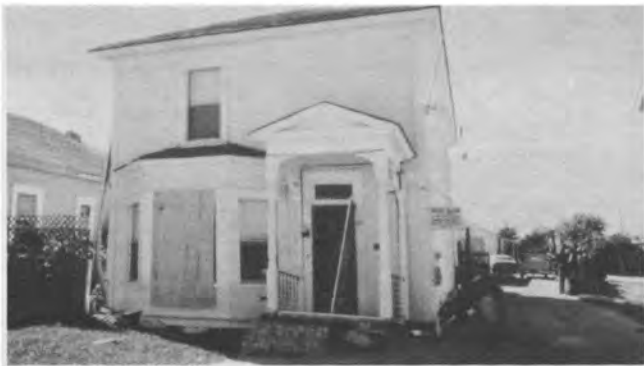
Fig. 4 Collapse of Home on "Pony" Walls

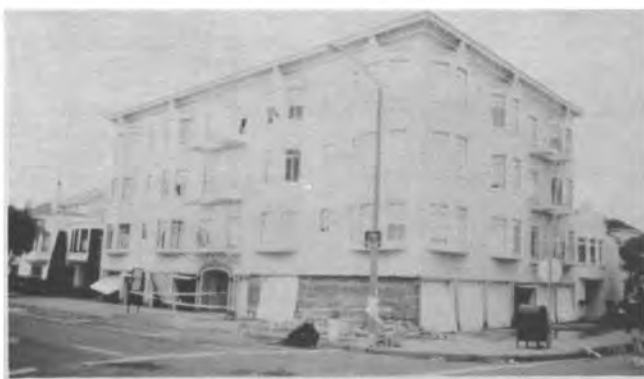
Fig. 6 Typical Marina District Apartment

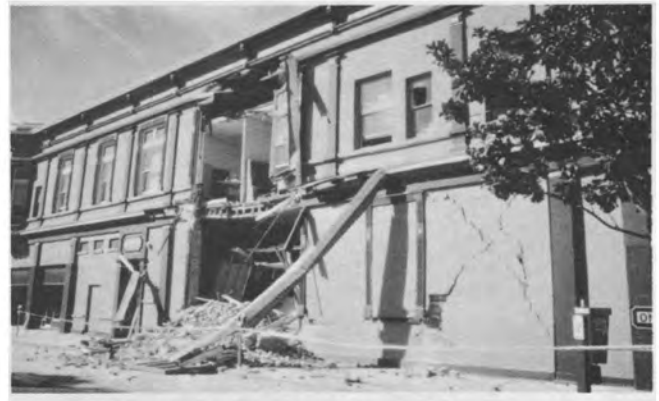
In some cases in-plane shear failures of brick walls was observed (Fig. 9). In some cases this distress resulted in local collapse of wall panels. In other buildings wide spread, inclined cracks developed, stepping along weak mortar joints. In many cases buildings with moderate cracking have been left un-repaired with continued occupancy or the cracks have been simply repaired with epoxy injection to insure water tightness.

Fig. 9 In-Plane Failure of Masonry Wall

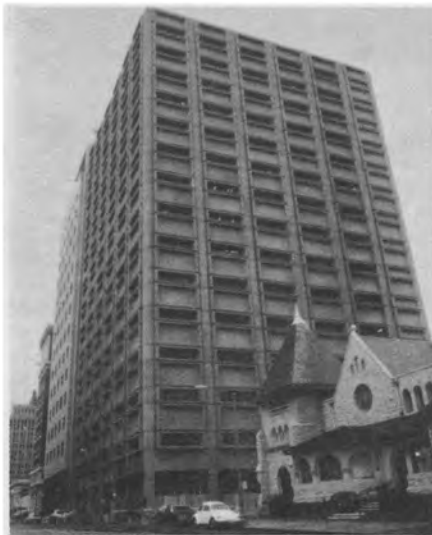
Fig. 10 Lightweight Concrete Shear Walls Failed at Base of Building

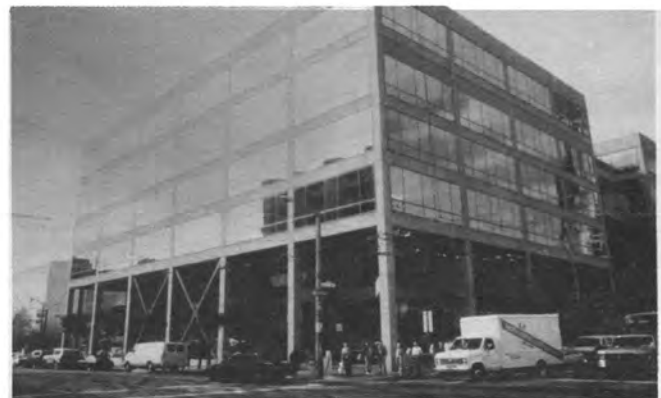
One example of this situation is a 6 story reinforced concrete building constructed in San Francisco at the order of corner and Fourth Street during the early 1980's (Fig. 11). During change of ownership a few years after it was built a number of seismic deficiencies were identified. These were remedied on the basis of

Fig. 11 Retrofit of New Reinforced Concrete Building

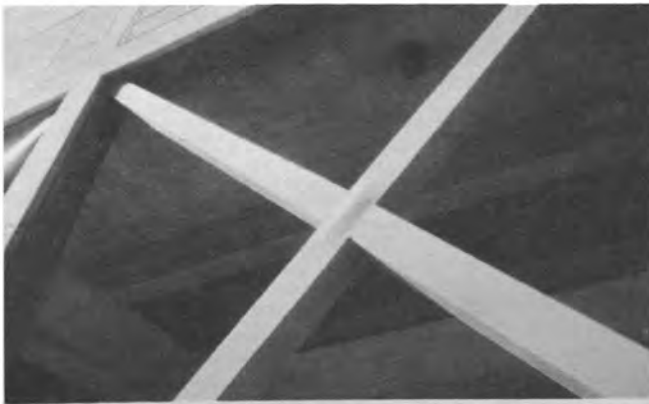
protection of the life safety of the occupants by adding steel braces and shear walls. Following the earthquake, the connections in the steel braces were observed to buckle (Fig. 12), the attachments of the braces to the concrete frame had slipped (in some cases due to faulty installation of anchor bolts), extensive cracking occurred in the shear walls, and initiation of punching shear failures in a few column to flat plate connections. The building has been since repaired (Fig. 13) to restore the capacity that existed at the time of the earthquake.

Fig. 12 Buckled Brace Intersection

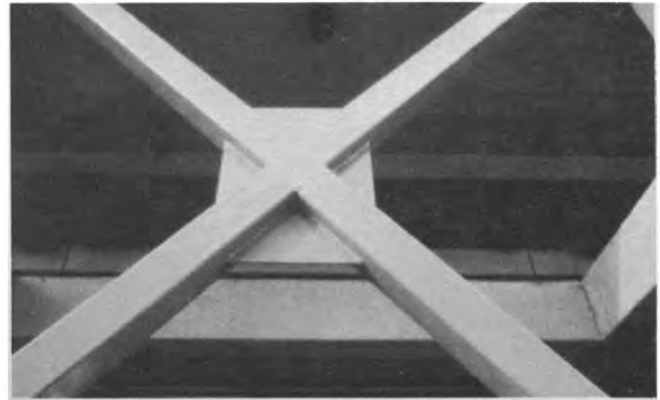
Fig. 13 Repair of Damaged Intersection

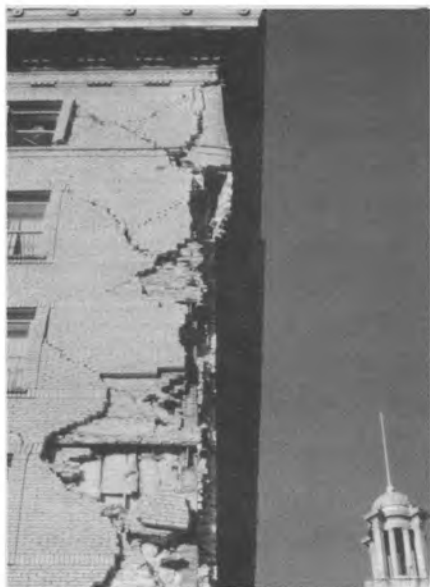
Fig. 14 Damage to Retrofit Steel Frame Building with Masonry Infilled Walls

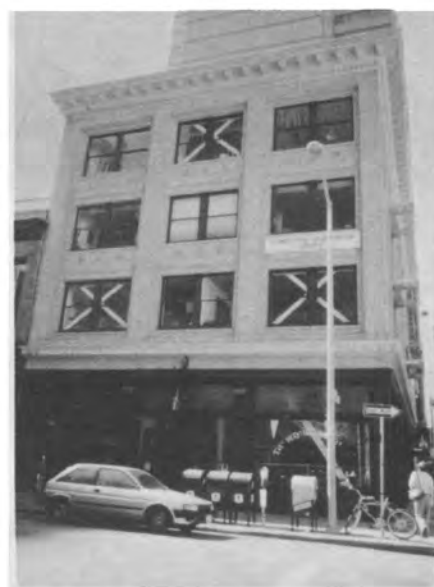
One of these structures (259 Front Street) was located at the corner of a block and it was heavily braced along two street sides (Fig. 15). The added braces at the street level buckled out of plane significantly (Fig. 16), but no damage was actually found in the masonry portions of this four story building. The second structure (1051-1075 Battery Street) was also braced but the mortar in the existing masonry walls was apparently so poor that random sections of the exterior wall fell from the building. Another building (located at Sixth Street and Bluxome Streets) had apparently been partially retrofit by addition of wall anchors. Five people were killed as the upper level wall on one side of the structure fell onto the sidewalk and street. In all of these cases it is clear that the lack of a consistent, systems approach to the design of the retrofits had a detrimental effect and that a new class of potentially hazardous buildings (i.e., the inadequately retrofit structure) needs to be investigated.

Fig. 15 Retrofit URM Building with Steel Braces

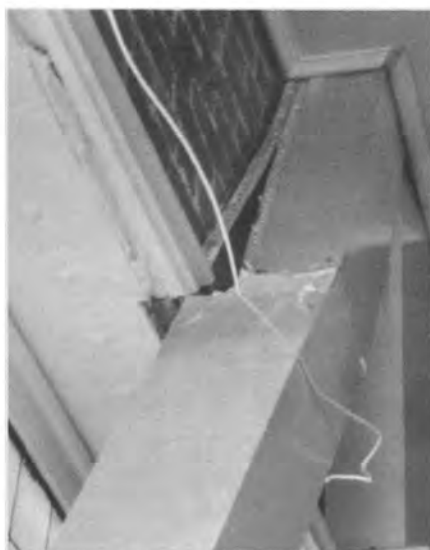
Fig. 16 Buckled Brace in URM Building

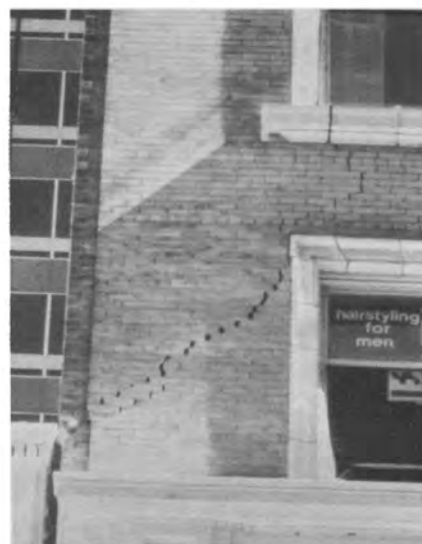
Fig. 17 Pounding Damage

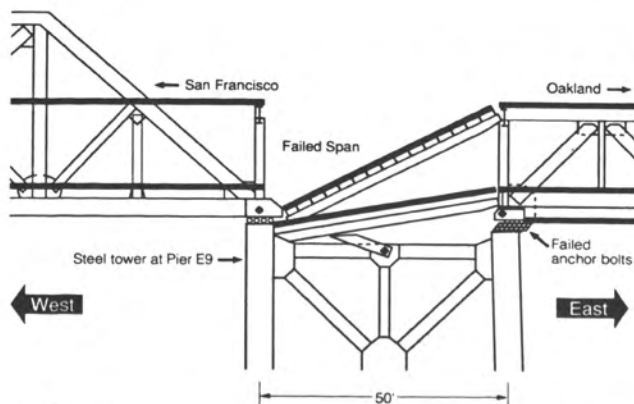
In addition, the bottom chords of the trusses were attached to the tower by means of twenty 1-in. diameter bolts. During the earthquake the bolts in the connection on the east side of the tower sheared completely and the bearing plate moved approximately 5-10 inches to the east. This was probably the proximate cause of the roadway beams slipping from their seats.

Fig. 18 Detail at Collapsed Section of Bay Bridge

The bridge was repaired by jacking the eastern segments back into place and providing new roadway beams and supports. The support seats were constructed about 50% longer than in the original design. A more extensive study is currently under way by Prof. A. Astaneh and his colleagues at the University of California, Berkeley and by Caltrans to assess more reliable long term retrofits.

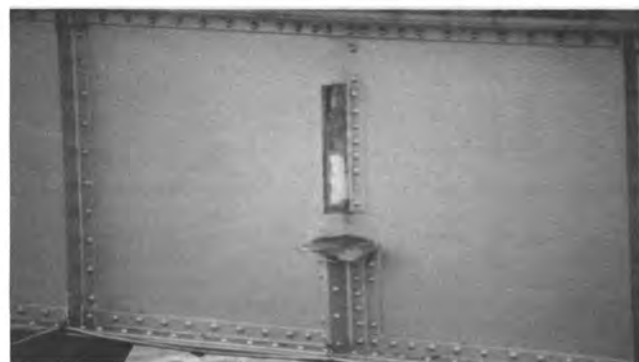
Fig. 19 Detail of Seat Connection on Bay Bridge

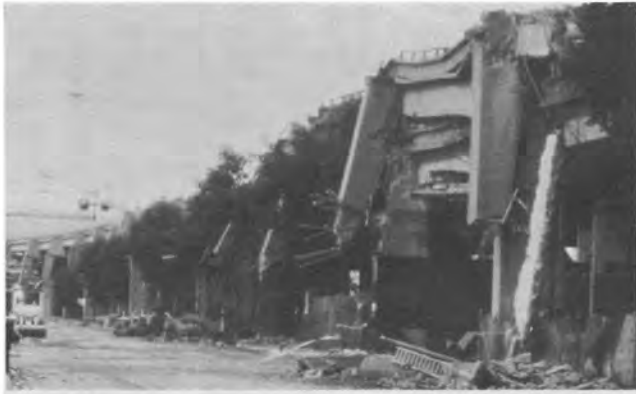
The most spectacular damage to reinforced concrete bridges was the catastrophic collapse of nearly a mile long portion of the upper deck of the Cypress Street Viaduct located in west Oakland on poor soil reclaimed from the bay (Fig. 20). This structure was designed in the early 1950's and construction was completed in 1957. The death toll for its collapse was 42, though as mentioned earlier a thousand fatalities or so casualties might have been expected had the earthquake occurred during congested rush hour traffic. A variety of factors contributed to the failure of the structure. These include the amplification of the ground motions in the vicinity due to the soft soil conditions, traveling wave effects, and variable soil conditions. The structure also was designed at a time when earthquake resistant design procedures were not highly developed. Thus, while the bridge appears to have been conservatively designed relative to the structural requirements in force at the time of its construction, it has a number of major deficiencies with respect to current construction practices.

Fig. 20 Collapse of Cypress Street Viaduct

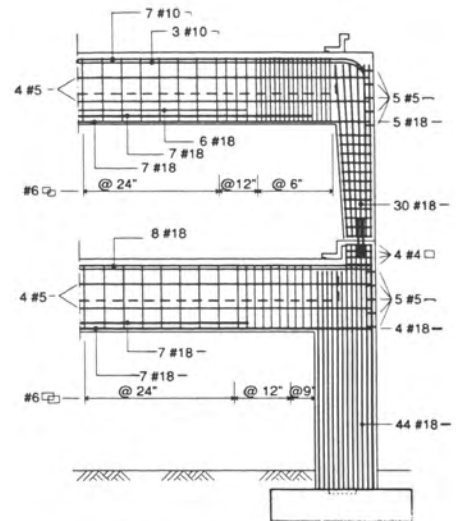
This bridge represented in many respects a substantial advance in the state of the art at the time it was built. Not only did it have two levels, it was one of the first major bridge structures in the U.S. to employ post-tensioning and large diameter reinforcing bars. In most cases the structural system incorporated a significant number of flexural hinges in order to simplify the future addition of access ramps, to reduce secondary forces resulting from deformations associated with post-tensioning and foundation settlement, to reduce computational effort and to control moments that could be transferred to the foundations. This resulted in a structure that was nearly statically determinate. In addition, detailing did not incorporate features needed to impart ductility to the elements (shear reinforcement sufficient to develop the flexural capacity of members, confinement of potential plastic hinge regions and inadequate development length on reinforcement), and joints were neither confined nor designed to resist the shear forces associated with realistic lateral loadings. Details of a typical transverse bent are shown in Fig. 21. In addition, in the longitudinal direction, frame action depended on the

Fig. 21 Detail of Typical Bent [from Housner (1990)]

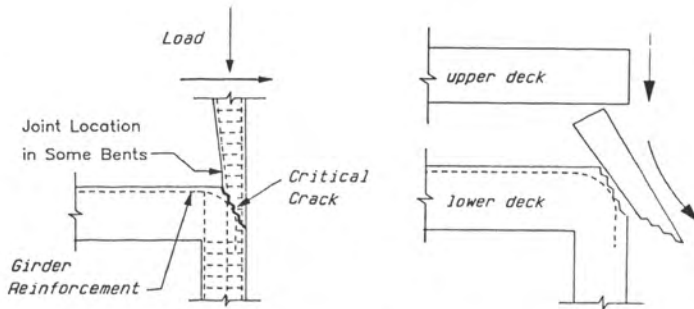
The dominant features of the typical collapse mechanism are shown in Fig. 22. Shear cracks in the pedestal supporting the hinged upper level columns were able to extend downward into the joint region following the projection of downward bending hooks on the end of the transverse girder's (cap's) top level reinforcement. The lack of shear reinforcement in the joint allowed this inclined crack to act like a slide, with the resultant pancake collapse of the upper level.

Fig. 22 Postulated Failure Mode

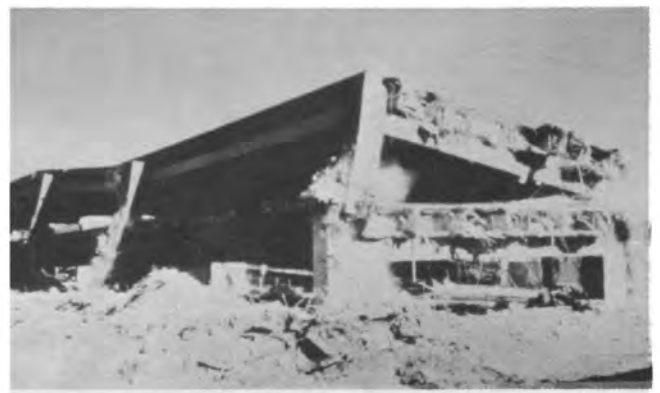
The sudden and catastrophic nature of this failure mechanism was demonstrated convincingly during the demolition of the Viaduct. A wrecking ball was used to initiate failure in a single column. Almost immediately progressive collapse occurred throughout the upper level not only extending transversely across the roadway, but also longitudinally for six bays to the end of the remaining standing portion of the viaduct. Clearly, such brittle structures are not compatible with seismic resistant design.

Fig. 23 Failure Mode Observed during Demolition

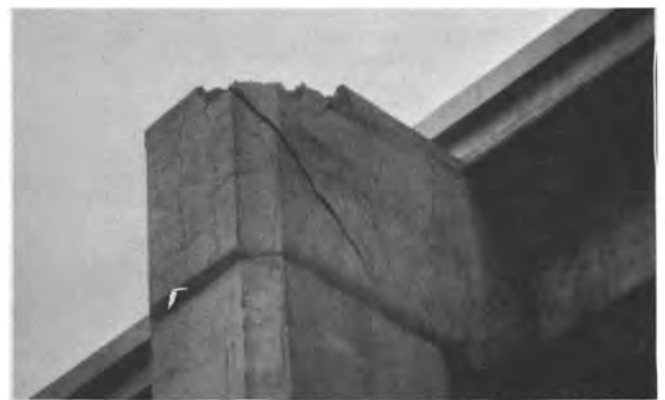
Fig. 25 Damaged Knee Joint in New Freeway
