# Post Flight Review

#2036  
INHARO

# Failure Analysis

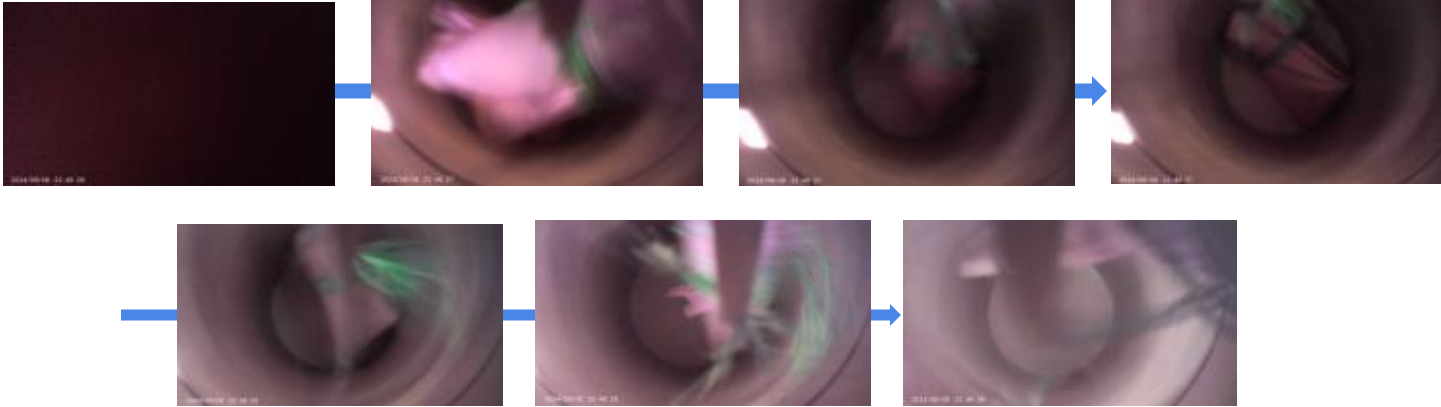
From the bonus camera video, we can see that the parachute plate was broken due to the impact at rocket launch.

→ the servo motor wire connected to the parachute plate was released and caught in the heat shield arm, and the heat shield injection failed.

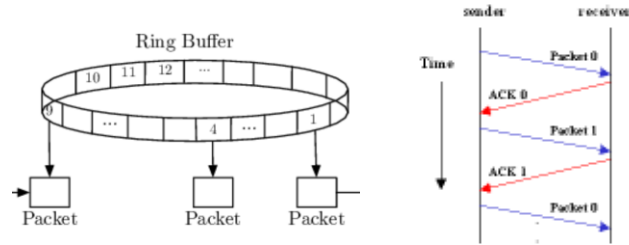
## Software reset occurred

But discrete packet is received

→ Software reset might be occurred

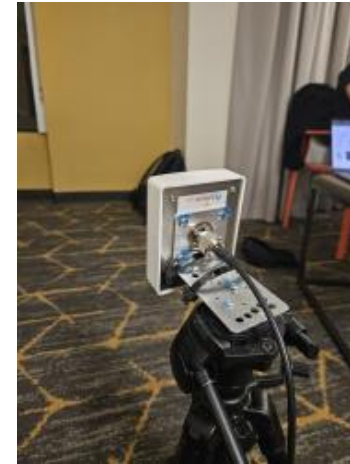
## Antenna directionality issue

We use the panel antenna and It is difficult to know where the antenna is directing

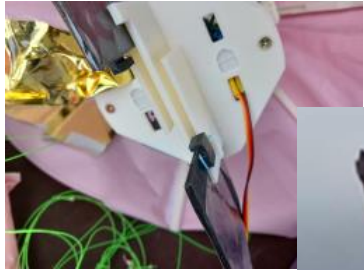
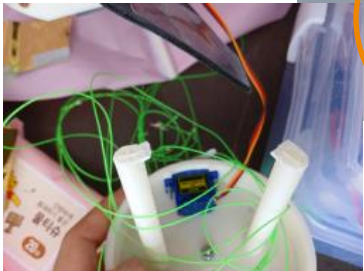
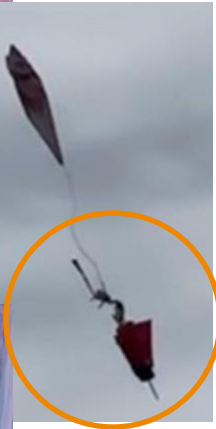
## Heat shield

- The two columns of the RCU broke when launched. At this time, the servo line attached to the parachute plate twisted with the heat shield arm, and it unfolded only a little.
- However, the unfolding of the heat shield and some deceleration can be confirmed through the naked eye and the recorded video. The deceleration effect of the heat shield allowed the egg to be safely protected.

- Add or change springs to allow the heat shield to spread with greater elasticity.
- Added devices to secure the 'hit shield arm' to keep it unfolded in strong winds.

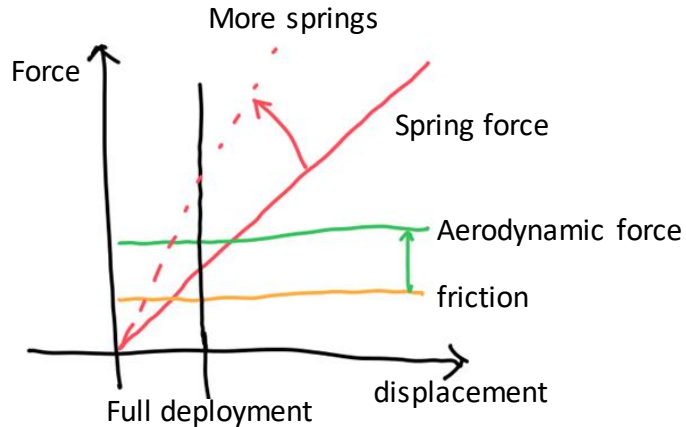
- failed to deploy heat shield
- Failed to release heat shield

- Under estimated the aerodynamic force
- Lack of release impulse due to parachute damage

- Add more springs or change heatshield structure
- Heat shield can be a backup plan for a parachute failure
- We can add a function to detect parachute deployment in FSW so that the cansat release heat shield only when the parachute is properly deployed

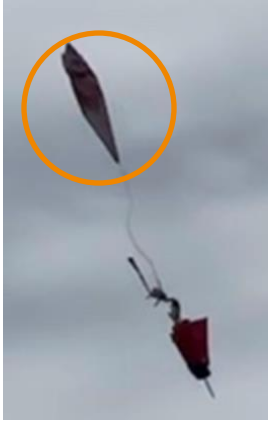
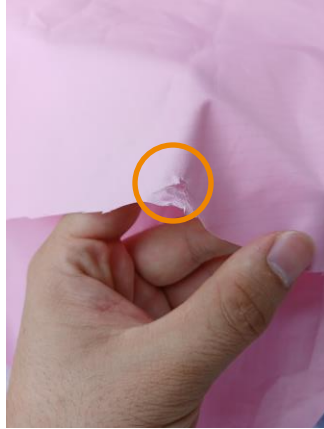
- Early deployment of parachute
- Parachute teared

- Parachute fastened with rubber band
- High-g during ascent caused parachute deployment

- Add a container to secure the parachute properly
- Reinforce the hole on parachute using some grommets

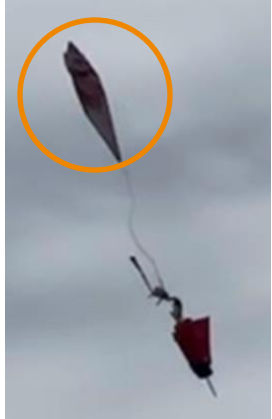
- Nosecone interrupts camera view
- Nosecone stuck on the Cansat

- Nosecone orientation is not constrained
- Part to constrain the nosecone's longitudinal position is not properly designed

- Modify nosecone design

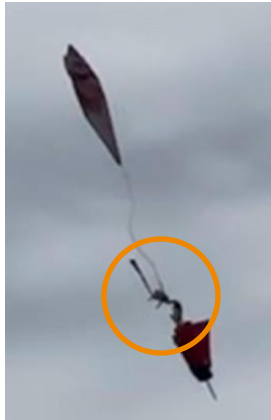
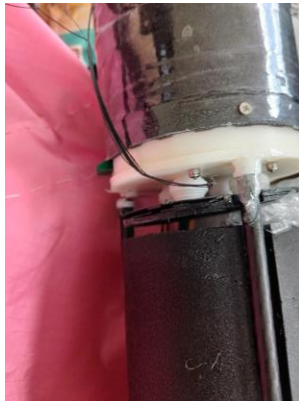
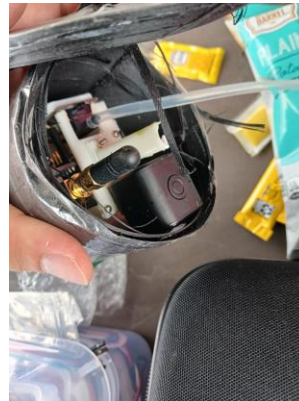
- Structural failure of various parts

- Most of our elements are consist of PLA/ABS/lite weight PLA
- They have low specific strength

- Change materials to relatively high specific strength materials such as balsa wood, PET, composites

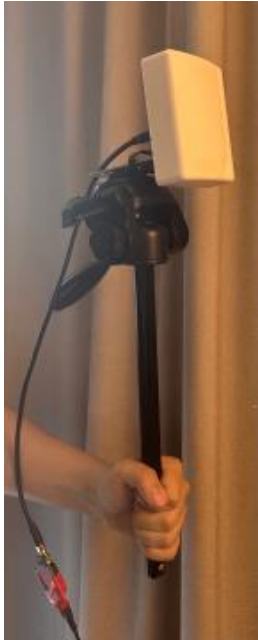
- Most of telemetry data lost

- Antenna direction error

- Add a scope to the antenna
- Mounted antenna to handheld antenna
