TT SOUTH AFRICA PROCESSING

MAINTENANCE WORK INSTRUCTION

MAW02

Blanking line Washer unit clutch clearance

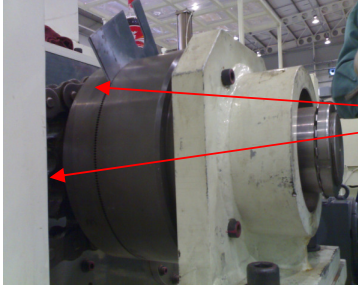
No.	DEFECTS	COUNTERMEASURES
	<p>THE MAGNETIC CLUTCH ON THE WASHING UNIT WAS OVERHEATING DUE TO MISSALIGNMENT</p>	<p>AFTER THE REMOVAL OF THE CLUTCH GUARD, IT WAS DISCOVERED THAT THERE WAS INSUFFICIENT CLEARANCE BETWEEN THE CLUTCH COUPLINGS INNER AND OUTER PARTS THUS CAUSING FRICTION RESULTING IN THE HEAT BUILD UP</p>
	<p>THE CLUTCH IS DRIVEN BY A CHAIN CONNECTION TO THE LEVELLER</p>

<p>AFTER DISSINGAGEMENT OF THE CLUTCH AND LOOSING OF THE HOLDING DOWN BOLTS THE GAP BETWEEN THE TWO COUPLINGS WAS RESET TO 1MM ALL ROUND AND A GAP ESTABLISHED BETWEEN THE INNER AND OUTER PARTS OF THE COUPLINGS BY MEANS OF A FEELER GAUGE AGAIN EQUAL GAP ALL ROUND</p>
