VALUE INTEGRATOR	PRODUCTION WORK INSTRUCTIONS	SOP No: MAW1543
	Blanking line Washer unit clutch clearance	Rev: 0.0
		Date: 13 OCT 2025

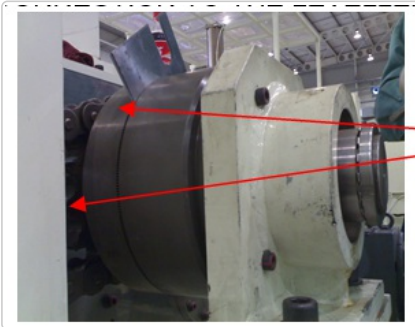
No.	INSTRUCTIONS	VISUALS	KEY POINTS / CONTACTS
1.	<p>THE MAGNETIC CLUTCH ON THE WASHING UNIT WAS OVERHEATING DUE TO MISSALIGNMENT</p>		<p>AFTER THE REMOVAL OF THE CLUTCH GUARD,</p> <p>IT WAS DISCOVERED THAT THERE WAS</p> <p>INSUFFICIENT CLEARANCE BETWEEN</p> <p>THE CLUTCH COUPLINGS INNER AND</p> <p>OUTER PARTS THUS CAUSING FRICTION</p> <p>RESULTING IN THE HEAT BUILD UP</p>

No.	INSTRUCTIONS	VISUALS	KEY POINTS / CONTACTS
2.	THE CLUTCH IS DRIVEN BY A CHAIN CONNECTION TO THE LEVELLER

<p>AFTER DISSINGAGEMENT OF THE CLUTCH AND</p> <p>LOOSING OF THE HOLDING DOWN BOLTS THE GAP BETWEEN THE TWO COUPLINGS WAS RESET TO</p> <p>1MM ALL ROUND AND A GAP ESTABLISHED BETWEEN</p> <p>THE INNER AND OUTER PARTS OF THE COUPLINGS</p> <p>BY MEANS OF A FEELER GAUGE AGAIN EQUAL GAP</p> <p>ALL ROUND</p>
