Community: Red Mill 1 Condominiums
17745 134th Lane SE
Renton, WA 98058

Location: Community Cabana

Moisture Intrusion Inspection

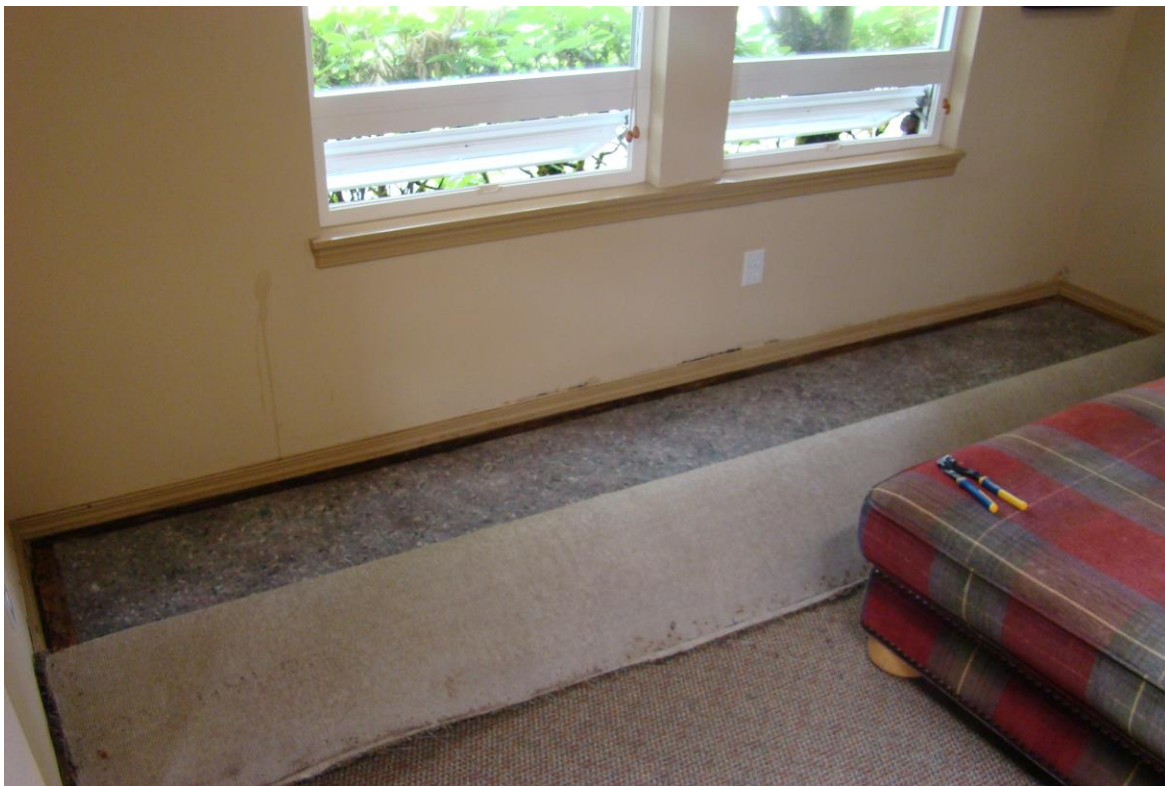
Interior Moisture Intrusion Damage – Bump Out

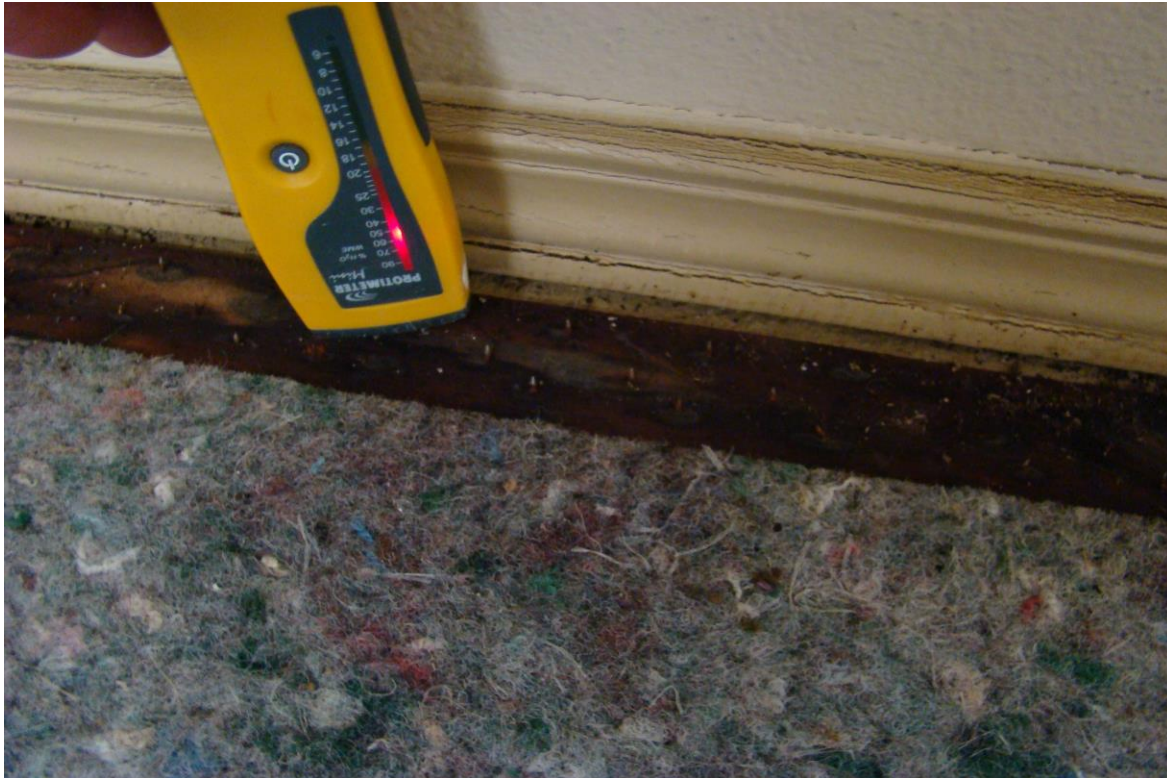
High Moisture Level Readings at Base, Carpet, Pad and Tack Strip

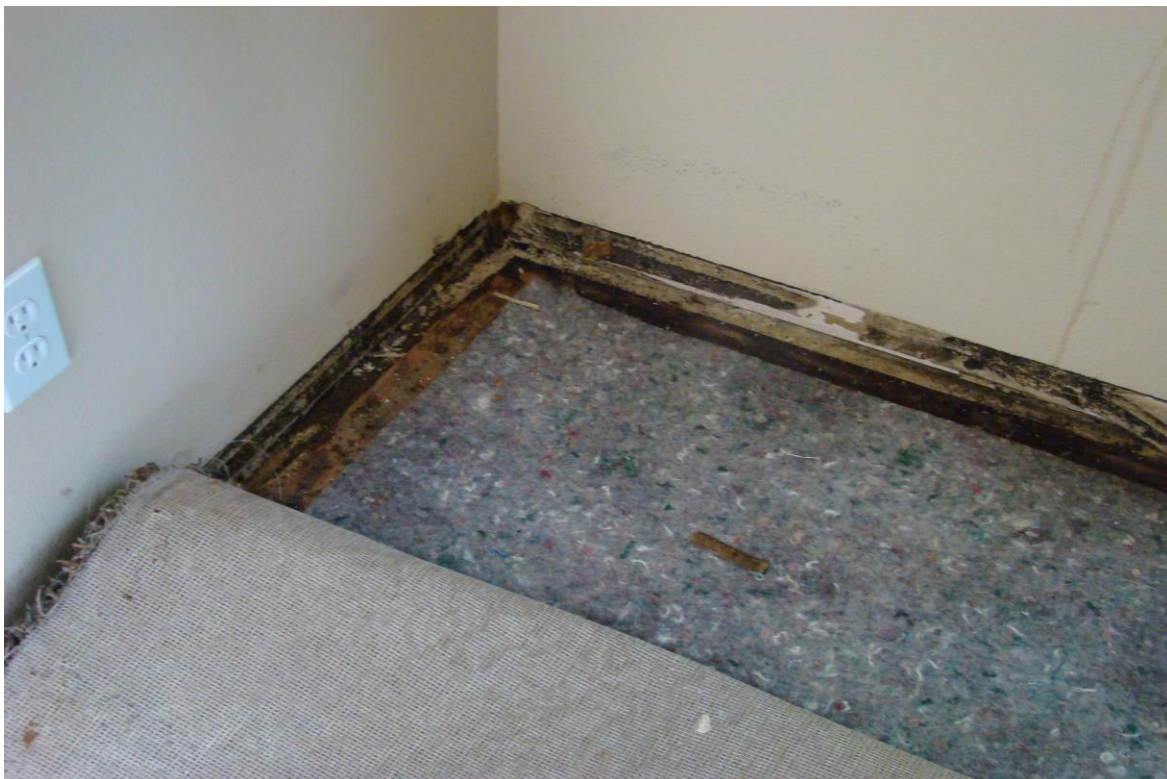
Interior Wall Moisture Damage

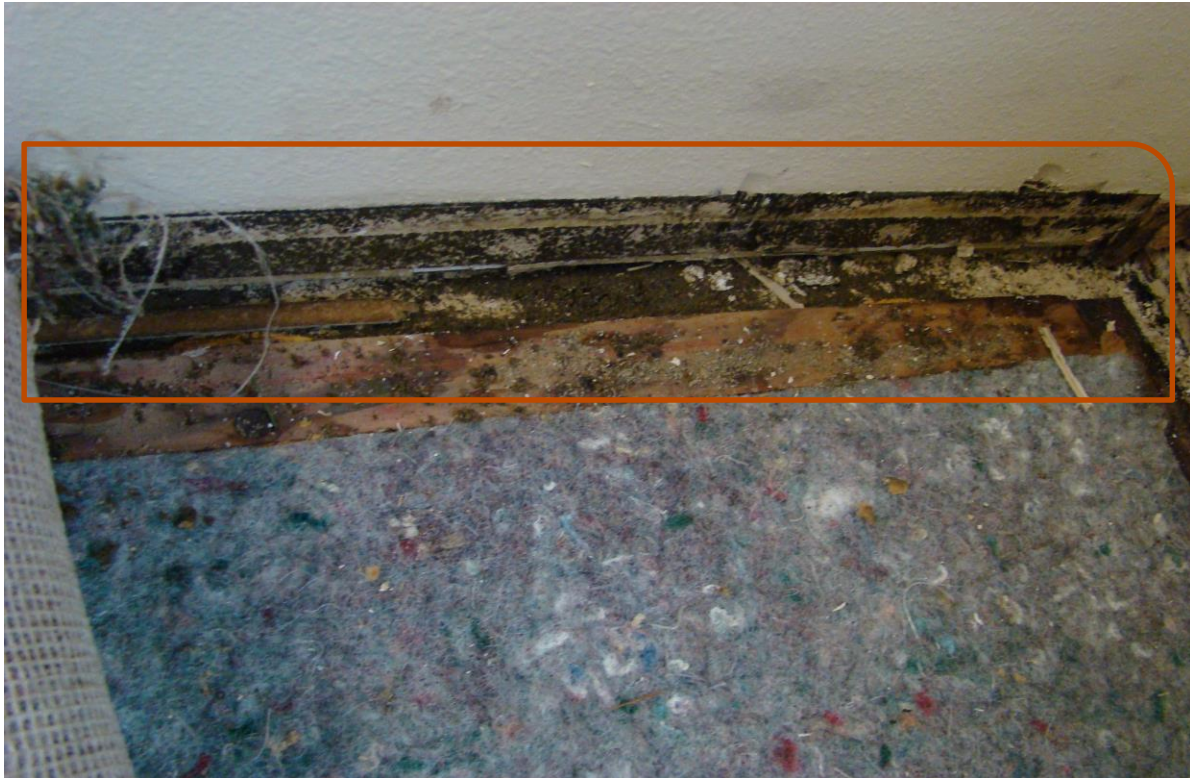
Moisture and Soil Intrusion Between Footing and Wall Plate

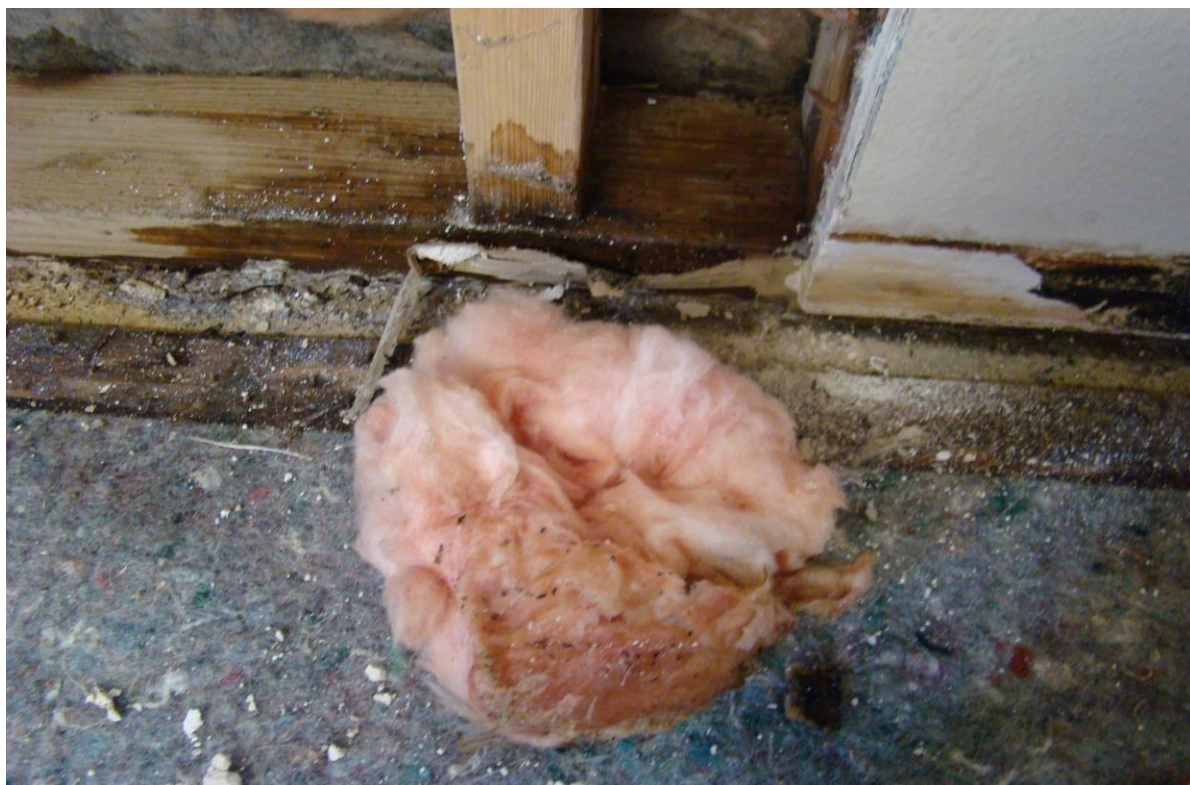
Moisture Damaged Wall Insulation and Exterior Gypsum Board

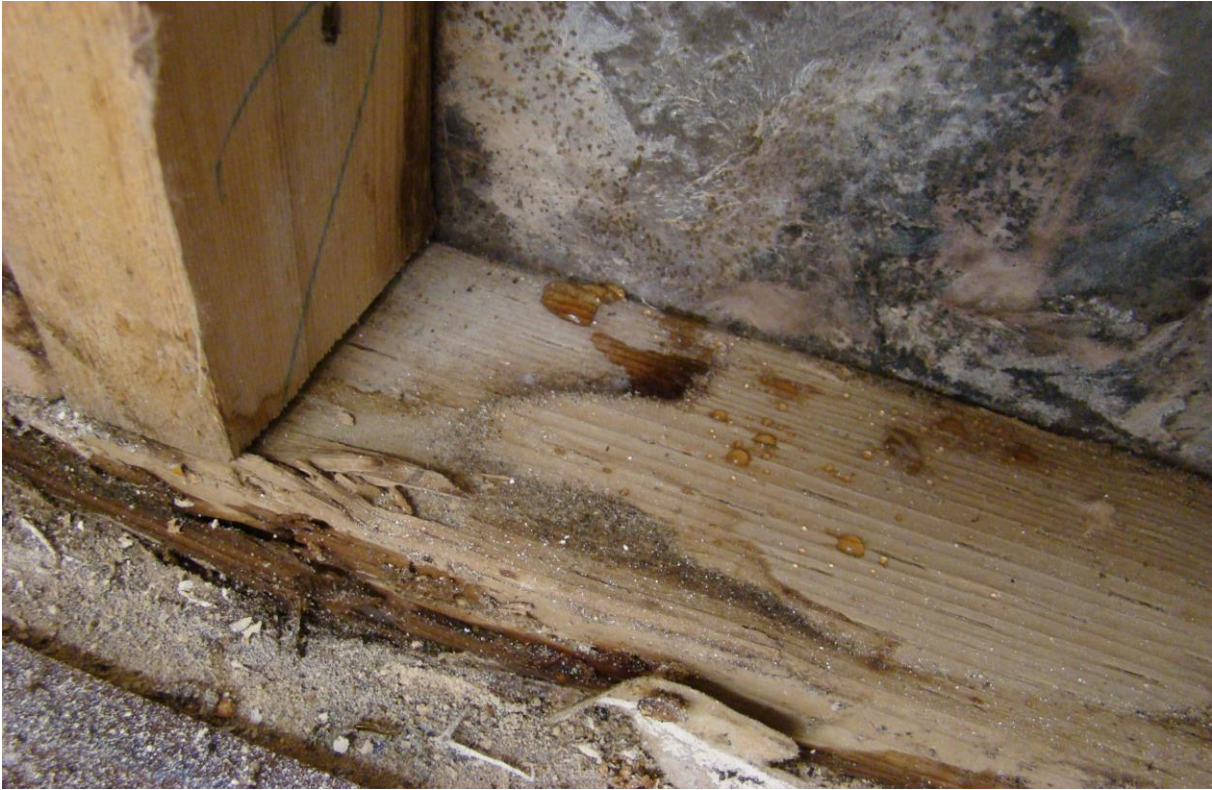
Moisture From Window to Lower Wall Transition

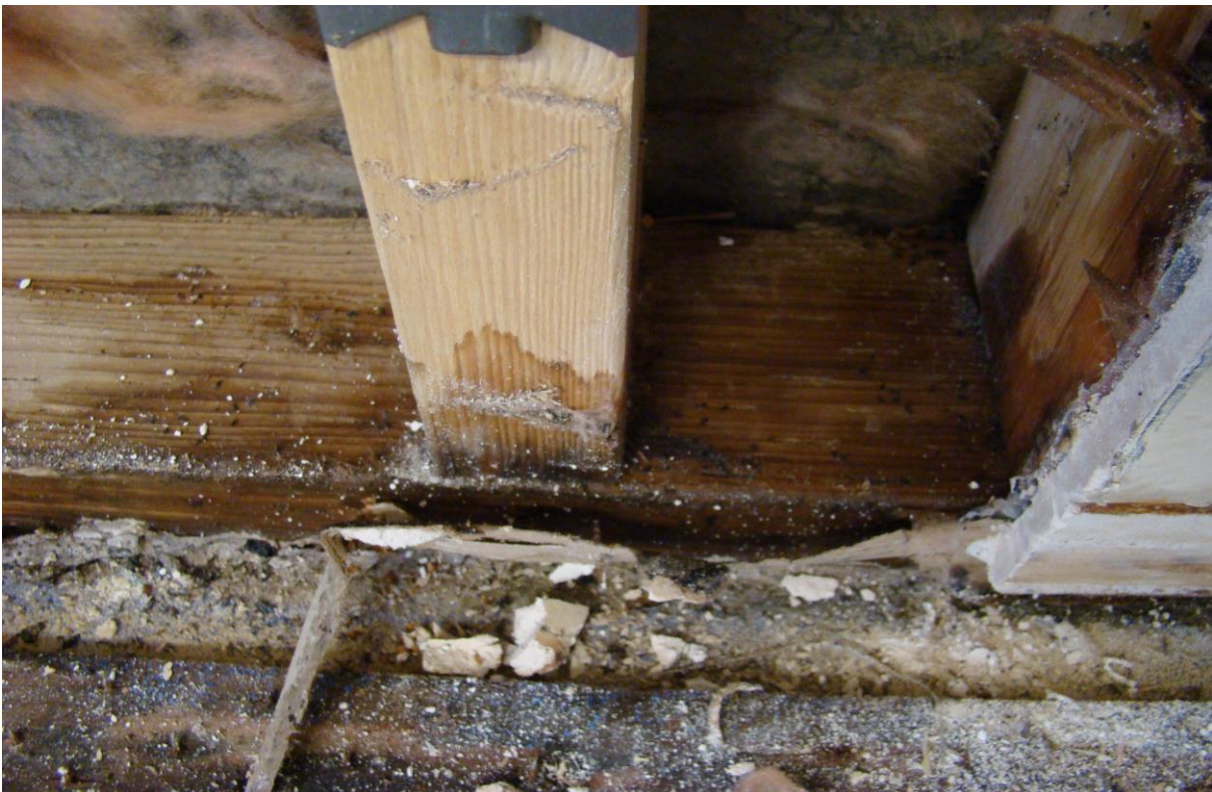
Moisture From Exterior Gypsum Board and Wall Plate

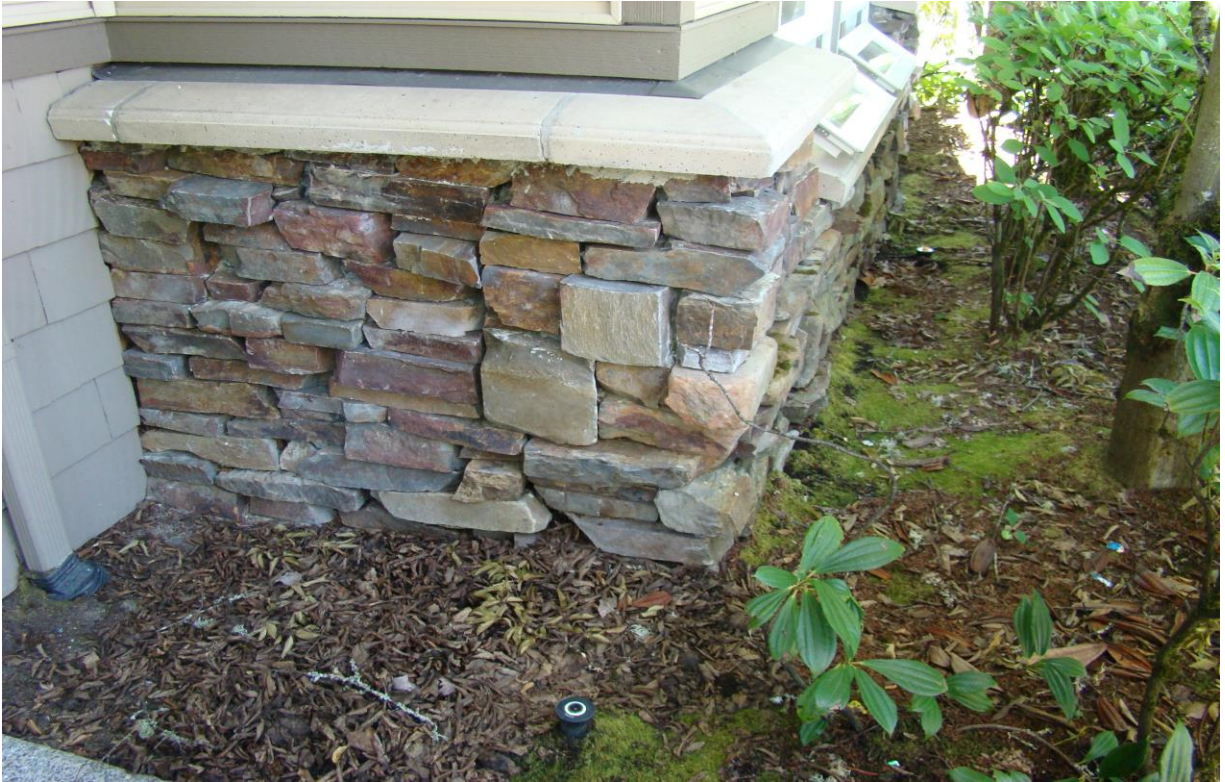
Soil Elevation Higher Than Footing

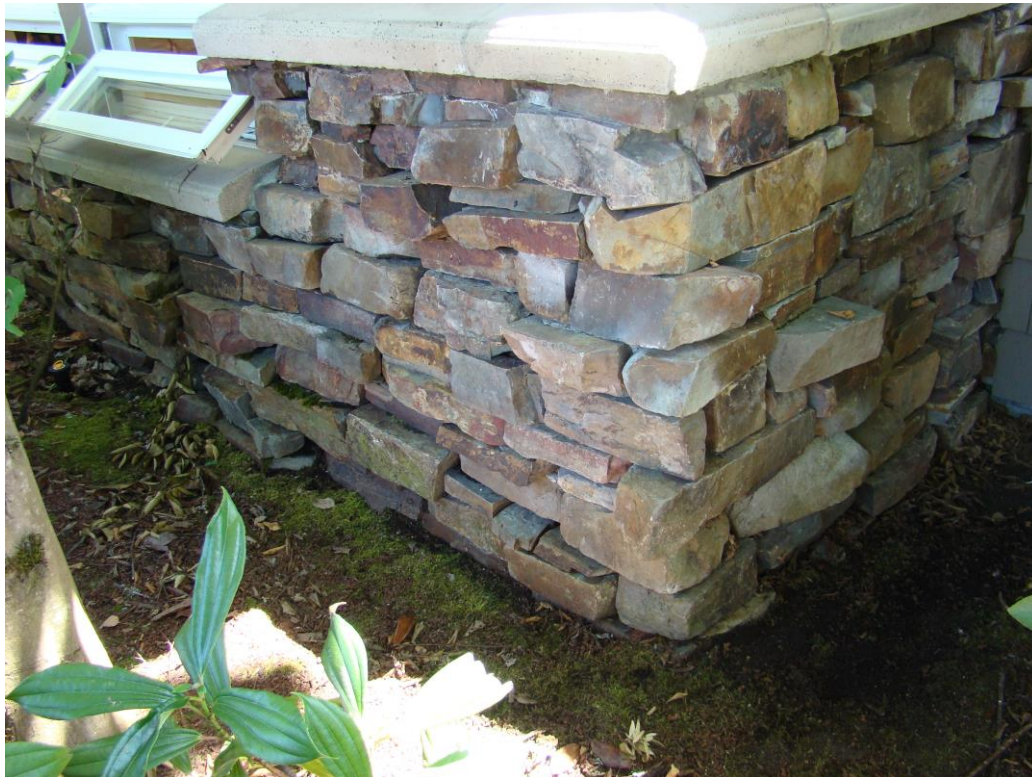
Soil Elevation Higher Than Footing
