**Report of the Chief Inspector of Marine Accidents
into the grounding and subsequent salvage of the tanker**

SEA EMPRESS

at Milford Haven

between 15 and 21 February 1996

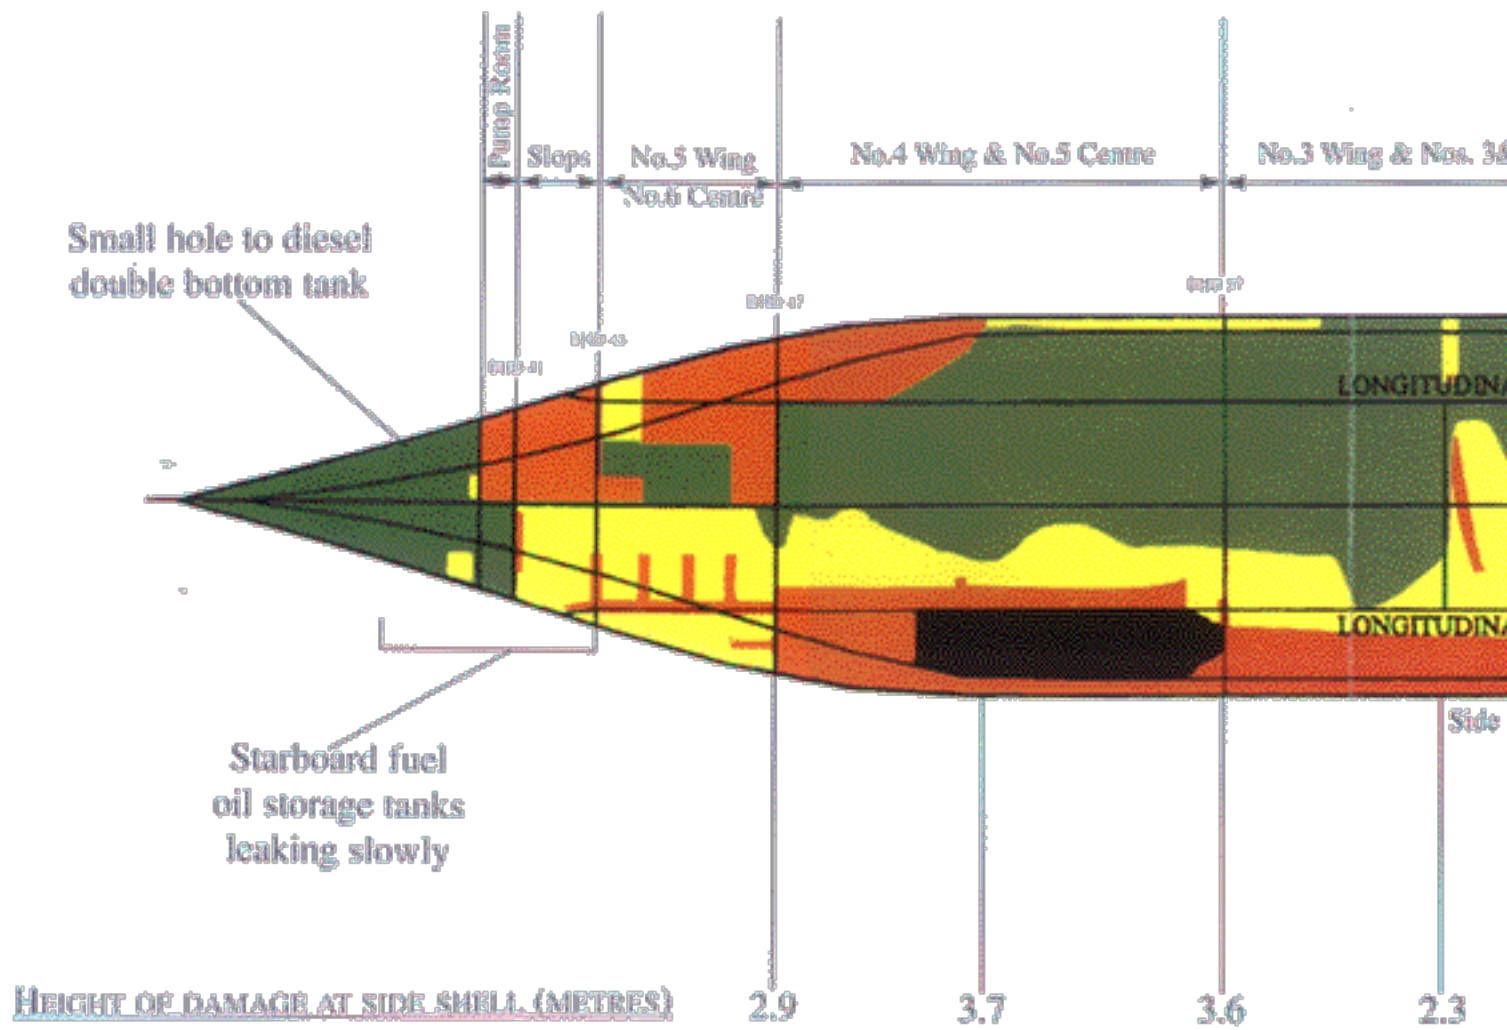
Figure 6.
An Overview of the Damage to SEA EMPRESS

20.2 A broad overview of the hull bottom damage is shown in Figure 6 (Image 63k). It can be seen that the most severe damage ran in a continuous band from around the Fore Peak and down the length of the starboard wing tanks. In marked contrast the port wing tanks showed only isolated areas of damage, whilst the majority of the area in way of the centre tanks was largely undamaged or only lightly so. The entire damaged area exhibited pounding damage with the plating dished in between adjacent stiffeners with fractures running along the lines of bulkheads and frames (see Photographs 3 - 6).

20.3 The most striking aspect of the damage was the extreme degree of deformation to the starboard bottom right along the line of the starboard wing tanks. In this area the turn of bilge had disappeared over virtually the whole of the cargo tank length, and the bottom shell appeared to meet the side shell along a knuckle line some 3 to 4 metres above the keel. Over large areas the longitudinal bulkhead plating had protruded through and then been forced flat against the bottom shell.

20.6 A section of plating some 2 metres square was missing from underneath No 2 Starboard tank while underneath No 3 Starboard tank there were several areas of plating completely detached from their stiffeners and sagging down. There was also an area some 5 metres long by 2 metres wide which had been folded back along the bottom shell leaving a clear opening in the

bottom. The bottom of No 4 Starboard tank had suffered catastrophic damage, the bottom shell structure having been destroyed over almost the entire area of the tank.

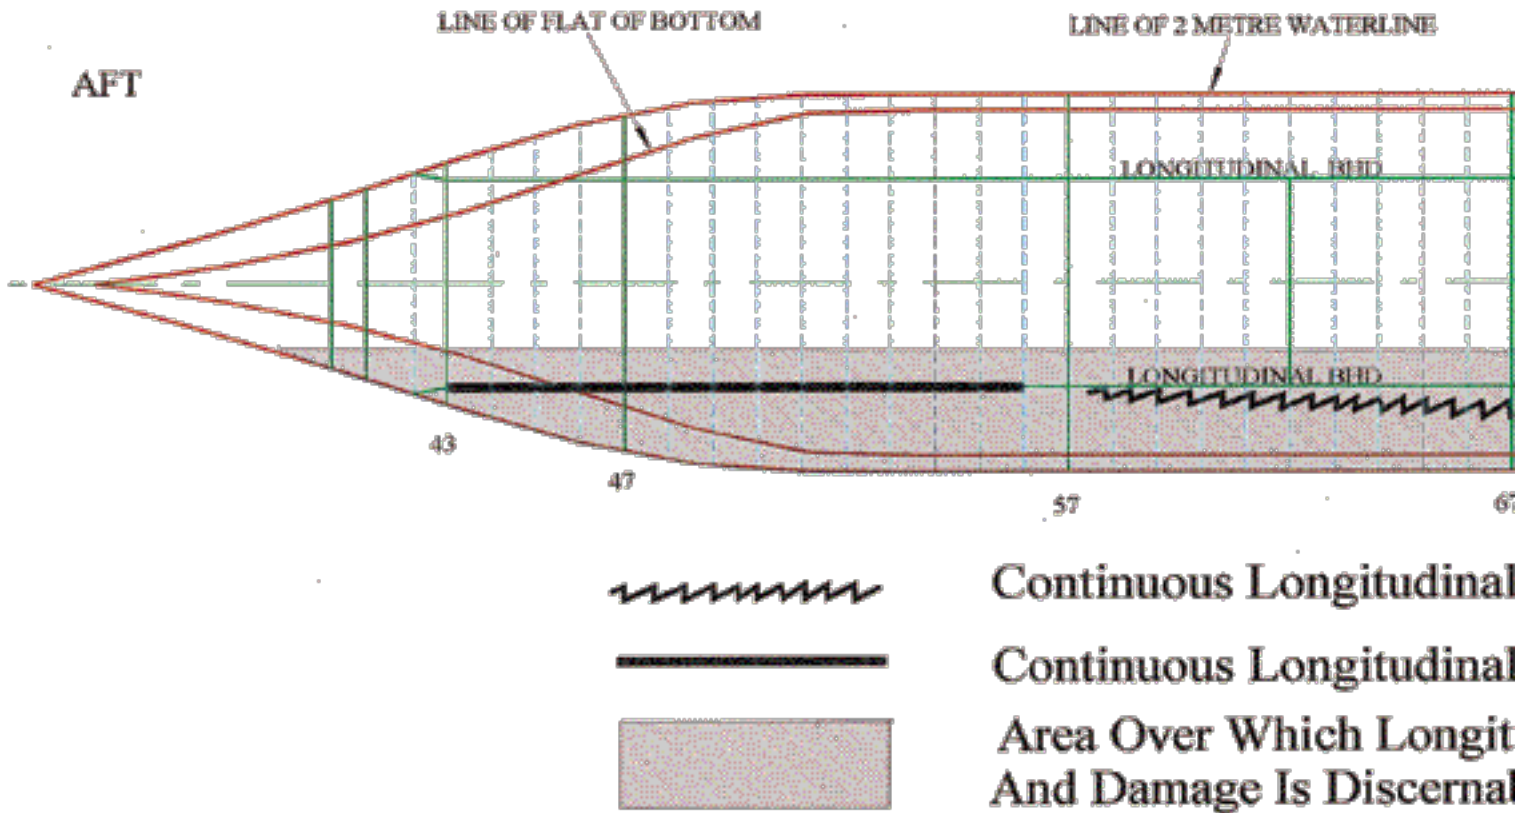
Figure 7.

20.5 The damage which caused the initial flooding to No 1 Centre tank, is thought to have been along the line of the longitudinal bulkhead as this was the only damage which was found on the starboard side which would have opened No 1 Centre tank to the sea. The source of the initial flooding to the pump room was found at bulkhead 41. Associated with this damage were fore/aft scores in the hull plating along a line about 6 metres off the centre-line. These two damages suggest that the initial raking damage extended inboard from the starboard side to about 6 metres off the vessel's centre-line. This is illustrated in Figure 7 (Image 37k).

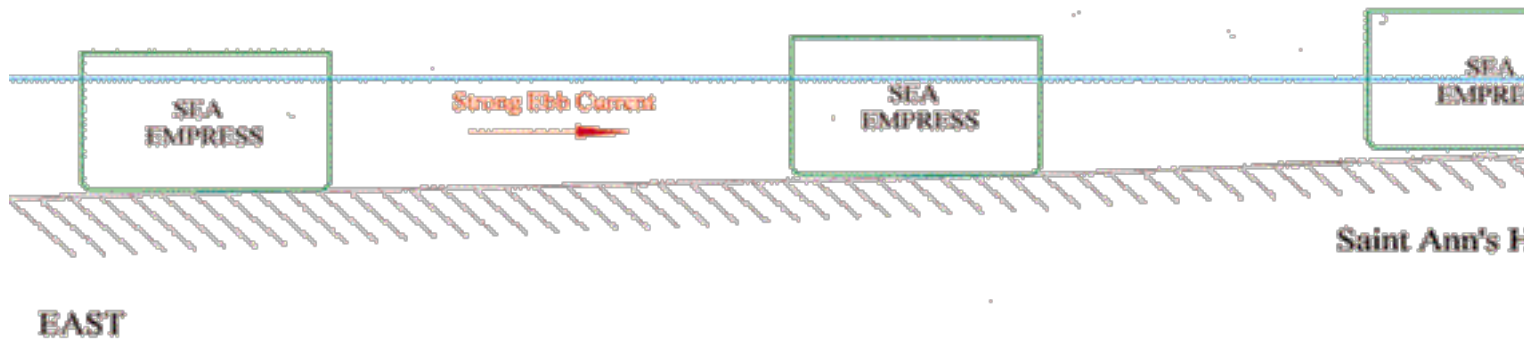
Tuesday 20/20 - During the failed re-floating the vessel is held against the shoal by the strong ebb current and carried into shallower water, finally grounding with a mean draught of about 16.6 metres. There was insufficient tug power available to pull her away from the shoal against the ebb current.

Wednesday 21/02 - The vessel, which is at about 12 metres, has been moved to an extent that she now floats close to the shore and can be turned by the tugs so that she is with the ebb current, greatly reducing the risk of collision and allowing the tugs to pull her out of the
