MEM 333 - 001

Mechanical Behavior of Materials

Engineering Consulting Report:

JAGR Engineering Consulting Firm Members:

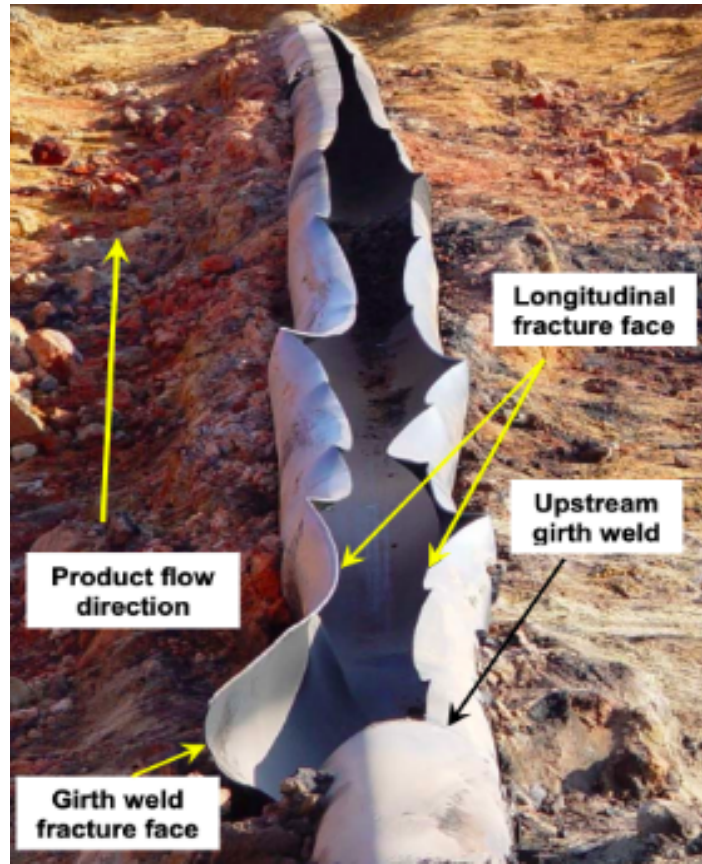
Figure 1: Ruptured Steel Pipe

The damage of the pipeline extended over a distance of 52 feet and 4.75 inches. A large portion of the fracture extended through the longitudinal ERW seam. The fracture faces that were along the seam weld had a layer of oxide that is consistent with fire exposure. There was no evidence of a pre-existing crack in the girth weld, but there was evidence of a 1-inch fracture portion of the downstream face of the girth weld. A void (metal discontinuity due to pollution or other conditions) was found in the upstream girth weld, which was about 0.05 inches in cross section with respect to the fracture surface. According to welding standards at the time (2007), any void smaller than 25 percent of the wall thickness, or 0.0625 inches in this case, is deemed acceptable. The void of the failure pipe was within the permissible size.

The NTSB report suspected that the cause of failure was a faulty weld along the longitudinal seam (the weld done during manufacturing to join sheet metal together to create the circular pipe), a portion of the upstream girth weld (the weld that joins two pipes together at their circumference), and portions of the adjacent pipe joints. The burst pipe could be seen as a longitudinal fracture at the 12 o'clock position and ran the entire length of the seam. As can be seen in the report, the initial burst was upstream, and continued downstream. The upstream portion of the pipe had the largest separation of burst pipe, maxing out at 17 7/8 inches (see Figure 1).

During examination of the burst pipe, there were no outside dents, major scratches or gashes that would lead investigators to suspect a third party was involved in vandalising the pipe, leading to the explosion. There was no internal or external corrosion and fractographic examination showed there was no stress corrosion that would've led the pipe to fail. The pipeline controller working, reported the lead correctly and on time, and was not under the influence of any drugs or alcohol, so it wasn't a staff error. There was evidence of high standing pressure in the beginning of the 2007 calendar year, as well as evidence of a void, both deemed within acceptable limits. Finally, the pipeline was working under regular regulations, leading to the idea there was an error during the construction of the pipeline or the pipe itself that failed because of long term stress. However, the NTSB report provides any description on why the pipe at that point, other than long term stress over time.

JAGR does recommend checking all the welds connecting the pipe sections before making any decisions. If possible, JAGR recommends reinforcing the welds between pipe sections to further prevent any possible failures. The weld, in the section that bursted, failed because of long term stress on the manufacturing error, and JAGR believes it is possible that a similar accident could happen in the future. To prevent this from happening, JAGR suggests developing a replacement schedule for high risk pipeline sections. High risk pipe sections are sections that have been in use for a long time and sections that frequently experience high volume displacement and pressure changes. Older sections and sections that are exposed to greater stress should be checked and replaced more often. In conclusion, X52 steel is the better material option; however, like any material, the steel can begin to fatigue over

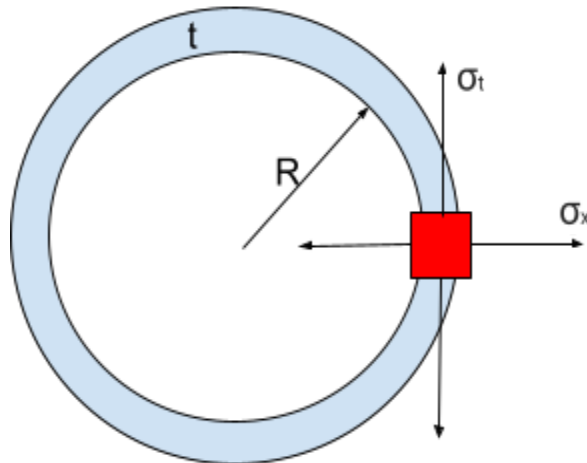
Figure 2: Stress state of the pipe at any given time

Because there is no mention of initial shear stress within the report, JAGR assumed that these three stresses provided the stress state of the pipe at any point in time. While there could be some shear stress as pressures vary within the pipe, JAGR took these shears into consideration with **Eq. 5**. The three stresses give us the following stress state in **Figure 2**, with the two stresses shown and another stress coming out of the page (not shown).
