SUMMARY
1234 Main Street McDonough GA
30252
Buyer Name
11/30/2023 9:00AM

Tanner Hall
ASHI
Avalon Home Inspections
678-782-3497
info@avalonhomeinspections.net

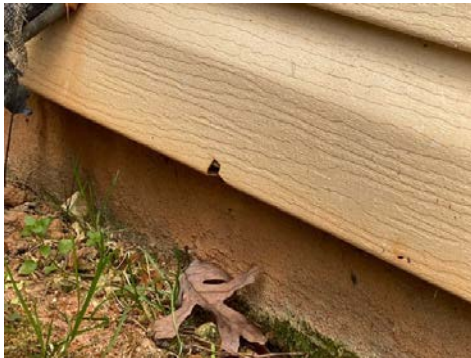
Left side of home

VINYL SIDING - DAMAGE

There was some degree of damage present to areas of the vinyl siding (holes, cracks, etc.). Repairs or replacement of damaged sections is recommended to be conducted as needed by an exterior contractor or other qualified person.

Recommendation
Contact a qualified siding specialist.

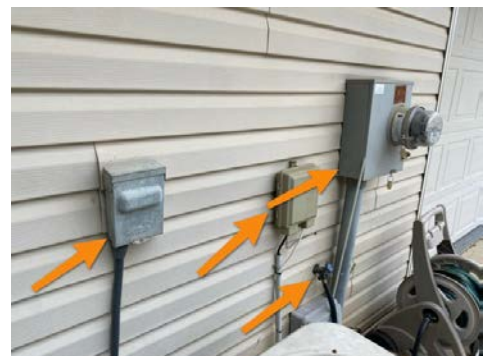
Left side of home

VINYL SIDING - MISSING ACCESSORY BOX(ES)

There were wall protrusion(s) present that were missing an accessory box. Accessory boxes or "J" blocks provide flashing around wall protrusions, preventing moisture infiltration. The installation of proper blocks at any areas in need is recommended to be performed by a qualified contractor.

Recommendation
Contact a qualified siding specialist.

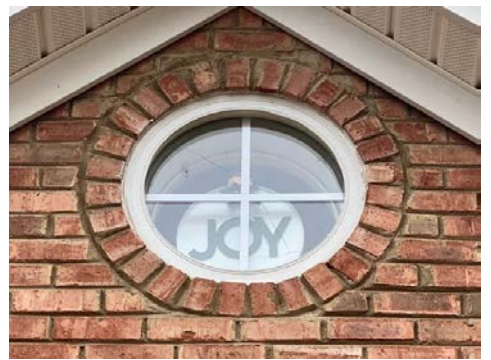
Front of home

GLASS - BROKEN OR CRACKED WINDOW

Referenced window(s) were broken or cracked. I recommend a qualified contractor repair or replace as needed.

Contact a qualified professional.

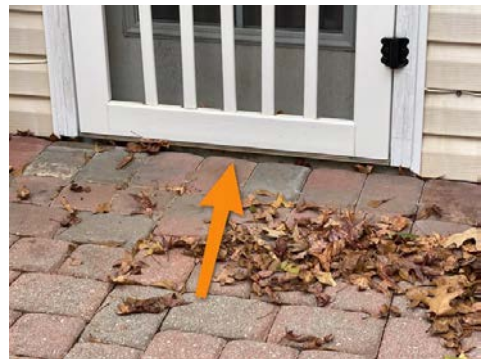
Rear of home

MISSING THRESHOLD SUPPORT

The entry door is missing a threshold support. A small repair is needed. A qualified contractor should inspect and repair as needed.

Contact a qualified professional.

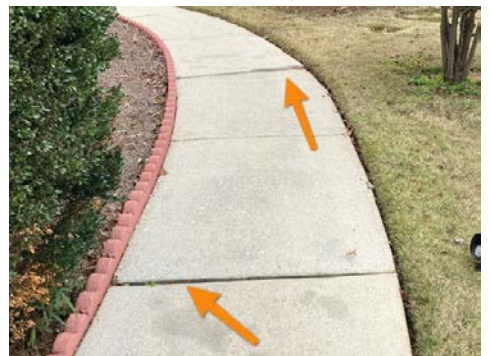
Front of home

TRIP HAZARD(S) PRESENT

SFTY - Cracking, heaving, settlement, movement, deterioration, and/or other deficiencies resulting in trip hazards were present on the referenced surface(s). Repairs are recommended to be conducted to these area(s) as needed for safety by a qualified contractor.

Contact a qualified professional.

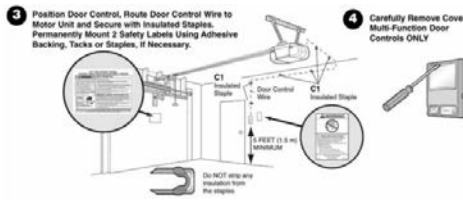
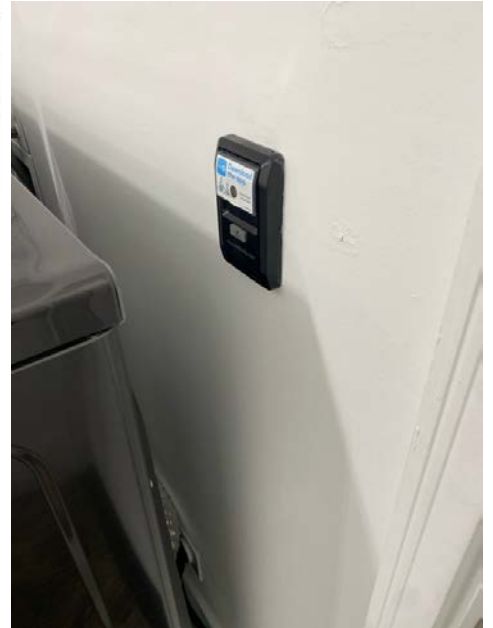
DOOR CONTROL - WITHIN 5 FEET OF STANDING SURFACE

The garage door control(s) were within five feet of a standing or walking surface. Controls are recommended to be elevated at least 60" to prevent a child from operating the door. Raising the control(s) to the proper height is recommended to be conducted by a qualified person for child safety.

Contact a handyman or DIY project

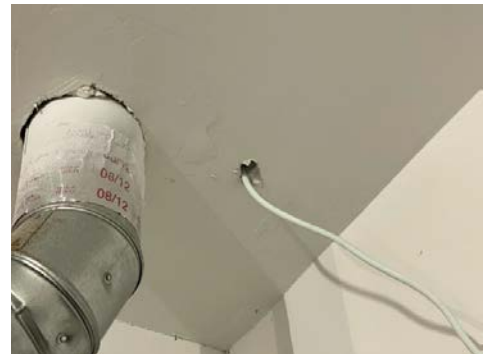
SEPARATION - DEFICIENCY (REPAIR)

FYI - The ceiling in the garage was "unfinished", finished with an improper material, or had gaps present in the drywall. Current standards require the installation of 5/8" Type X drywall on the ceiling to provide proper separation of garage to living area space, with no holes or gaps allowed in the ceiling without being sealed with an approved material. The installation of proper drywall or repairs made as needed to achieve proper separation is recommended to be performed for safety by a qualified person.

Contact a qualified professional.

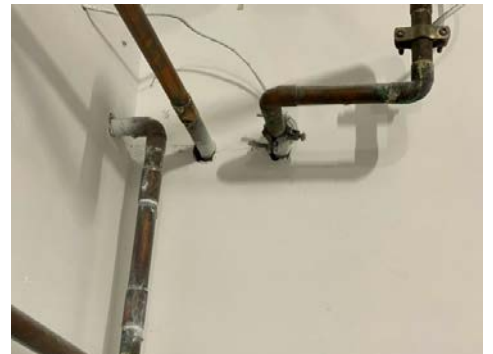
SEPARATION - UNSEALED WALL PROTRUSIONS

There were holes and/or protrusions through the walls that were not sealed. This compromises garage to living space separation. Proper sealing of these areas is recommended to be conducted by a qualified person.

Contact a qualified professional.

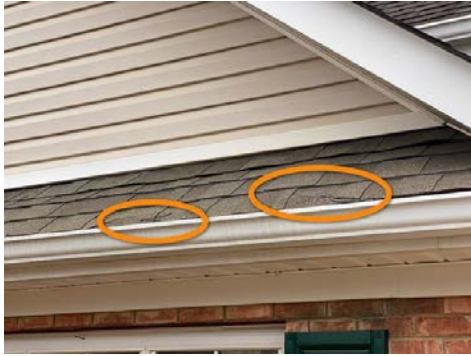
Front of home

SHINGLES - DAMAGED

There were damaged shingle(s) present on the roof surface. Repairs to the affected shingle(s) is recommended to be conducted as needed by a roofing contractor.

Contact a qualified roofing professional.

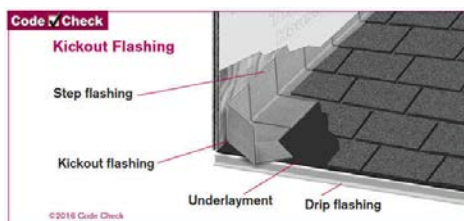
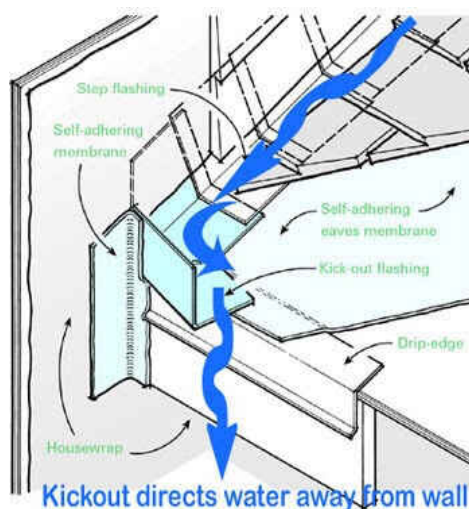
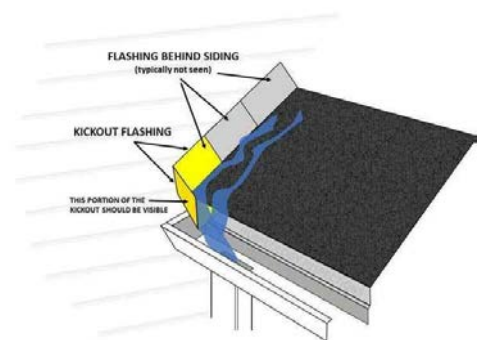
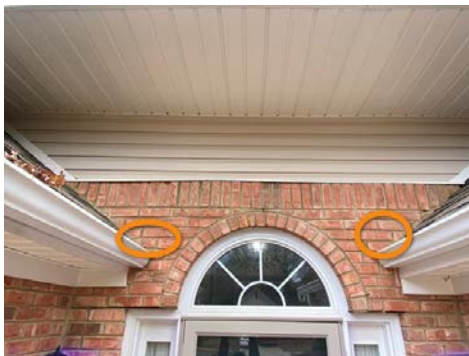
Front of home

5.5.1 Roof Flashings KICKOUT - MISSING

Kickout flashing was not present in area(s) where guttering and/or fascia abutted a sidewall. The installation of kickout flashing is recommended to be performed by a roofing contractor at any areas where gutters or fascia meet a sidewall, preventing rain water from infiltrating between the end of the gutter/fascia and the wall. Hidden damage may exist in areas where kickout flashing is missing and this should be investigated during the installation of kickout flashing. This is a 2015 code and the seller is not obligated to update home to today's standards.

IRC R703.8

R905.2.8.3 Sidewall flashing.

Contact a qualified roofing professional.

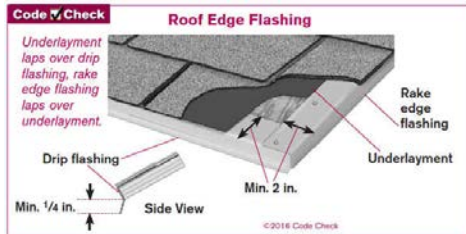
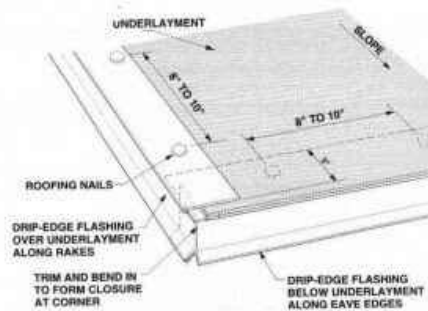
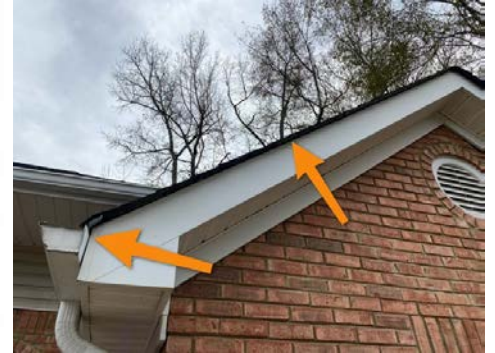
AROUND EXTERIOR OF HOME

DRIP EDGE - MISSING

Drip edge flashing was not present in areas that were checked. Drip edge flashing is recommended to be installed at the eaves and rakes of the roof (called rake edge at the gables), to protect the edges of the sheathing from sustaining water damage. The installation of proper drip edge flashing is recommended to be conducted by a roofing contractor. This is a 2012 code and the seller is not obligated to update home to today's standards.

Contact a qualified roofing professional.

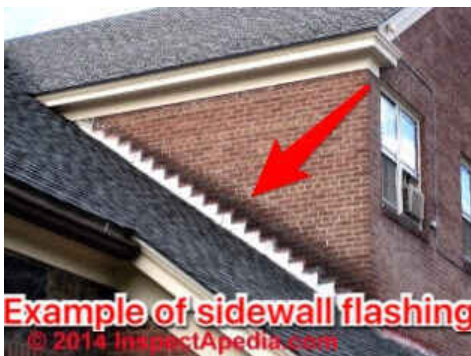
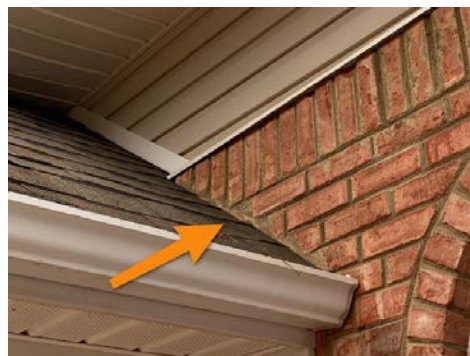
Front of home

SIDEWALL - MISSING (MASONRY)

Proper sidewall flashing was not present where a lower roof abutted a sidewall. Some form of flashing is presumed to be present behind the brick, as no indications of leaks were present at visible/adjacent areas at the time of inspection. In a proper application, step and counter flashing would be visible here. The installation of proper step and counter flashing is recommended to be conducted by a qualified roofing contractor.

Contact a qualified roofing professional.

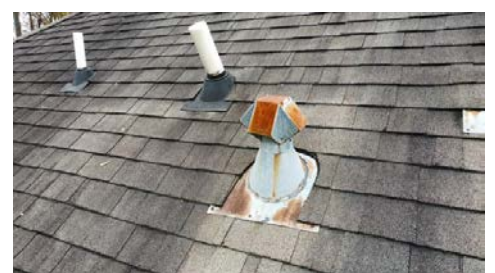
FLUE PIPE(S) - RUSTED

The gas flue vent(s) rusted at the referenced area(s). Further deterioration will occur if not corrected resulting in leaking into the attic space. A qualified licensed roofing contractor should evaluate and repair/replace as needed.

Contact a qualified professional.

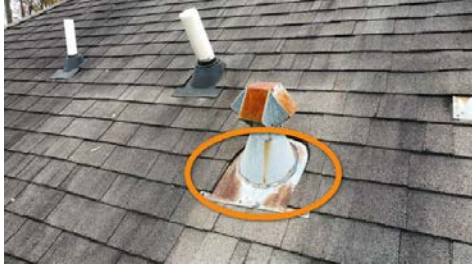
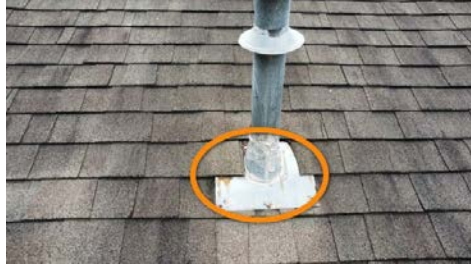
BOOT(S) - RUSTED

The metal boot flashing was rusted at the referenced area(s). Further deterioration will occur if not corrected resulting in leaking into the attic space. A qualified licensed roofing contractor should evaluate and repair/replace as needed.

Contact a qualified professional.

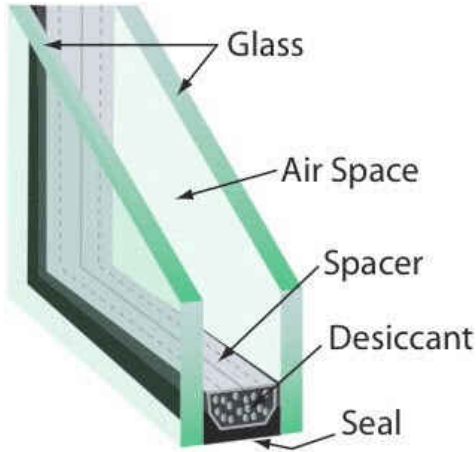
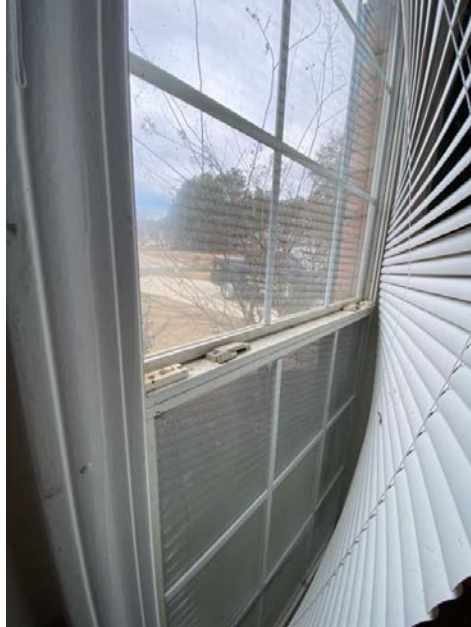
Garage

WINDOWS - CLOUDY (SEAL FAILURE)

There were window(s) present with seal failure present. This is where the double pane glass loses its adhesion with the inner spacer, allowing moisture/debris in between the panes of glass. Seal failure can result in some loss of energy efficiency and can obscure visibility through the glass. Some windows may not show signs of seal failure due to desiccant in the glass spacer absorbing moisture in between the panes, as well weather conditions

Contact a qualified window repair/installation contractor.

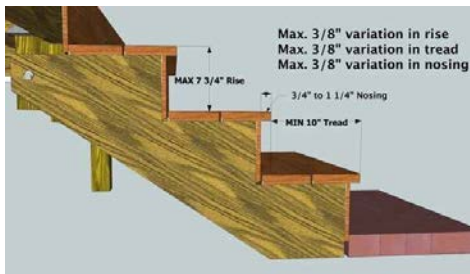
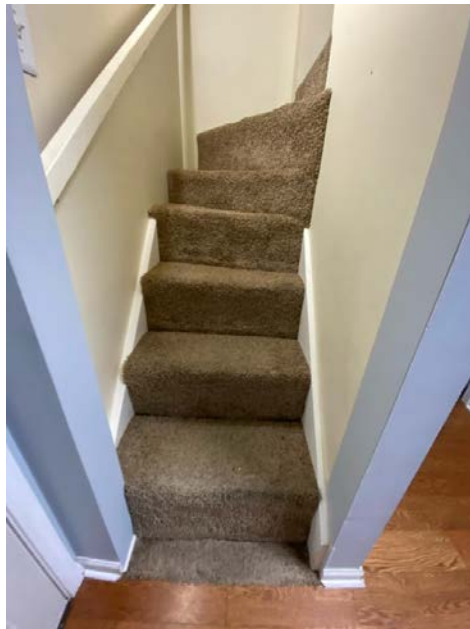
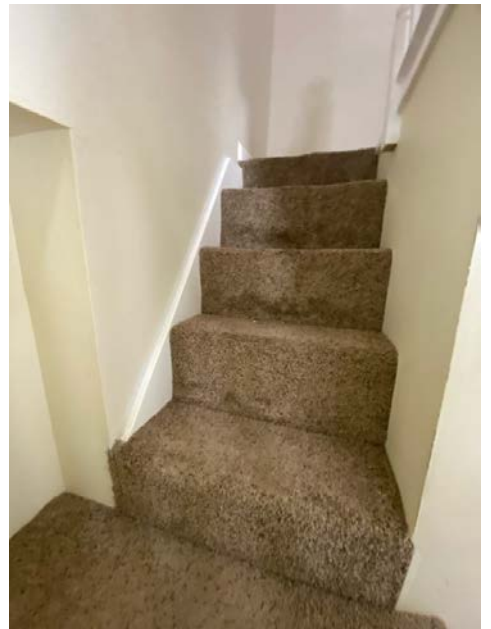
STAIRS - RISER, TREAD, AND/OR NOSING DESIGN DEFICIENCIES

SFTY - The stairway contained one or more of the following deficiencies:

- There were riser heights in excess of 7 3/4". *Riser heights should not exceed 7 3/4".*
- There were tread depths present that were less than 10" in depth. *10" is the minimum recommended tread depth.*
- The stair tread nosing projected more than 1 1/4" or less than 3/4". *Current standards call for a 1 1/4" maximum and 3/4" minimum tread nosing.*
- There were non uniform risers, treads, and/or nosings present. *There shouldn't be more than a 3/8" variance between the individual riser heights, stair tread depths, or nosings.*

Any variances from these numbers can result in a potential trip hazard. I recommend consulting a contractor who specializes in stairs to discuss possible modifications or repair options as needed for safety.

Contact a qualified professional.

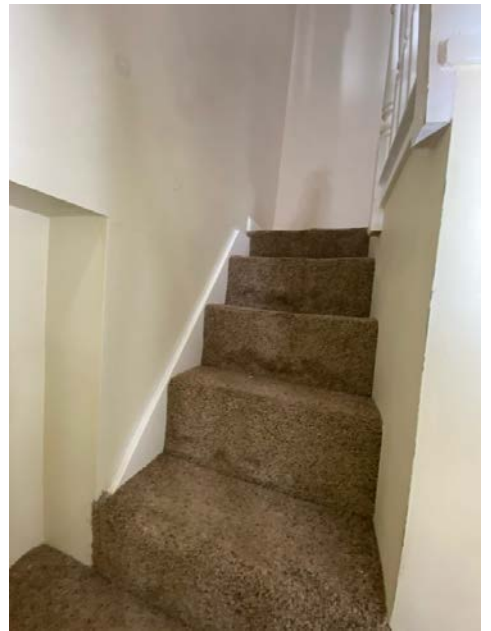
HANDRAIL - MISSING

There was no handrail installed on the stairs. A continuous handrail is recommended to be installed by a qualified person for safety, that extends from a point directly above the top stair tread nosing, to a point directly below the bottom stair tread nosing.

Contact a qualified handyman.

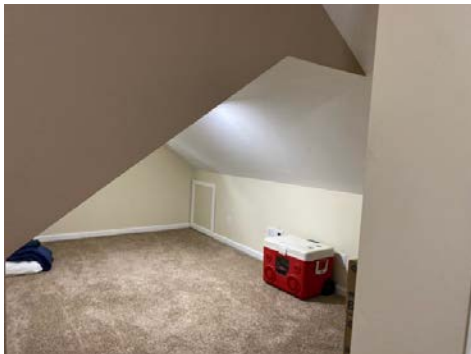
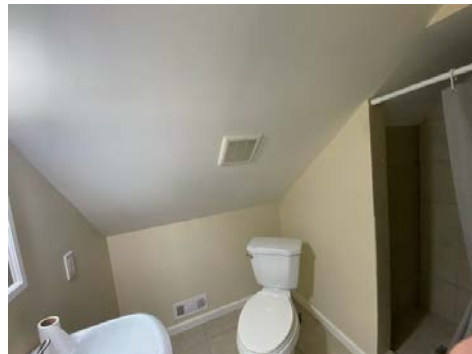
Upstairs Bath

CEILING(S) - HEIGHT UNDERSIZED

FYI - The referenced room(s) or area(s) had an inadequate ceiling height by today's standards. Current building standards require a minimum ceiling height of seven feet in height in habitable rooms, or if the ceiling is sloped, 50 percent of the ceiling or more must have a minimum height of seven feet.

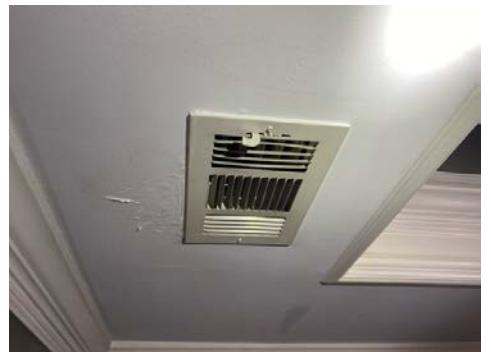
Master Bedroom

MOISTURE STAINING - VENT CONDENSATION

Moisture stain(s) were present on the ceilings in the referenced areas. The moisture appears to be from condensation producing on vent(s). We recommend inquiring with the sellers about the stains as they would have firsthand knowledge of why the stain is present, and what repairs were carried out to address it. If they are unsure of the stains or can not produce repair invoices, a roofing contractor or plumbing contractor (as applicable) should further evaluate and make repairs as needed, if needed.

Contact a qualified professional.

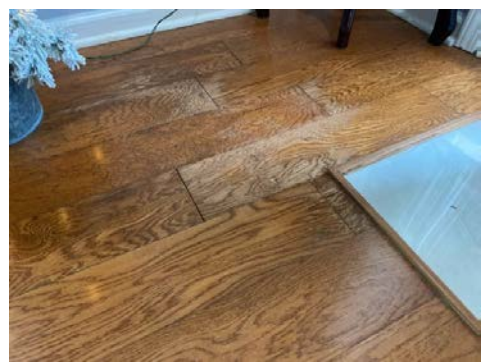
Foyer

WOOD FLOORING - DISCOLORED/SCRATCHED

The wood floor functions as it was designed, but is badly discolored and/or scratched. Consult a flooring contractor familiar with wood floors for an estimate to refinish or replace the floor during the inspection period. In our experience, it may be expensive to refinish or replace. This is FYI

Contact a qualified professional.

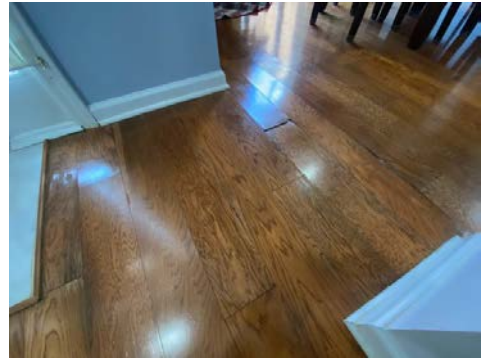
Foyer & Dining Room

FLOOR(S) - MOISTURE DAMAGE PRESENT

Moisture staining and related damage was present to the flooring at the referenced area(s). An evaluation of the subfloor, with repairs made as needed is recommended to be performed by a flooring contractor or other qualified person.

Contact a qualified flooring contractor

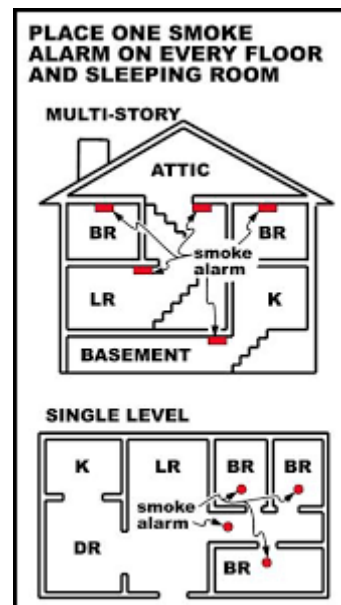
NOT PRESENT IN EACH BEDROOM

Smoke alarms were not present in each bedroom, this is a Safety Hazard. Current safety standards require a smoke alarm in each bedroom (sleeping area) for fire safety. Dual sensor alarms incorporating both an ionization sensing chamber and photoelectric eyes are recommended.

Contact a handyman or DIY project

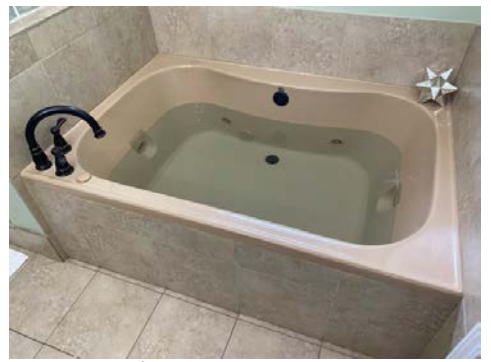
Master Bath

HYDROMASSAGE TUB - MOTOR NOT FUNCTIONAL

The hydromassage tub motor was not functional at time of inspection. Repairs are recommended to be performed as needed by a licensed electrician or other qualified person for proper operation.

Contact a qualified electrical contractor.

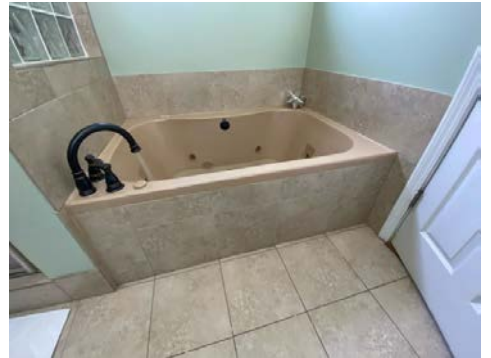
Master Bath

HYDROMASSAGE TUB - NO ACCESS PANEL PRESENT

No motor/plumbing access panel was present for the hydromassage tub. An access panel is recommended to be installed for future servicing of the motor as well as electrical and plumbing components by a qualified person, with an evaluation of these components made at that time.

Contact a qualified professional.

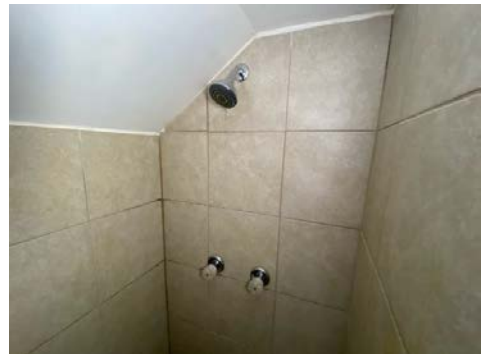
Upstairs Bath

WATER SUPPLY - NOT FUNCTIONAL

The water supply to the referenced shower was not functional at the time of inspection. Repairs are recommended as needed by a licensed plumber for proper operation.

Contact a qualified plumbing contractor.

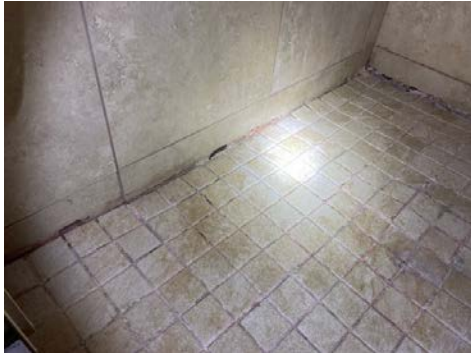
Master Bath

GROUT/SEALANT - CRACKED GROUT

Areas of cracked grout were present. This can possibly allow for water infiltration behind the tile shower walls. Repairs are recommended to be performed as needed to prevent any moisture infiltration by a qualified person.

Contact a qualified professional.

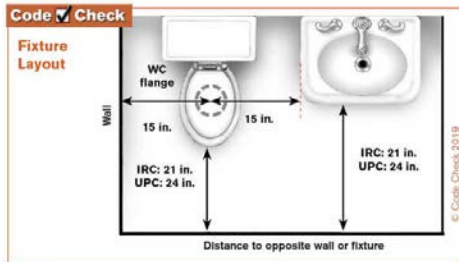
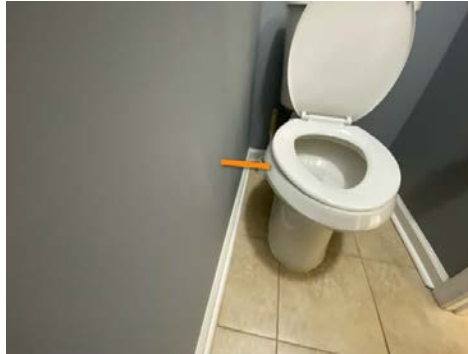
Master Bath

TOILET - IMPROPER CLEARANCE

The toilet had inadequate clearance from a wall, vanity, or other surface. Current standards require 15" of clearance to the sides of a toilet, with 21" - 24" of clearance in front of a toilet.

Contact a qualified plumbing contractor.

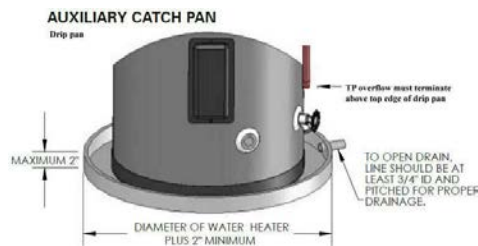
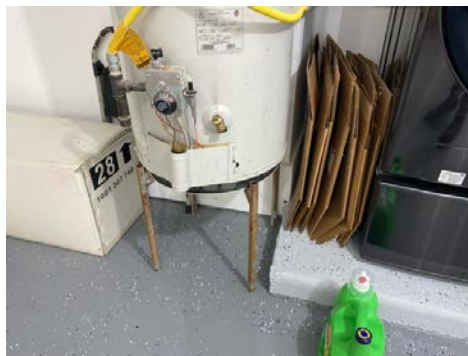
DRAIN PAN - MISSING

A water heater drain pan was not present. Drain pans also called "Smitty pans" are recommended when the water heater is installed in an area where leaks from the unit could cause damage to framing components and/or interior areas. The installation of a drain pan is recommended to be conducted by a qualified person.

Contact a qualified plumbing contractor.

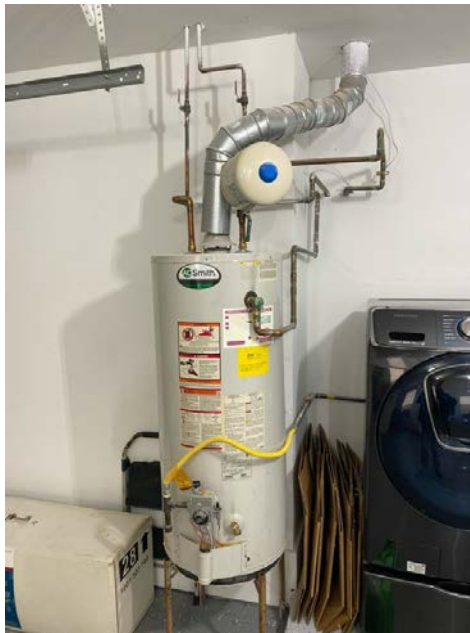
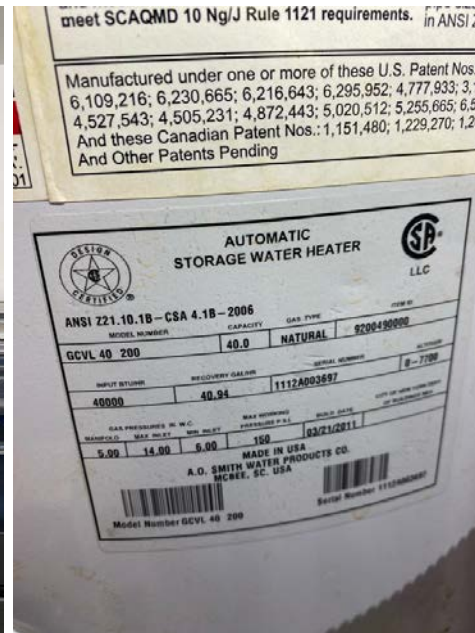
WATER HEATER - AGED

AGED - The unit near or past its typical service life. Major repairs or replacement should be anticipated in the future due to the age of the unit alone. Depending on prior maintenance and other factors the unit could last anywhere from days to years, the remaining life is undeterminable.

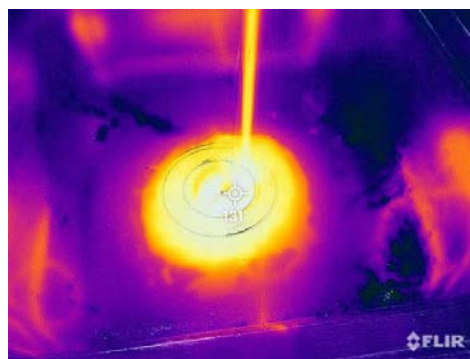
**WATER TEMP - IN EXCESS OF 130 DEGREES**

SFTY - The hot water temperature was over 130 degrees at the time of inspection.

The maximum recommended water temperature produced at faucets in the home should be 120 degrees due to the possibility of scalding at temperatures above this. But to prevent the formation of Legionellae bacteria in the water heater, tank temperatures are recommended to be kept between 135-140 degrees.

A tempering valve can allow for this combination, keeping water as faucets in the home to safe levels while keeping tank temperatures high enough to kill harmful bacteria. We recommend consulting with a licensed plumber regarding the installation of a tempering valve.

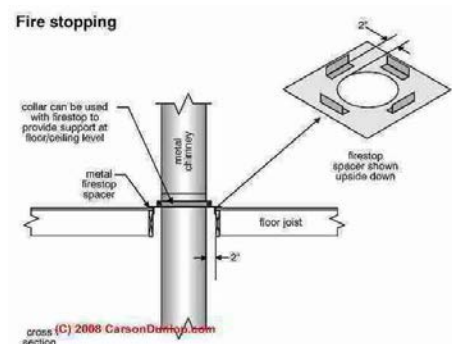
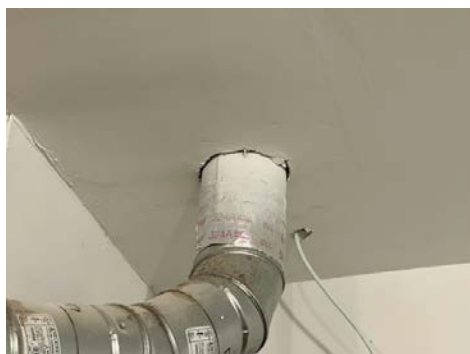
FLUE COLLAR - MISSING

The water heater flue pipe is missing the "flue collar/firestop" where pipe penetrates through combustible material. This is a safety issue. A qualified contractor should install as needed.

Contact a qualified plumbing contractor.

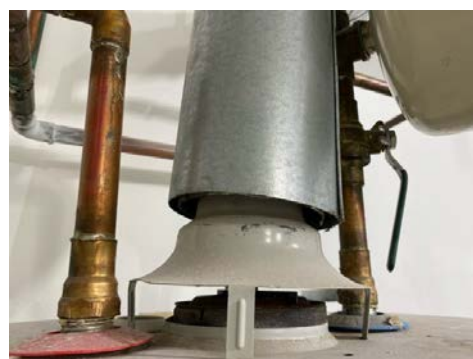
FLUE - LOOSE CONNECTION

The water heater flue has a loose connection. A repair is needed to prevent carbon monoxide spillage. A qualified licensed plumber should correct as needed.

Contact a qualified professional.

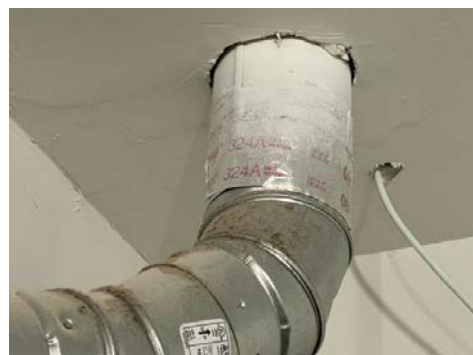
FLUE VENT - CONNECTIONS TAPED

The flue vent connections for the water heater were taped. Tape should not be used on single or double wall vents as the connections are UL listed to be locked in without the use of tape. Evaluation to determine why tape was used is recommended by a licensed plumber or other qualified person.

Contact a qualified plumbing contractor.

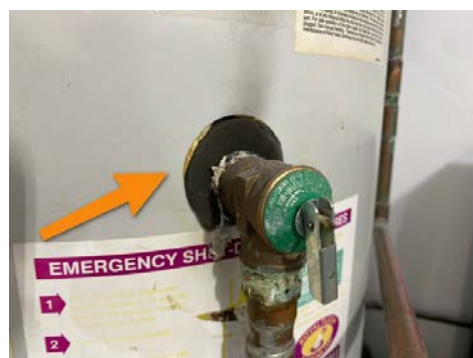
TPRV - GROMMET MISSING

The grommet for the water heater TPRV was missing. Recommend replacing as needed.

Contact a qualified professional.

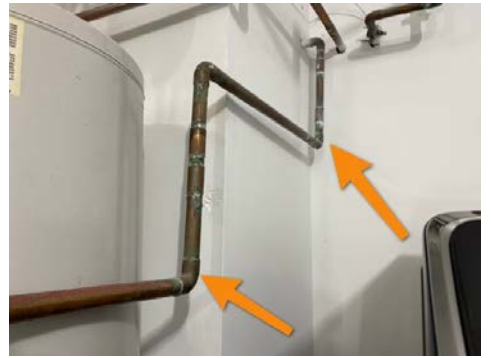
TPRV - SLOPED UP

The TPRV for the water heater was sloped up without a clean out valve installed below the joint. A repair is needed as this is not allowed. A qualified licensed plumber should repair as needed.

Contact a qualified plumbing contractor.

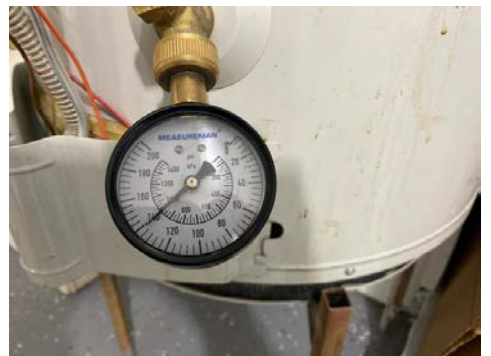
ELEVATED WATER PRESSURE

The water pressure tested greater than 80psi at the time of inspection. 80 psi is the maximum pressure recommended to protect water distribution pipes from leaking due to pressure (60-70psi is preferred). Pressure regulators are only adjustable from 25-75psi, and any pressure readings over 75psi are typically from a defective regulator (if present). Repairs are recommended to be conducted as needed by a licensed plumber to bring the water pressure under 80psi.

Contact a qualified plumbing contractor.

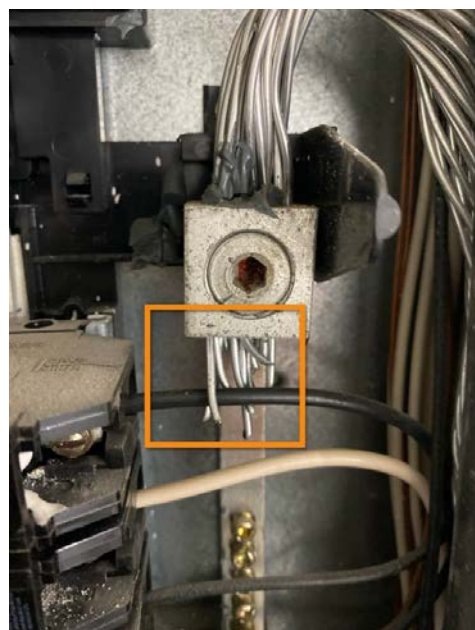
14.5.1 Service Equipment / Electrical Panel CONDUCTOR - IMPROPERLY TRIMMED

The conductor is improperly trimmed and is in context with other conductors. Repairs are needed. A qualified electrician should correct as needed.

Contact a qualified electrical contractor.

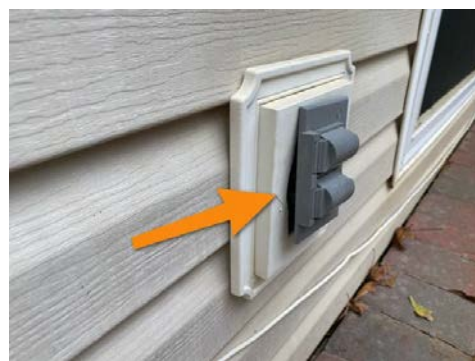
Rear of home

RECEPTACLE(S) - LOOSE AT WALL

There were receptacle(s) present that were loose at the wall. Proper securement of any loose receptacles is recommended to be conducted by a licensed electrician.

Contact a qualified electrical contractor.

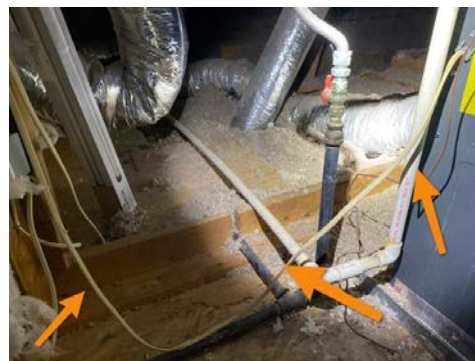
WIRING - CONDUIT MISSING

The service wiring for HVAC unit is missing. This is a safety issue that should be corrected due to susceptibility of damage to wiring. A qualified contractor should correct as needed.

Contact a qualified professional.

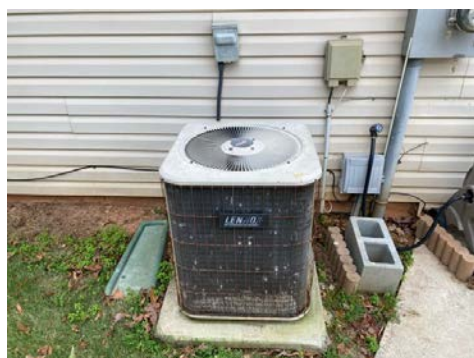
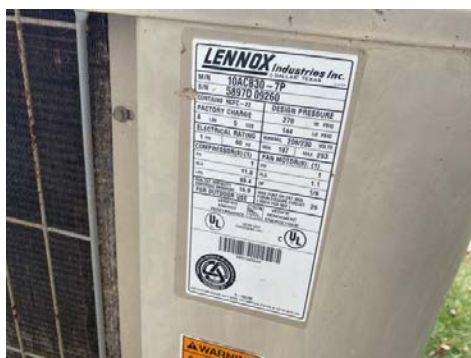
AGED - A/C CONDENSER

The condenser outside (AC unit) is aged and may last a few more years, but maybe not. I have seen units fail shortly after a home inspection during the seasonal change from mild to hot weather. I cannot determine how long your A/C will last before a replacement is necessary. Typical A/C life expectancy is around 15 years.

Contact a qualified heating and cooling contractor

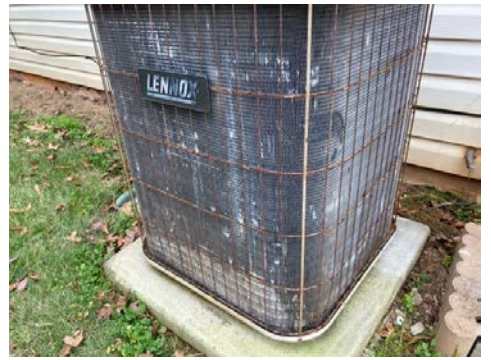
15.3.3 Air Conditioning Equipment **COOLING FINS DETERIORATED OR DAMAGED**

The cooling fins on compressor are deteriorated or damaged. This can shorten the units life span. I recommend further inspection by a licensed HVAC contractor.

Recommendation
Contact a qualified professional.

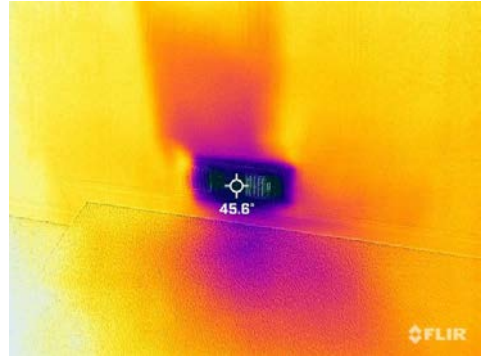
15.5.1 Cooling Air Supply (2nd Level) **RETURN DUCT - MISSING**

A return duct is not present in referenced area(s). I cannot accurately test for proper temperature differences between supply and return. The efficiency of HVAC cooling in this area is excluded from this report.

Recommendation
Contact a qualified professional.

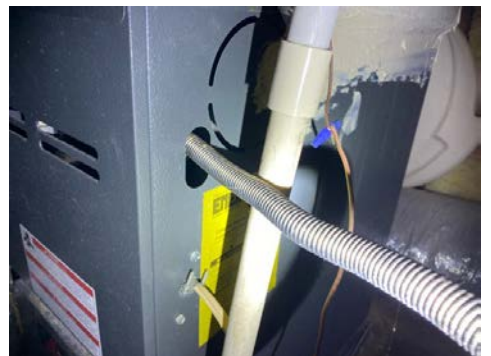
15.6.1 Furnace Equipment **FURNACE - CSST ENTERING CABINET**

CSST gas piping entered the furnace enclosure. This is prohibited as vibration from the unit could cause mechanical damage to the semi-rigid line where it enters through the sharp edges of the knockout at the furnace enclosure. The installation of a bushing around the knockout, or a hard pipe that extends outside the enclosure of the furnace is recommended by an HVAC contractor.

Recommendation
Contact a qualified professional.

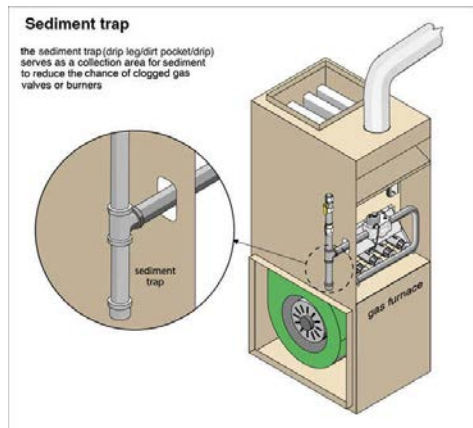
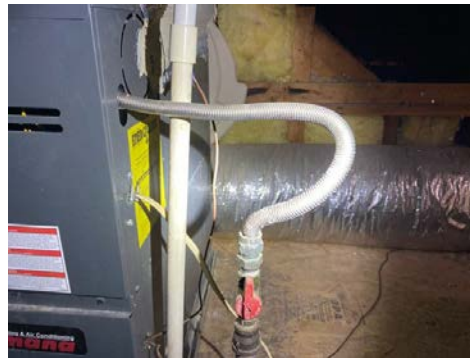
SEDIMENT TRAP - MISSING

A sediment trap was not present on the gas pipe supplying the furnace. Furnaces and water heaters are recommended to have a sediment trap as close to the appliance as possible, to prevent particulates from entering the appliance, possibly causing damage to the heat exchanger. The installation of a sediment trap is recommended to be conducted by an HVAC contractor or other qualified person.

Contact a qualified heating and cooling contractor

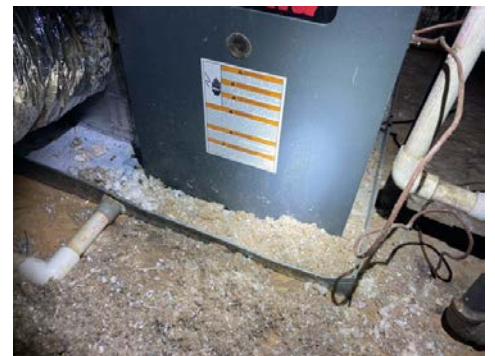
DRAIN PAN - FULL OF DEBRIS

Contact a qualified professional.

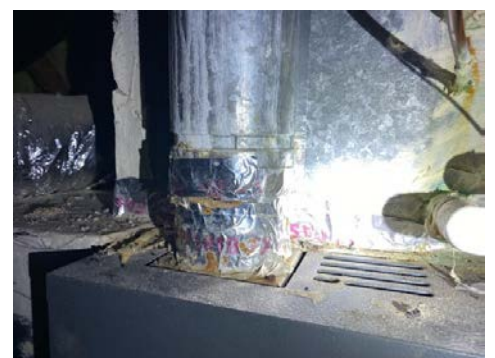
FLUE PIPE - TAPED CONNECTIONS

The flue vent connections for the furnace were taped. Tape should not be used on single or double wall vents as the connections are UL listed to be locked in without the use of tape. Evaluation to determine why tape was used is recommended by a licensed plumber or other qualified person.

Contact a qualified professional.

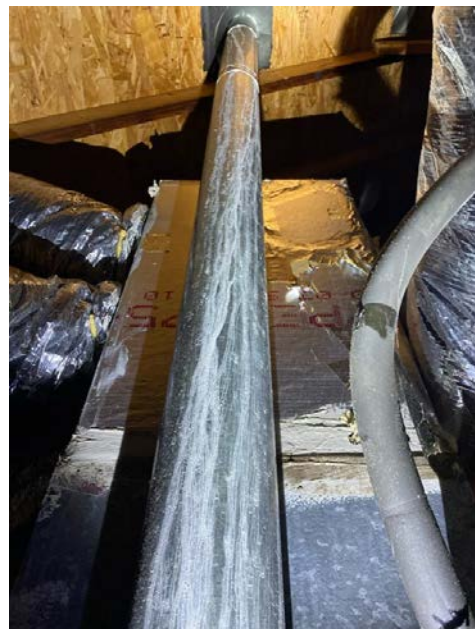
FLUE PIPE - EVIDENCE OF POOR VENTING

The vent pipe for gas furnace shows evidence of poor venting (white deposits, rust on piping). A more thorough inspection by a qualified contractor is needed. I recommend a qualified licensed heat contractor inspect further and repair as needed.

Contact a qualified heating and cooling contractor

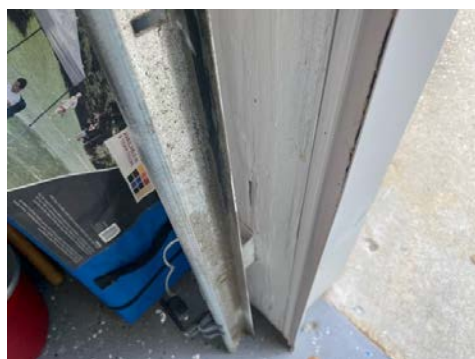
Garage

PRESUMED WDI ACTIVITY - DAMAGE PRESENT

Presumed wood destroying insect activity was present at the referenced area(s). An evaluation of the activity is recommended to be conducted by a licensed pest control company. An invasive evaluation of the area(s) of damage is recommended to be conducted by a qualified contractor with repairs made as deemed necessary to any damage found.

Contact a qualified All South Pest Control

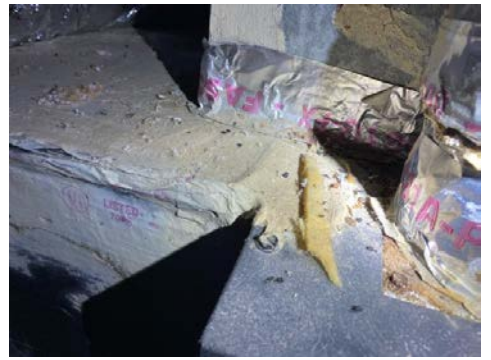
Attic

Presumed rodent feces was present in the referenced area(s). An evaluation by a pest control contractor is recommended, as well as cleaning as needed by a qualified person.

Contact a qualified All South Pest Control
