**RE: Asbestos Inspection**  
**605 Hodges St, Oriental, North Carolina 28571**  
**EI Project No: IHMO220083.00**  
**ReBuild NC Batch ID: APP-09213, INSP-0012863**

Per the contract outlined by The North Carolina Office of Recovery and Resiliency (NCORR), The EI Group, Inc. performed a limited asbestos inspection for the residence located at 605 Hodges St in Oriental, North Carolina. The inspection was performed by Mr. Brian Long (NC Asbestos Inspector #13212) on May 04, 2022 and limited to the residence's accessible interior and exterior.

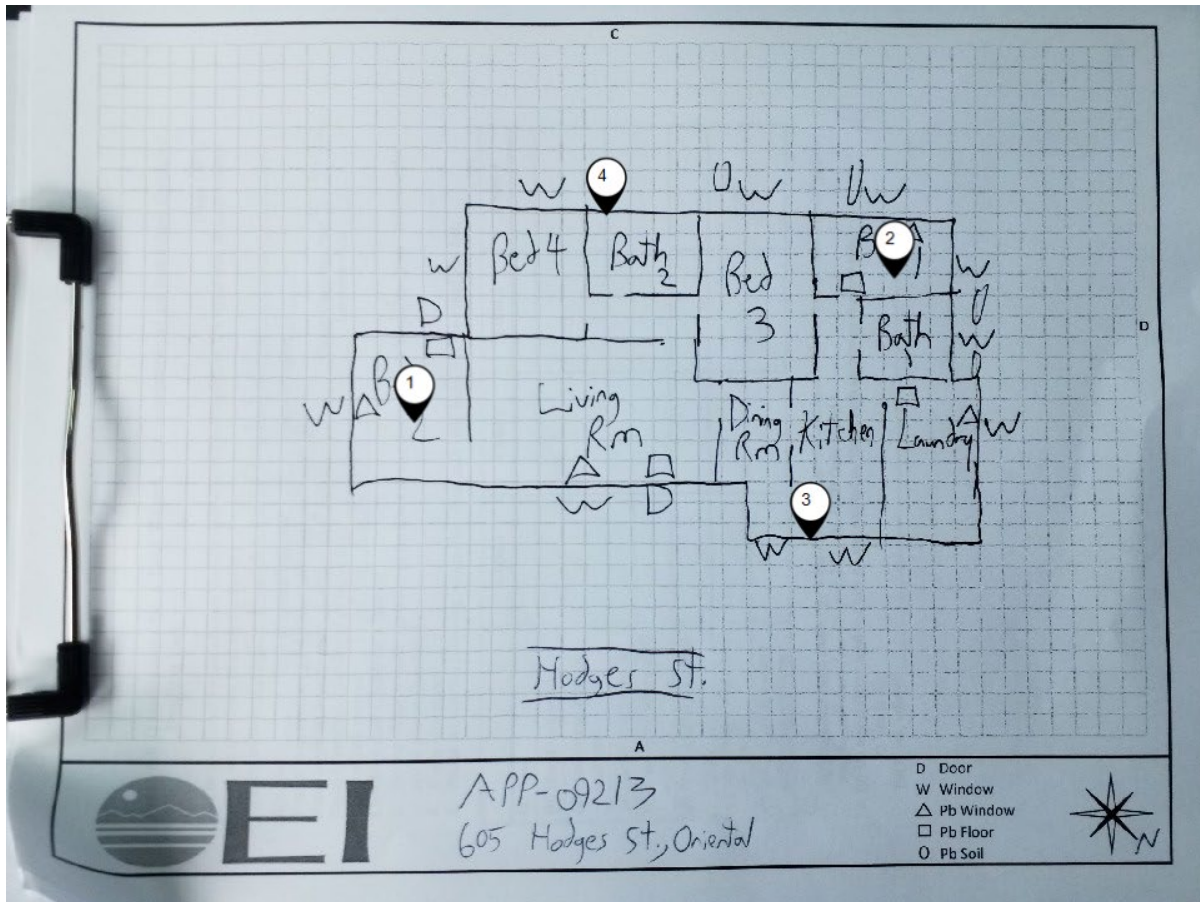
Map ID	Sample ID	Space Name	Material	Lab Result	Analytical Result
1	001A	Bedroom 2	001 - Gypsum Wallboard Joint Compound	Tested Negative by Lab (No Asbestos Detected)	N/A
2	001B	Bedroom 1	001 - Gypsum Wallboard Joint Compound	Tested Negative by Lab (No Asbestos Detected)	N/A
3	002A	Exterior	002 - Roofing, Composite Shingle	Tested Negative by Lab (No Asbestos Detected)	N/A
4	002B	Exterior	002 - Roofing, Composite Shingle	Tested Negative by Lab (No Asbestos Detected)	N/A

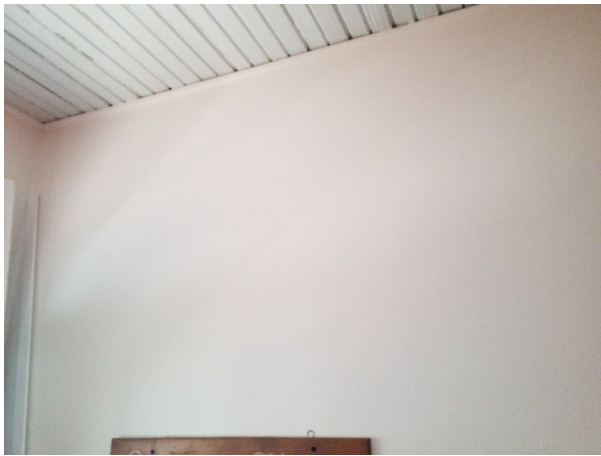
001A, 001 - Gypsum Wallboard Joint Compound, Bedroom 2, Main Floor

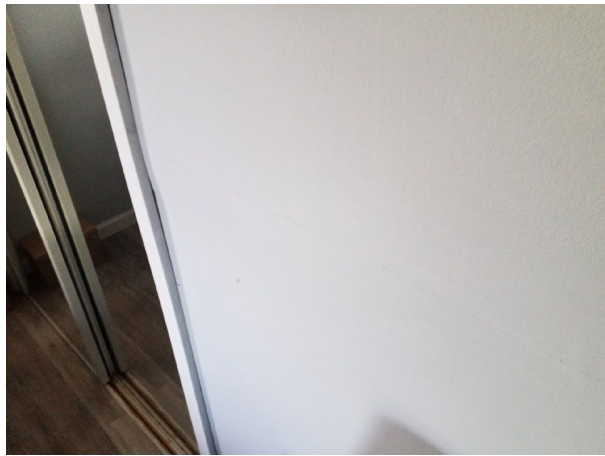
001B, 001 - Gypsum Wallboard Joint Compound, Bedroom 1, Main Floor

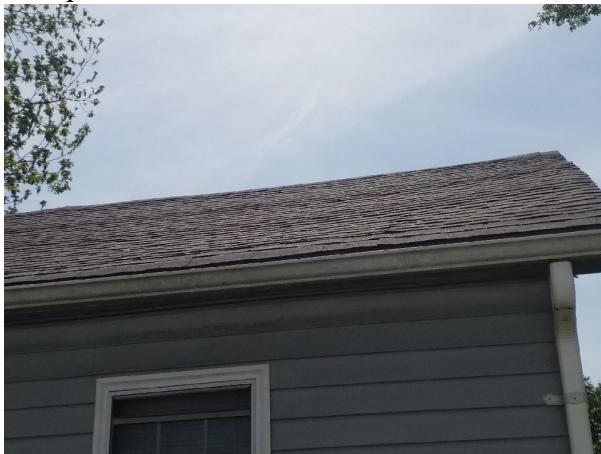
002A, 002 - Roofing, Composite Shingle, Exterior, Main Floor
