**RE: Asbestos Inspection**

**2105 Decor St., Fayetteville, North Carolina 28304**

**EI Project No: IHMO220083.00**

**ReBuild NC Batch ID: APP-09997, INSP-0012814**

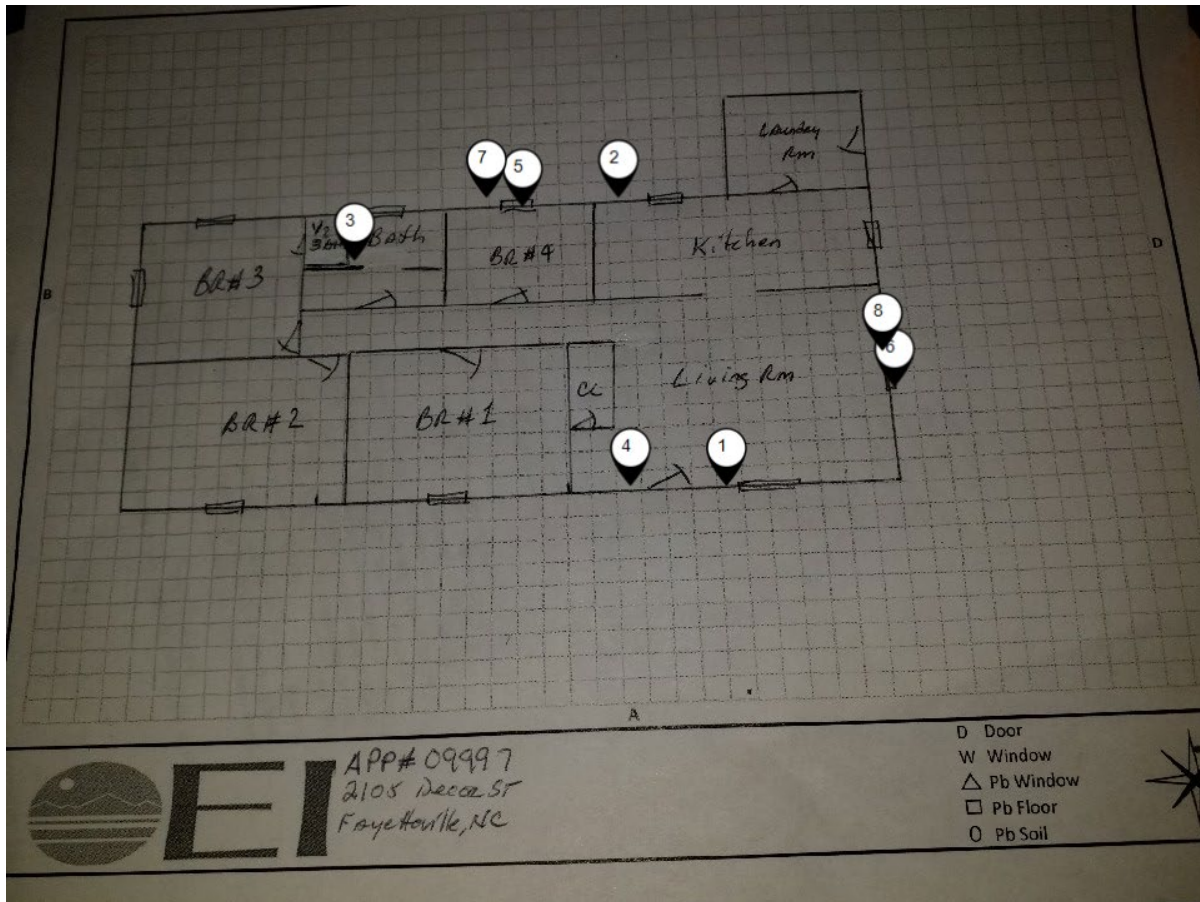
Map ID	Sample ID	Space Name	Material	Lab Result	Analytical Result
1	001A	Exterior	001 - Roofing, Composite Shingle	Tested Negative by Lab (No Asbestos Detected)	N/A
2	001B	Exterior	001 - Roofing, Composite Shingle	Tested Negative by Lab (No Asbestos Detected)	N/A
3	002A	Bathroom	002 - Gypsum Wallboard	Less Than or Equal to 1% Asbestos by Lab (Trace)	N/A
4	002B	Living Room	002 - Gypsum Wallboard	Less Than or Equal to 1% Asbestos by Lab (Trace)	N/A
5	003A	Exterior	003 - Caulk, Window	Tested Negative by Lab (No Asbestos Detected)	N/A
6	003B	Exterior	003 - Caulk, Window	Tested Negative by Lab (No Asbestos Detected)	N/A
7	004A	Exterior	004 - Window Glaze	Tested Negative by Lab (No Asbestos Detected)	N/A
8	004B	Exterior	004 - Window Glaze	Tested Negative by Lab (No Asbestos Detected)	N/A

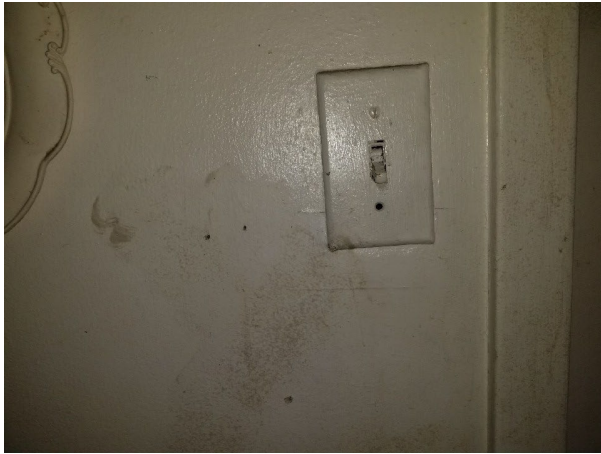
002A, 002 - Gypsum Wallboard, Bathroom, Main Floor

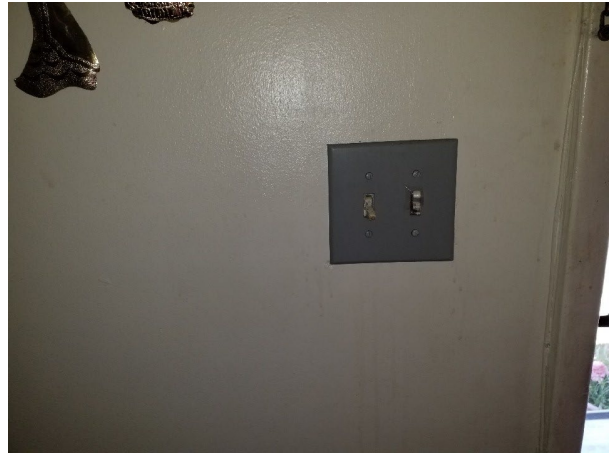
002B, 002 - Gypsum Wallboard, Living Room, Main Floor

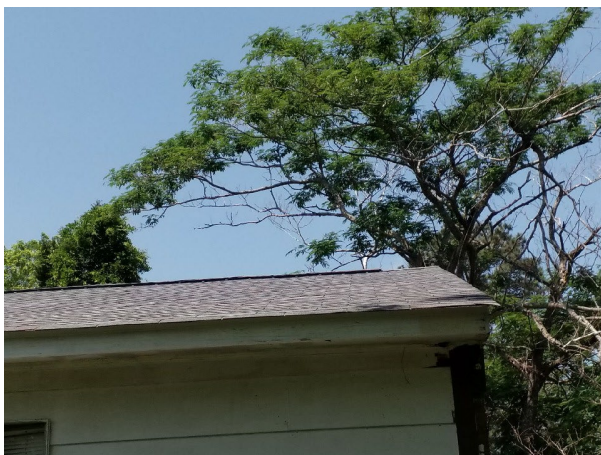
001A, 001 - Roofing, Composite Shingle, Exterior, Main Floor

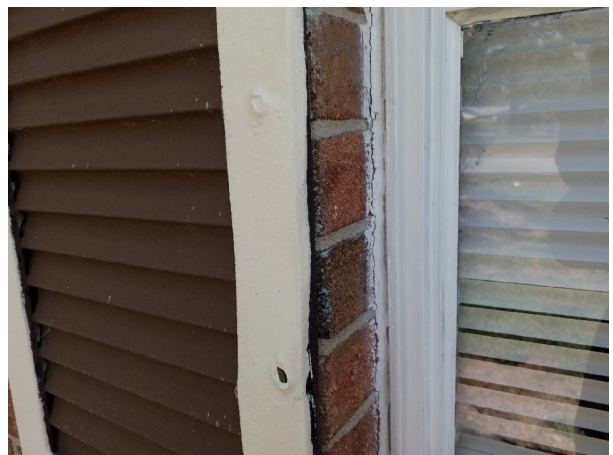
003A, 003 - Caulk, Window, Exterior, Main Floor

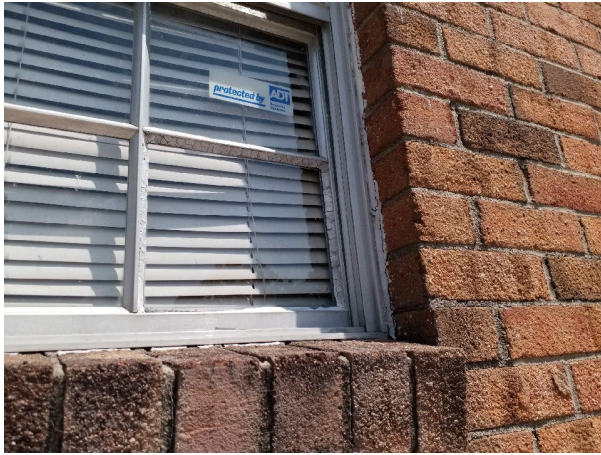
003B, 003 - Caulk, Window, Exterior, Main Floor

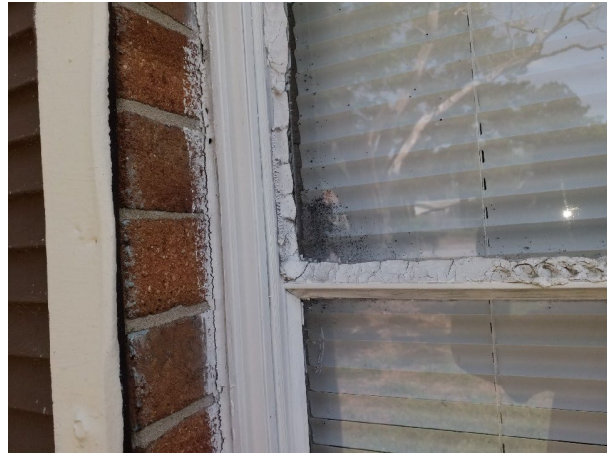
004A, 004 - Window Glaze, Exterior, Main Floor
