RE: Asbestos Inspection

1908 East 5th Street, Lumberton, North Carolina 28358

EI Project No: IHMO220083.00

ReBuild NC Batch ID: APP-10101, INSP-0012852

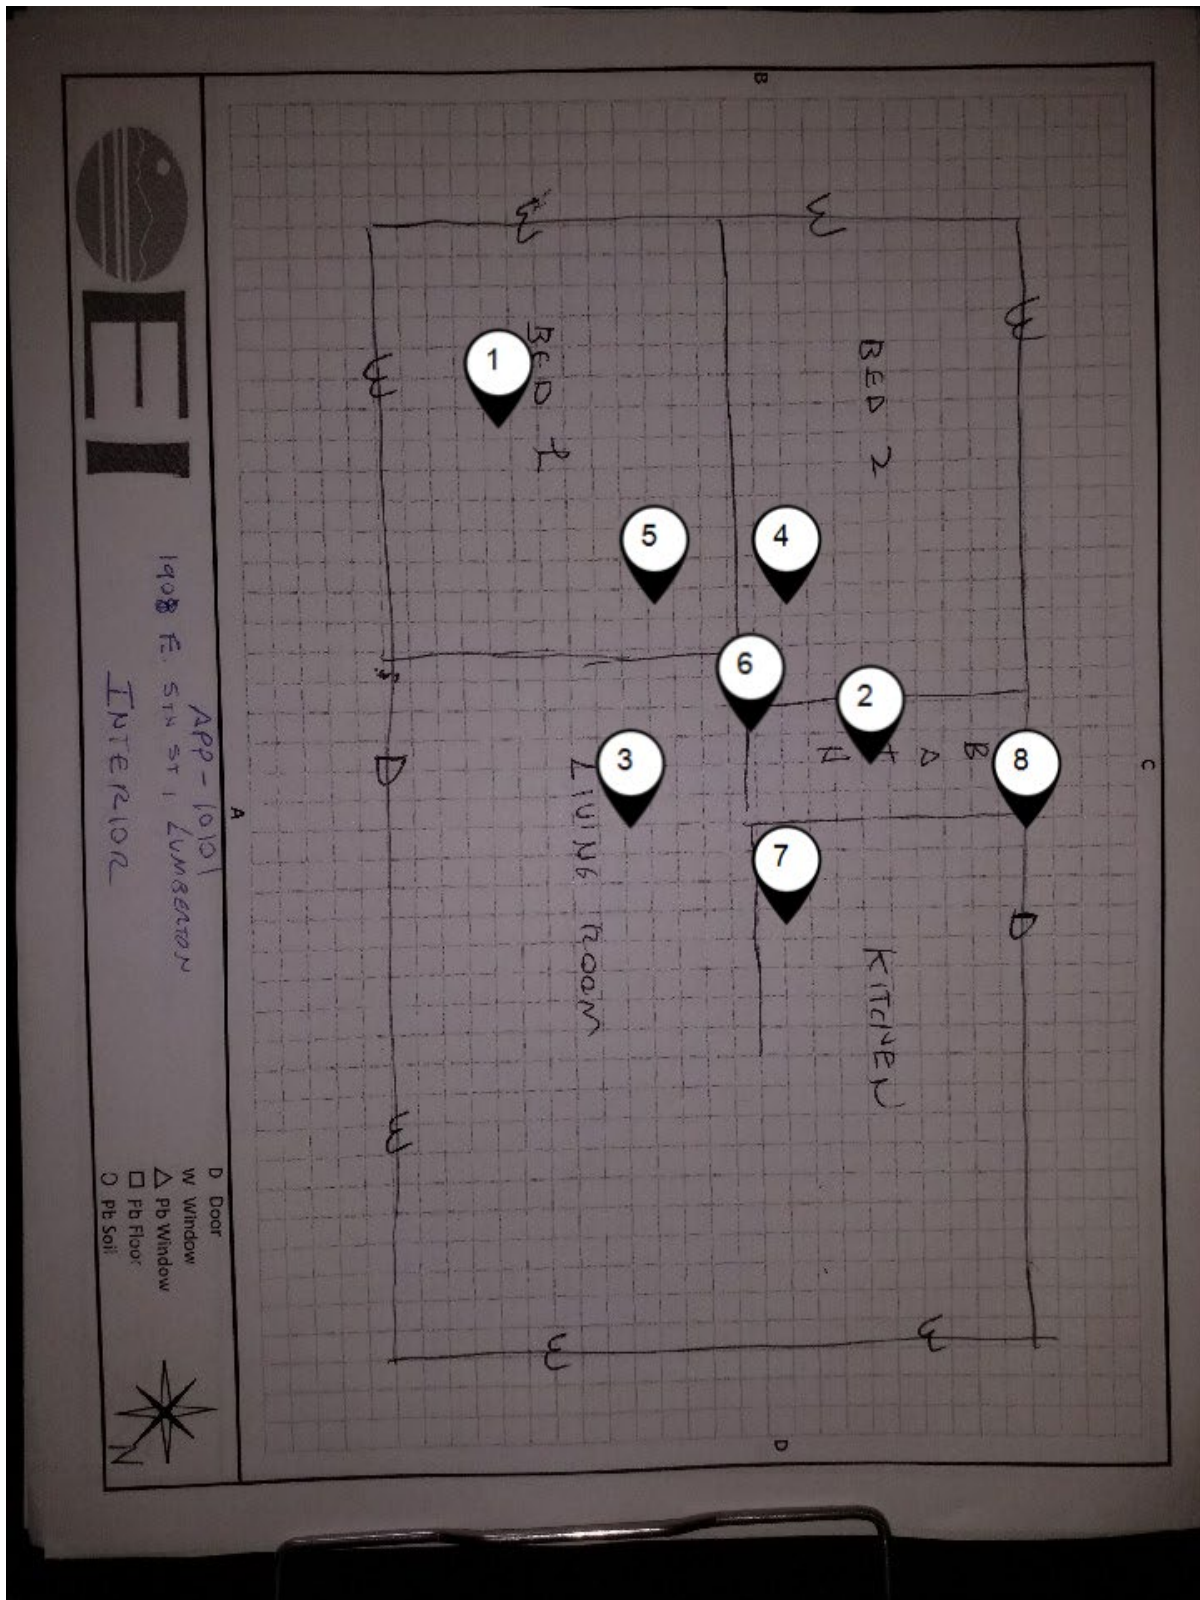
Map ID	Sample ID	Space Name	Material	Lab Result	Analytical Result
1	001A	Bedroom 1	001 - Textured Ceiling	Tested Negative by Lab (No Asbestos Detected)	N/A
2	001B	Bathroom	001 - Textured Ceiling	Tested Negative by Lab (No Asbestos Detected)	N/A
3	001C	Living Room	001 - Textured Ceiling	Tested Negative by Lab (No Asbestos Detected)	N/A
4	002A	Bedroom 2	002 - Gypsum Wallboard Joint Compound	Tested Negative by Lab (No Asbestos Detected)	N/A
5	002B	Bedroom 1	002 - Gypsum Wallboard Joint Compound	Tested Negative by Lab (No Asbestos Detected)	N/A
6	003A	Bathroom	003 - Floor, Sheet Vinyl Paper Backing	Tested Negative by Lab (No Asbestos Detected)	N/A
7	004A	Kitchen	004 - beige VF	Tested Negative by Lab (No Asbestos Detected)	N/A
8	005A	Exterior	005 - Roofing, Composite Shingle	Tested Negative by Lab (No Asbestos Detected)	N/A

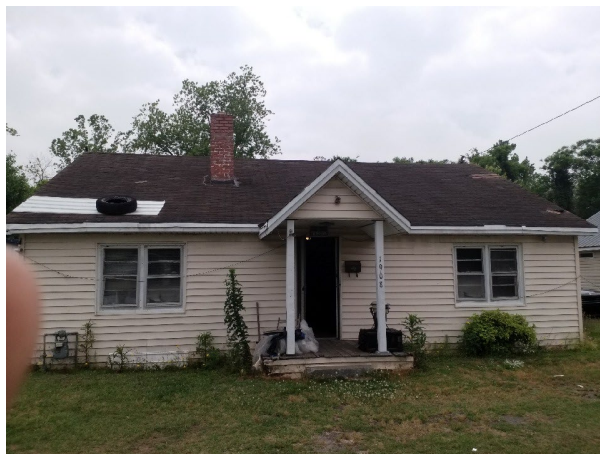
Of the suspected asbestos containing materials collected, none were found by analytical analysis to be regulated asbestos materials (>1% by weight). However, the mastic around the chimney was not accessible at the time of assessment. As such, the mastic is considered to be a presumed asbestos containing material (PACM). This material is summarized below:

Material	Location	Asbestos Amount	Condition	Approximate Quantity
Chimney Mastic	Exterior/Roof	Presumed ACM in Field (PACM)	Good	6 LF

Chimney Mastic

If the above identified material presumed to be containing >1 % asbestos is to be disturbed the owner must then adhere to all local, state and federal regulations regarding the removal and disposal of asbestos-containing materials (National Emission Standards for Hazardous Air Pollutants, Section 40 CFR Part 61.150).

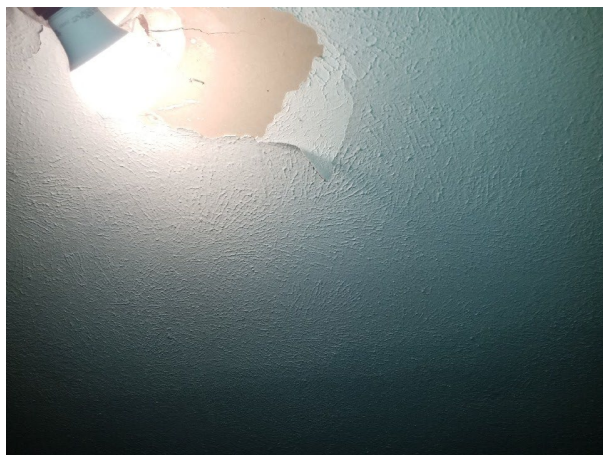
001A, 001 - Textured Ceiling, Bedroom 1, Floorplan

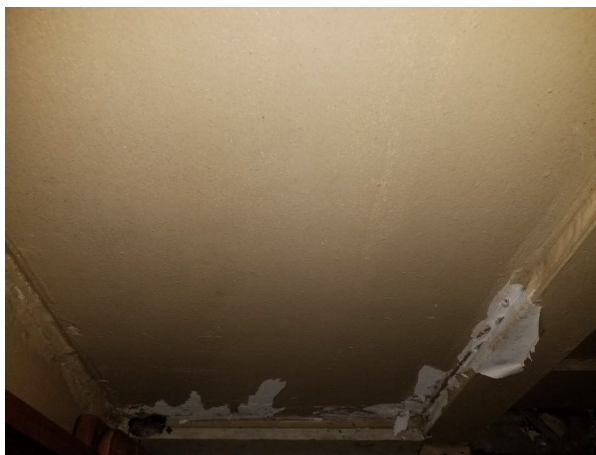
002A, 002 - Gypsum Wallboard Joint Compound, Bedroom 2, Floorplan

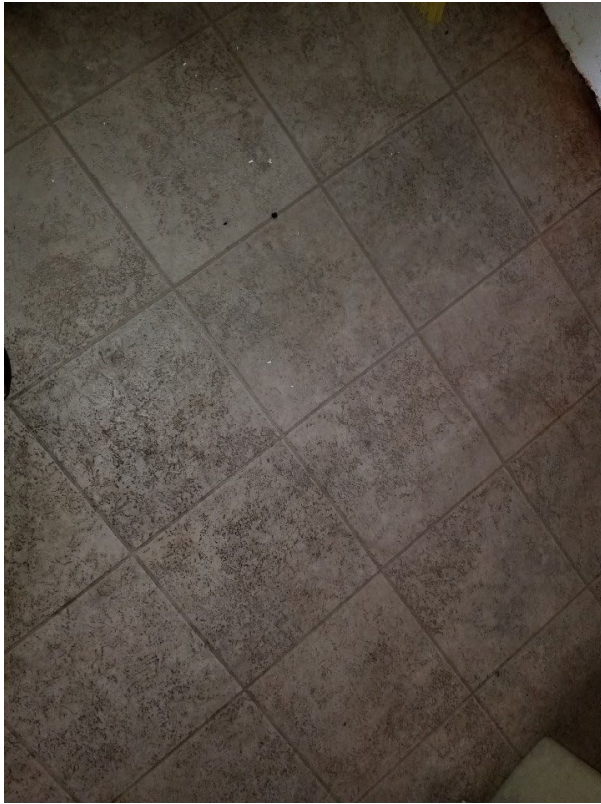
003A, 003 - Floor, Sheet Vinyl Paper Backing, Bathroom, Floorplan

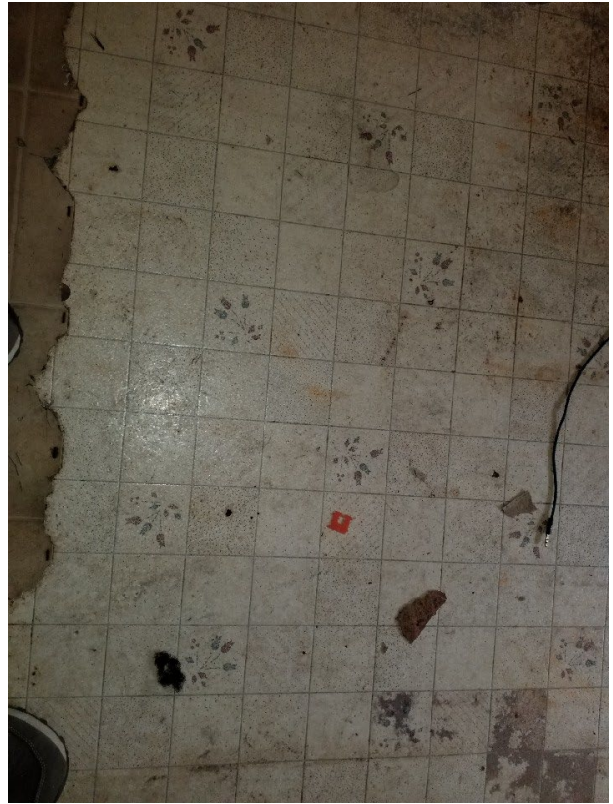
004A, 004 - beige VF, Kitchen, Floorplan

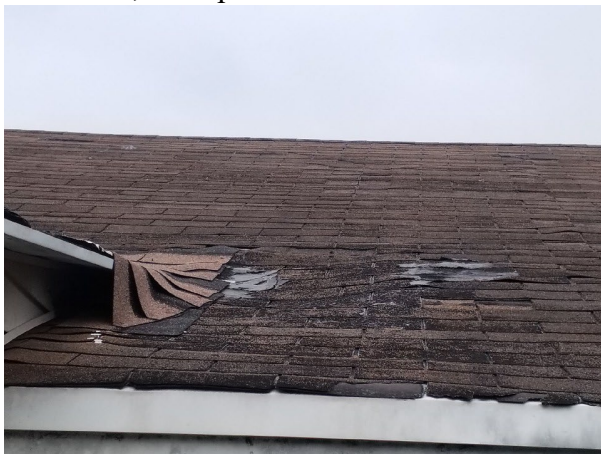
005A, 005 - Roofing, Composite Shingle, Exterior, Floorplan
