**BURNED-AREA REPORT**  
(Reference FSH 2509.13)**PART I - TYPE OF REQUEST****A. Type of Report**

A. Fire Name: Terwilliger

F. Forest: Willamette National Forest

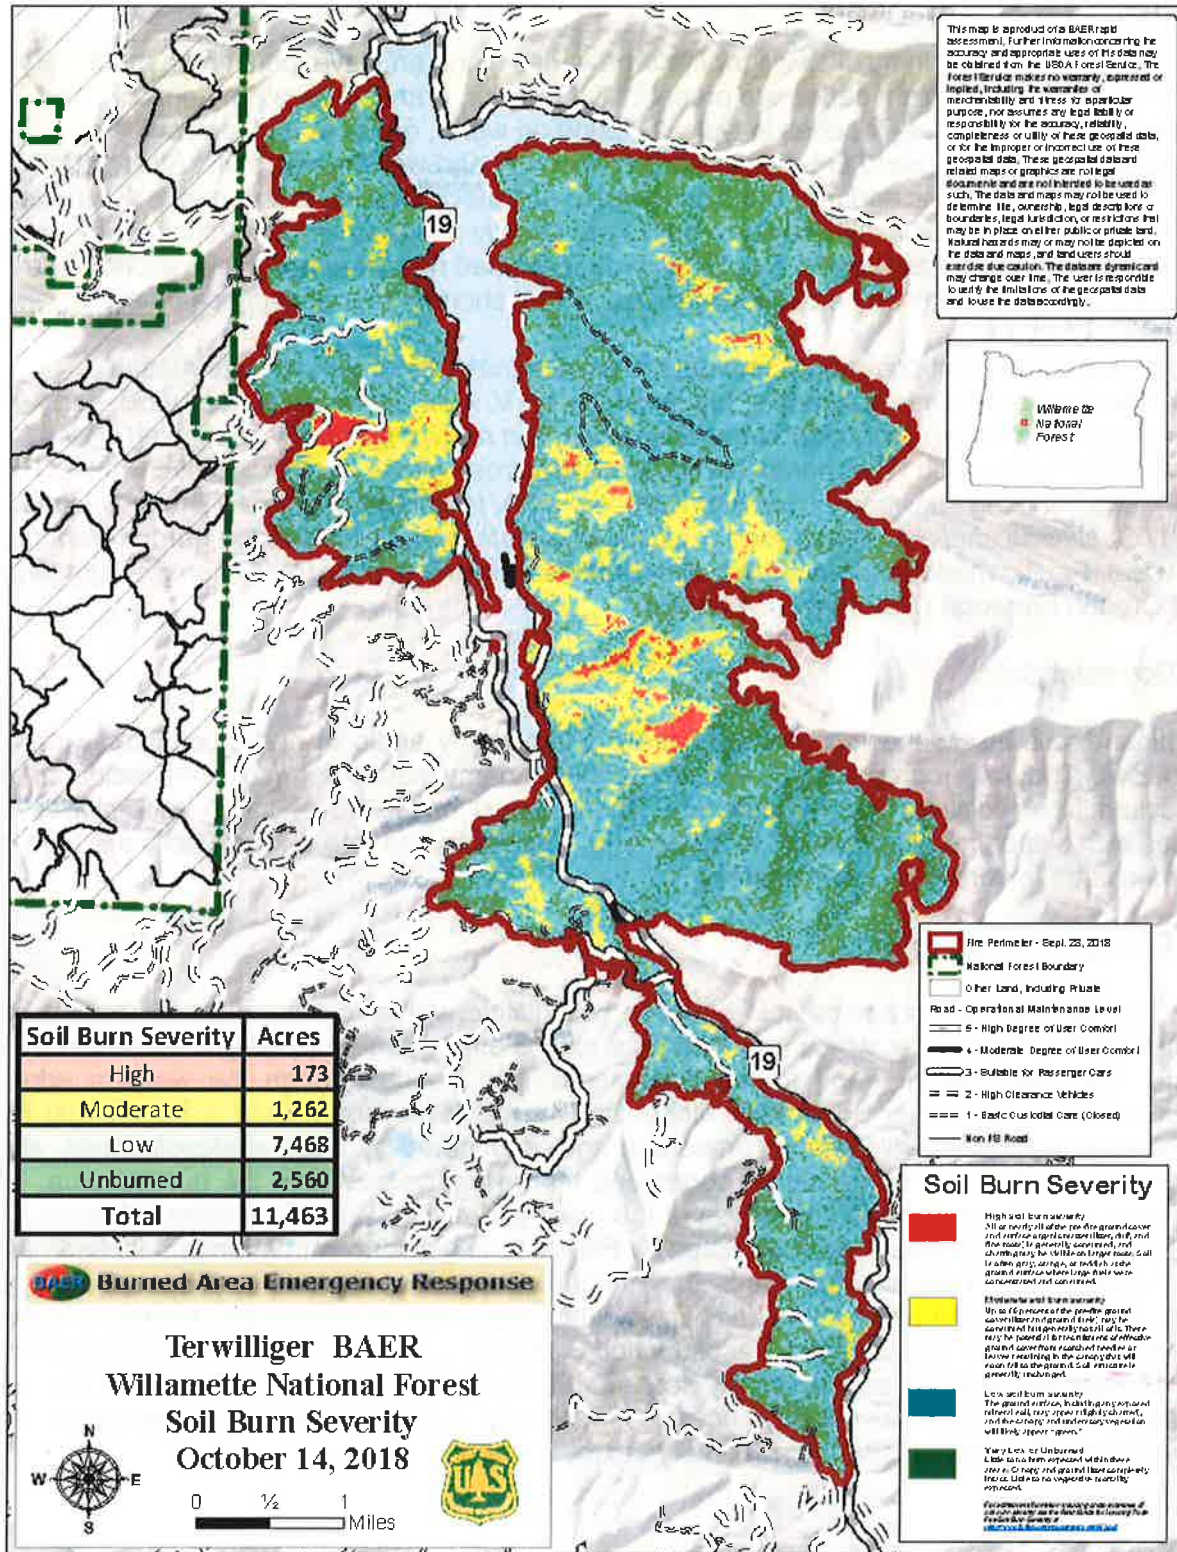
Terwilliger Fire Soil Burn Severity

**Total acres, Soil Burn Severity (SBS) by Subwatershed**

<b>Soil Burn Severity</b>	<b>Acres</b>	<b>Percent of Burned Area</b>
<b>Unburned</b>	2,560	22.3%
<b>Low</b>	7,468	65.1%
<b>Moderate</b>	1,262	11.0%
<b>High</b>	173	1.5%
<b>Total</b>	11,463	100.0%
