BURNED-AREA REPORT
(Reference FSH 2509.13)

- ☐ 1. Initial Request (Best estimate of funds needed to complete eligible stabilization measures)
- ☒ 2. Interim Report **# 1** **Interim report #1 Items are in Bold and in Red Font**
 - ☒ Updating the initial funding request based on more accurate site data or design analysis
 - ☐ Status of accomplishments to date
- ☐ 3. Final Report (Following completion of work)

- A. Fire Name: El Portal Fire B. Fire Number: CA-YNP-0083
- C. State: CA D. County: Mariposa County
- E. Region: 5 F. Forest: Stanislaus National Forest
- G. District: Groveland District H. Fire Incident Job Code: PPH9MF
- I. Date Fire Started: Saturday July 26th, 2014 J. Date Fire Contained: August 6, 2014
- K. Suppression Cost: Approximately \$10 million as of August 8, 2014
- L. Fire Suppression Damages Repaired with Suppression Funds
- Fireline waterbarred: 12.3 miles of Forest Service Dozerline
 - Fireline seeded (miles): None
 - Other (identify): None
- M. Watershed Number: HUC 6 Watersheds: 180400080306 Crane Creek-Merced River; 180400080305 Indian Creek-Merced River; 180400080307 Moss Creek-Merced River
- N. Total Acres Burned: Total 4,729 NFS Acres (3,575) Other Fed

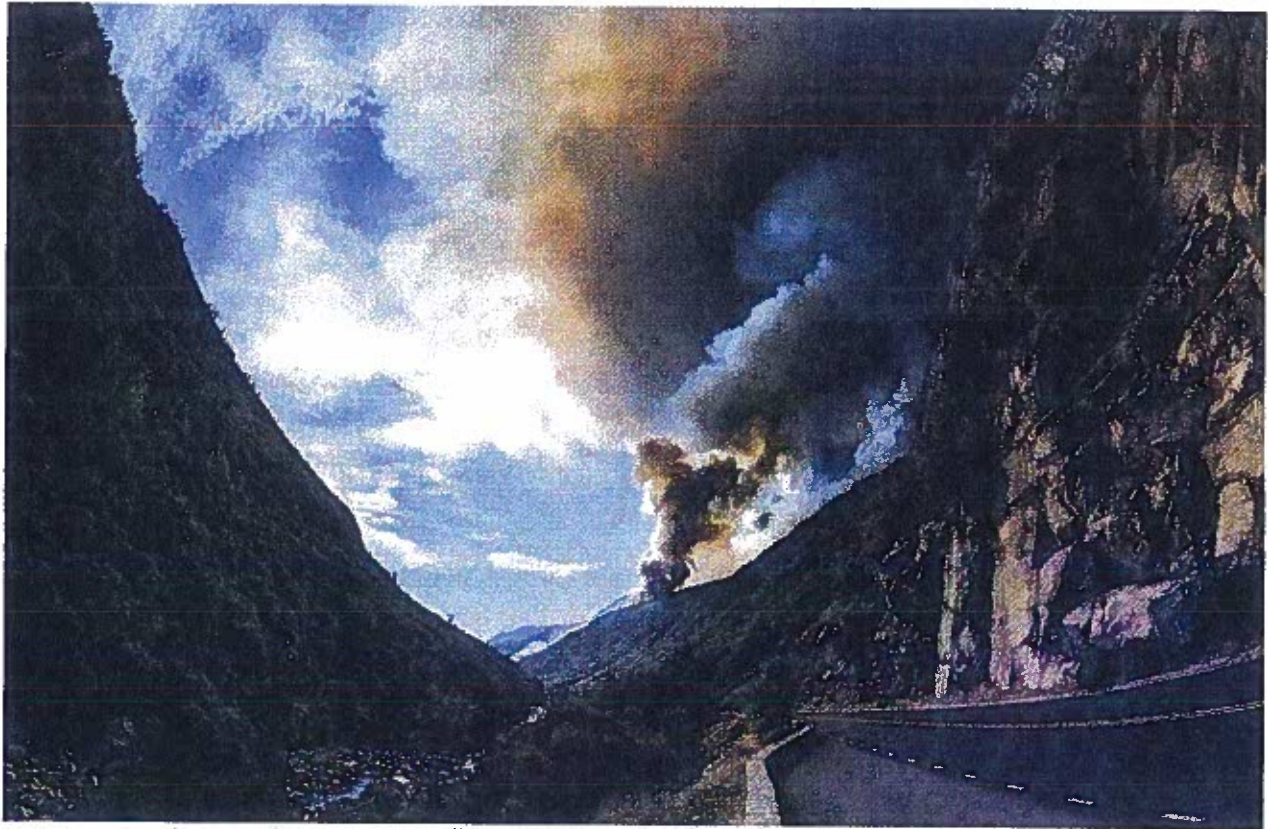
(El Portal Fire, looking down Merced River)
