BURNED-AREA REPORT
(Reference FSH 2509.13)**PART I - TYPE OF REQUEST****A. Type of Report**

- A. Fire Name: Lost Fire B. Fire Number: MVU 017587
C. State: California D. County: San Diego
E. Region: 05 F. Forest: Cleveland NF, 02
G. District: Palomar RD H. Fire Incident Job Code: P5K7P5
I. Date Fire Started: July 22, 2017 J. Date Fire Contained: July 26, 2017
K. Suppression Cost: Still determining final costs (negotiating final fire suppression needs).
L. Fire Suppression Damages Repaired with Suppression Funds
1. Fireline waterbarred (miles): minimal to none due to steep terrain.
2. Fireline seeded (miles): NA
3. Other (identify): damage to chip-seal on road surface.
M. Watershed Number: 180703030102—Canada Agunaga-San Luis Rey River
N. Total Acres Burned: 256 acres
NFS Acres(206 acres) Other Federal () State () Private (50 acres)
O. Vegetation Types: Primarily chaparral with groves of coast live oak. Lesser amounts of chamise and lower montaine mixed chaparral.

Appendix C. Photos of the Fire Burn Area

Lost Fire July 22, 2017

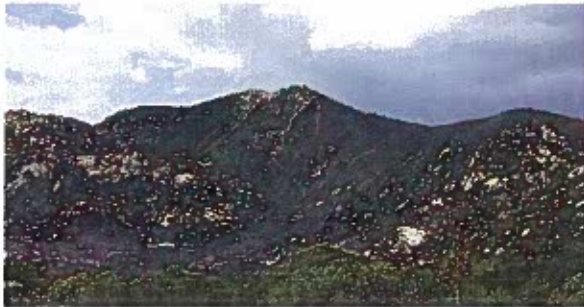
Caption: Overview of fire burn area. Steep headwaters and rocky outcrops. Vegetation comprised of mixed chaparral and oak woodlands.

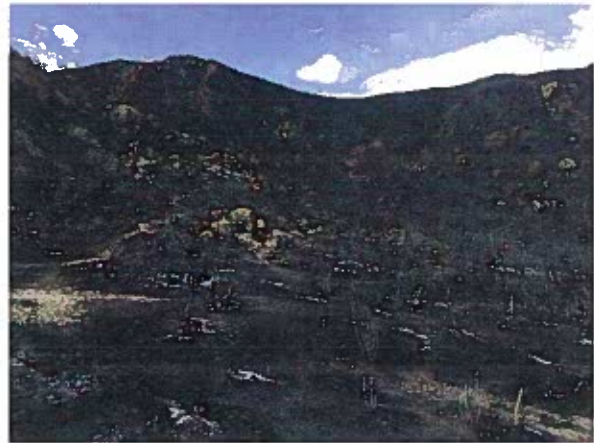
Caption: Overview of fire burn area. Steep slopes with alluvial fan below. Evidence of past rock fall. Steepest slopes are comprised of degraded metamorphic rock. Most rocky outcrops are comprised of granitic rock. Geology type has very low infiltration rates and capacity.

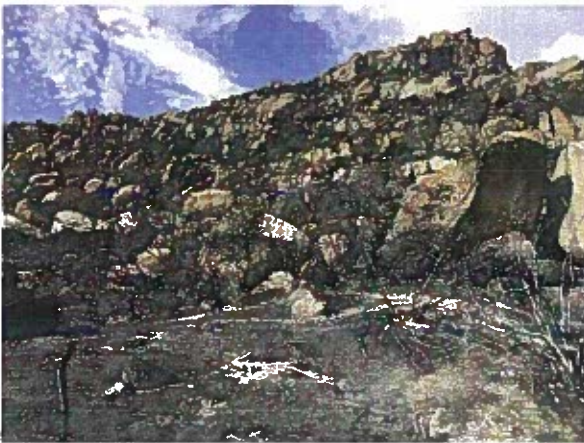
Caption: Rock outcrops may pose as safety hazards to Forest users accessing the burned area. Burn area has rock fall potential.

Closure Enforcement: Forest will be closing the fire burned area with a Forest Order for a period of one year, at the end of which the Forest will reassess the post-fire risk to the public. There is an existing gate to close the campground. Enforcement patrols will be necessary to ensure public safety and reinforce the Order. Signs will be placed at the campground entrance and along the road at potential entrance points. Signs will be placed at the fire perimeter to warn Forest users of post-fire risks along 9S04. Additional signage and a stream gage will be installed at the low-water crossing on 9S04 to protect Forest users who may try to cross the low-water crossing during a runoff event. The stream gage will help Forest users determine whether their vehicle should attempt the crossing or not. Forest Hydrologist will assist in the installation of the gage, tracking of implementation of closure, and reassessment of closure order.

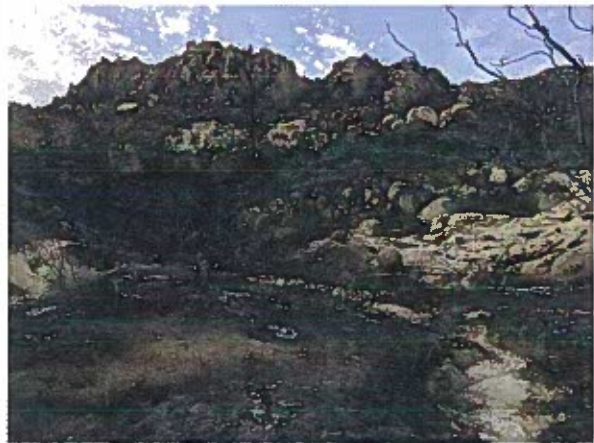
Caption: Unstable slopes have evidence of past failures. There is some distance between rocky slopes and the main road where boulders may accumulate if the slope fails. There is low potential for boulders to fall on the road.

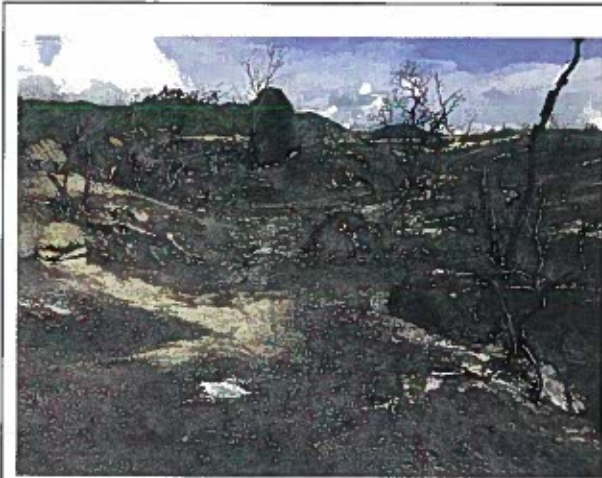
Caption: Stream channels have accumulated sediment that will be easily mobilized during runoff events now that vegetation has been removed. Burned soils were found to have strong water repellency responses despite low to moderate soil burn severity.

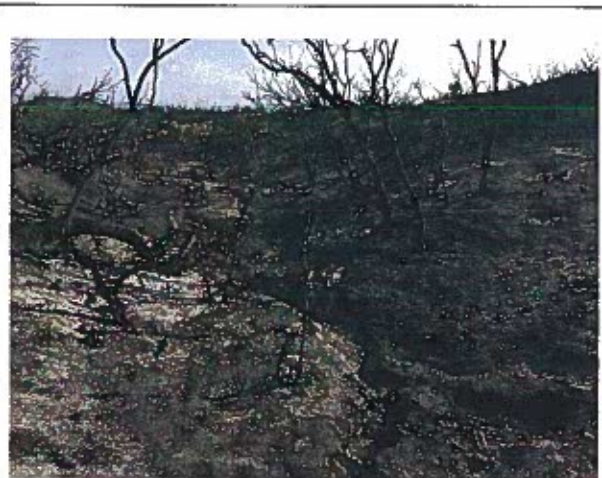
Caption: Sediment accumulation in channels. The channels below the steep slopes are low gradient and have accumulated sediment overtime. With the increase in runoff and lack of vegetation, this sediment will be mobilized. Several low water crossings and the campground are located downstream.

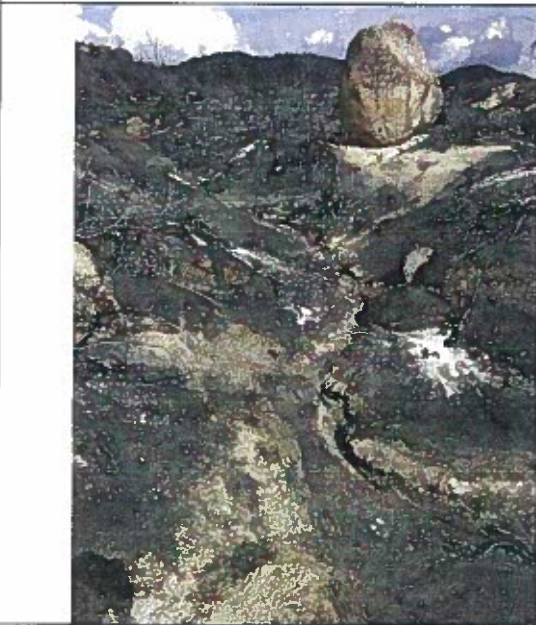
Caption: Although much of the area is considered "igneous rockland" there are sediment laden channels and thin veneers of soil that will be easily mobilized in the post-fire environment.

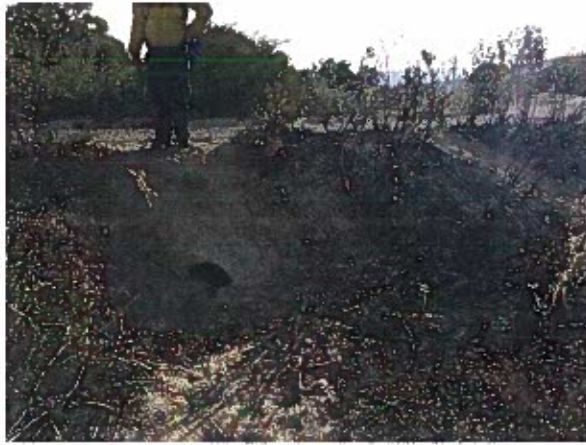
Caption: FS road 9S04 is a level 4 road and the main access road for this part of the forest. The surface is chip-sealed. Photo depicts an undersized culvert that may be at risk of plugging due to post-fire runoff and erosion.

Stormproofing and patrol: In order to protect infrastructure (FS road 9S04, a level 4 road), patrols will need to clean out culverts following storm events. Culverts are expected to plug due to the substantial increase in sediment delivery from the fire. There are two places on the road that have diversion potential should the culverts plug. Although these culverts have not plugged in the past, they are expected to be at risk in the post-fire environment. It is recommended to install two dips to prevent diversion potential and significant loss of the road.

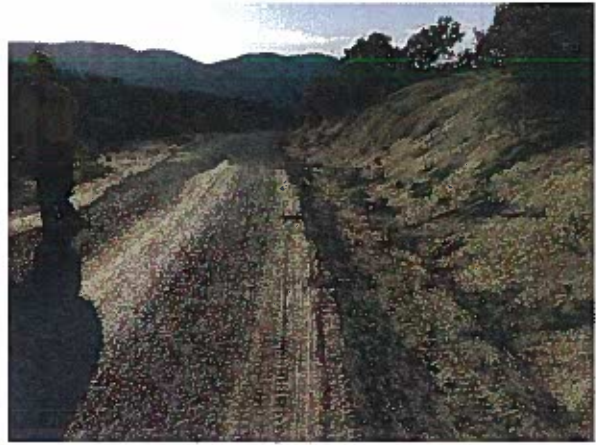
Caption: Diversion potential down road 9S04. Culvert expected to plug due to increased sediment and woody debris from the fire burned area. Installing a dip/drivable waterbar would ensure drainage is not diverted down the road surface.

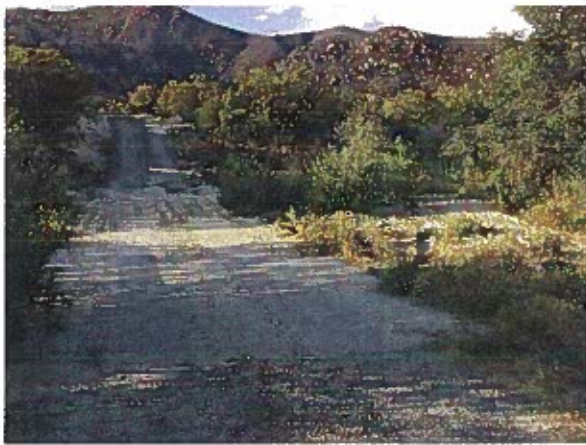
Caption: Low-water crossing is at risk of debris flow, flooding, and increased sediment delivery. The headwaters to this low-water crossing include the unstable metamorphic bedrock. In the pre-fire environment, this crossing has been impassible in high flows. This crossing could be very dangerous to Forest users during runoff events. To assist drivers in determining where or not to cross, installation of a stream gage is recommended.

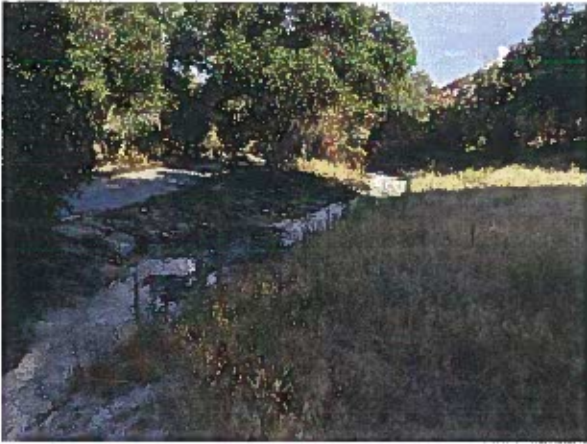
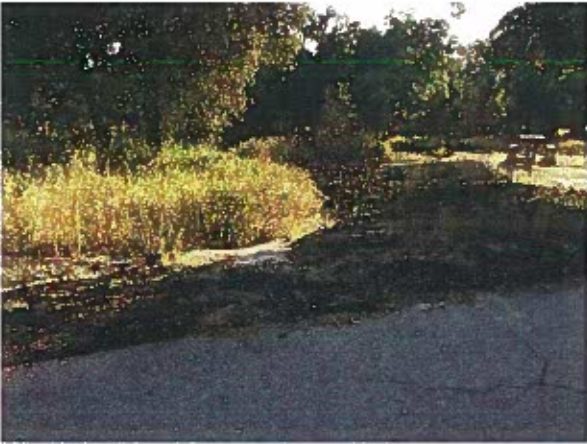
<p>Caption: Photo depicts the flat depositional terrain that the campground is located in. This is downstream/slope from the fire burned area. It is expected this site will be susceptible to increased sedimentation and flooding due to post-fire runoff. There are three low-water crossings on the access road to and within the campsite. The crossings may become impassable during runoff events.</p>	<p>Caption: Campsite is located on the cutbank of a sharp turn in the channel. This area was identified as a site at risk of flooding and sedimentation.</p>
