**BURNED-AREA REPORT**  
(Reference FSH 2509.13)

A. Fire Name: Holcomb Fire

B. Fire Number: CA-BDF-9443

F. Forest: San Bernardino National Forest

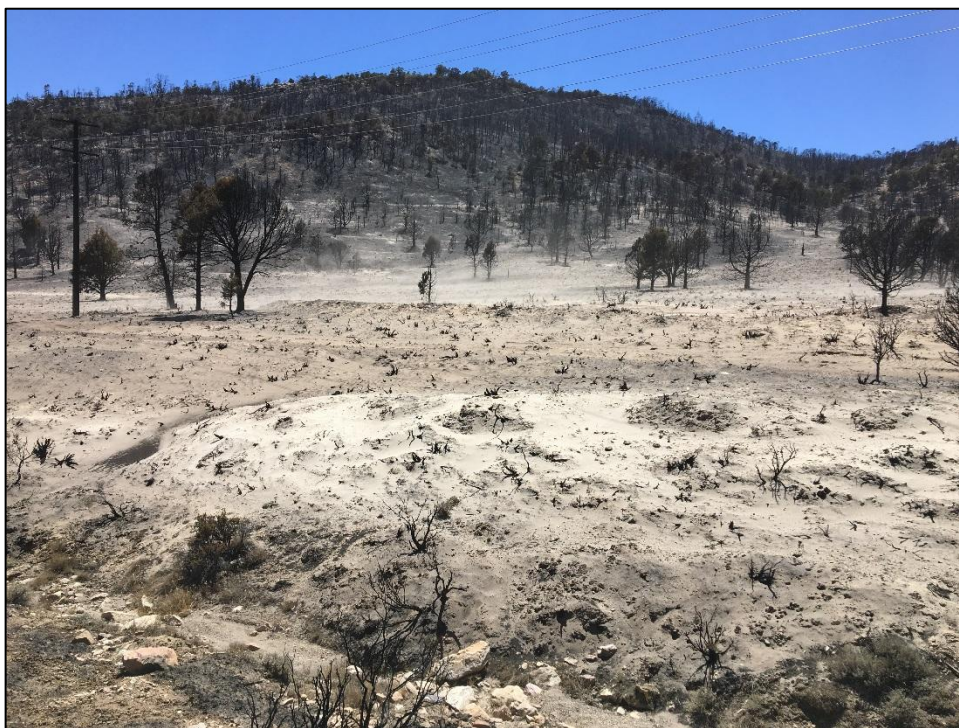
The BAER team determined that the historic mine tailings that are located in the basin of the Doble area (below the historic Baldwin Mine) may be a risk to life and safety. Historic mining operations utilized hazardous chemicals in the mining process and there is some risk that residual chemicals may still exist at the site. Mining in the area began in the 1860's and continued until around the 1950's, creating an accumulation of tailings in the basin of the catchment. Over time, vegetation re-established on the site and in the catchment, stabilizing the tailings and minimizing off-site mobilization and exposure to people. Based on the pre-fire vegetation type and size, this area has not experienced a sizable fire since before the mining operation.

**Figure 1: Photo of depositional area below historic mining facility. Vegetation that was stabilizing the site has been removed by the fire. Area is susceptible to erosion.**

- Area Closure via Forest Order of the Doble area until hazardous waste testing can be completed;
- Road Closure via Forest Order of Jacoby Rd.
- Barrier Treatment for the Area Closure/Doble Area
- Barrier Treatment for the Jacoby Road
- Enforcement of the closures

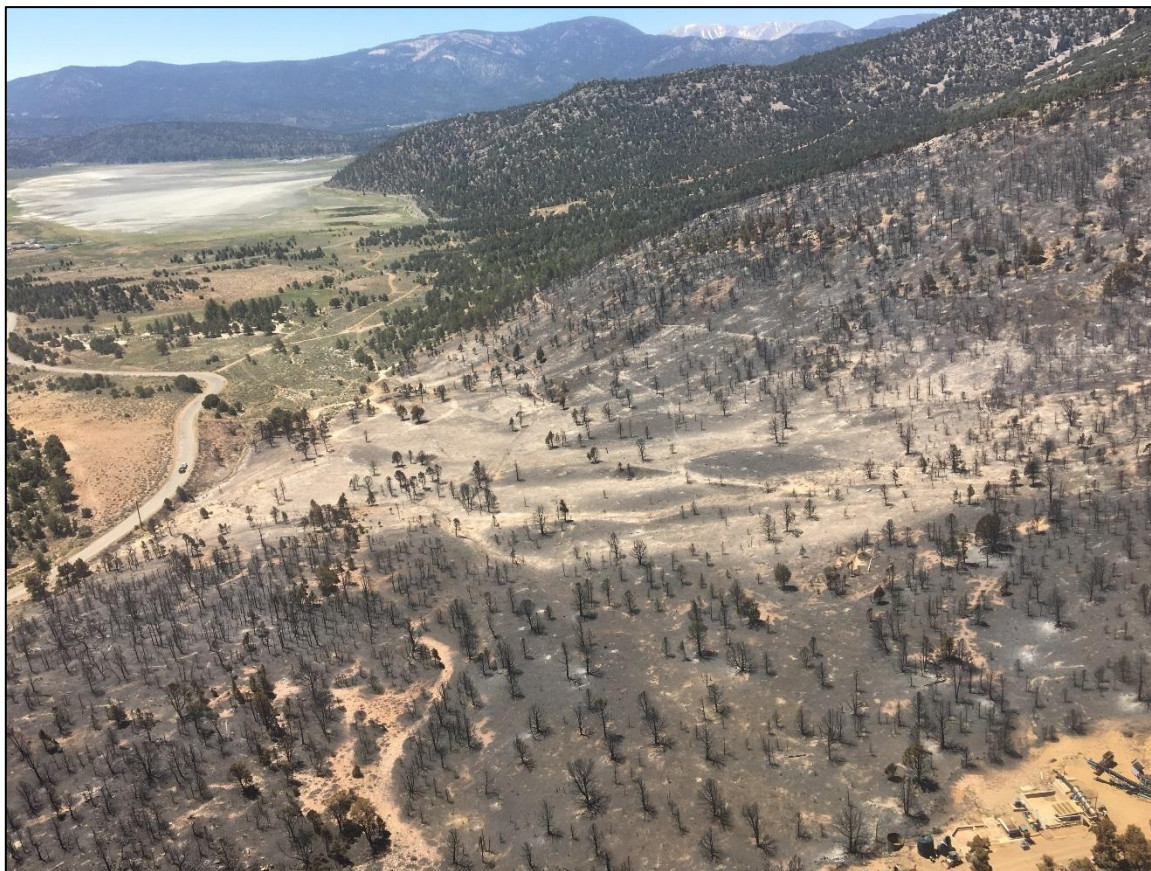
**Figure 2. Overview of the Doble closure area. Site is easily accessed by OHV now that vegetation has been removed. Photo depicts depositional area of mine tailings as well as downstream beneficial uses. Montane meadow and Baldwin Lake Ecological Reserve are visible downstream.**

Once the SBNF has received the hazardous waste test results, the closure area would be re-evaluated to determine the next course of action. Should the above Doble Area Closure be lifted (upon testing results), the BAER team recommends evaluating the area for a separate hard closure of Doble area within and just downstream of the fire boundary for resource protection. The hard closure is recommended because in addition to risks from OHV, other off-trail travel can trample and damage vegetation. See OHV prevention treatment.

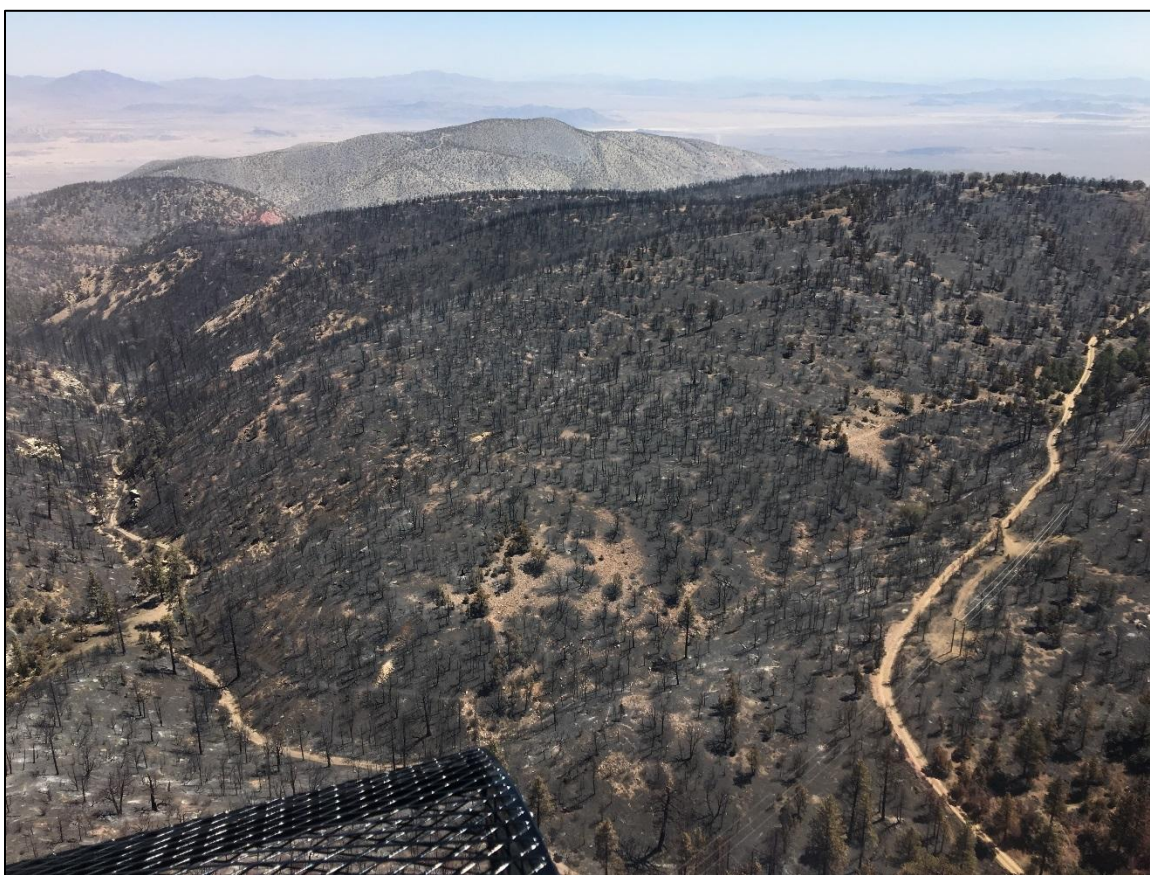
The post-fire hydraulic response, burn severity, topography, and geology of Jacoby canyon pose a threat to use of the road. Runoff and erosion of slopes are expected to increase significantly during post-fire storm events potentially resulting in flooding of the canyon and road, and erosion and burial of the road. Additionally, there are a substantial amount of standing fire-killed trees that pose a risk to forest users in the canyon. Based on the potential for debris flows, flooding, rock falls, hazard trees, etc. in Jacoby Canyon, the BAER team identified serious risk to the public and employees.

**Figure 3: Photo depicts location of Jacoby Road. Road in at the bottom of a narrow canyon with steep slopes. Hazard trees, rock fall, debris flows and flooding would be hazards to road users over the next year or so until recovery.**

<b>Protection/Safety Treatment #2: Jacoby Road Closure Treatment – Gates, Signs, Enforcement, Water Quality Protection</b>				
<b>Item</b>	<b>Unit</b>	<b>Unit Cost</b>	<b># of Units</b>	<b>Cost</b>
Angeles Gates on Forest Service roads – gates and installation: <ul style="list-style-type: none"> <li>• 3N61 – 2 gates</li> </ul>	Gate and installation	\$9,000	2	\$18,000
Warning Signs (flooding, rock fall, burned area, etc.) – initial signing and replacement signs	Each	\$200	4	\$800
Patrols to enforce closure (see <i>Monitoring</i> )				
GS-9 Archaeologist Clearance/Monitoring	Day	\$300	2	\$600
GS-11 Botanist Monitoring	Day	\$400	1	\$400
Travel (mileage) 2 vehicles	Miles	\$1.00	100	\$100
<b>Total Cost</b>				<b>\$19,900</b>

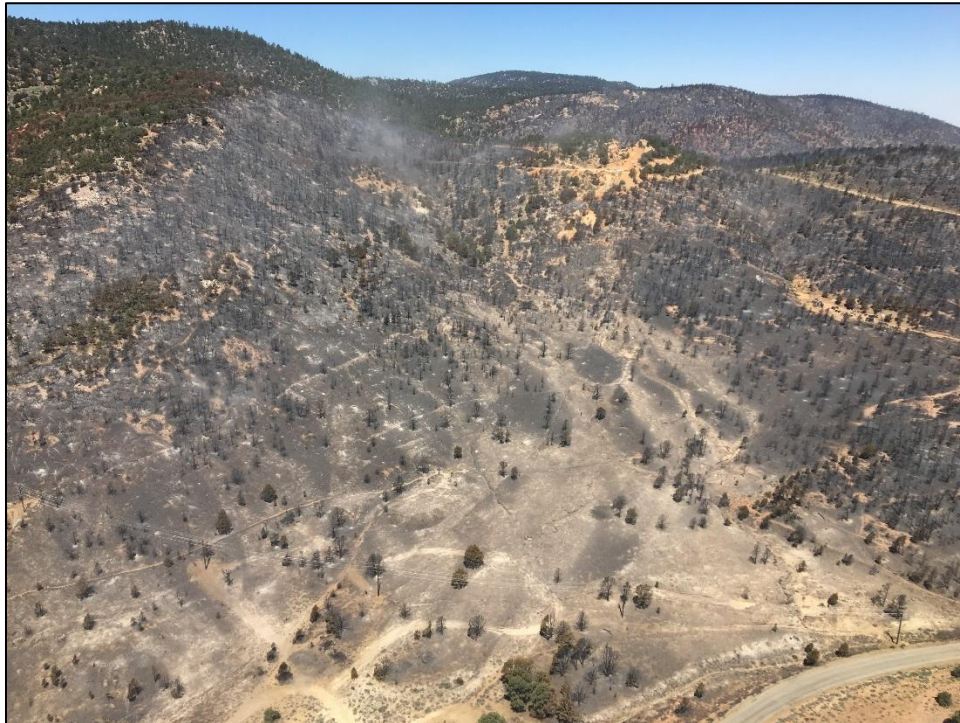
Increased unauthorized off-road vehicle access to the Holcomb Fire burned area is expected to occur due to removal of vegetation, easy terrain, and “inviting” curiosities (e.g., historic mining operations, etc.) that are now visible from a main Forest Service road. Unauthorized vehicle use is a major threat to the burned watersheds and resources within the burned area.

**Figure 4: Photo depicts main road adjacent to fire burn area. Area is now susceptible to OHV incursion as vegetative barriers have been removed and site has increased visibility.**
