**Date of Report: 6/24/20****BURNED-AREA REPORT****PART I - TYPE OF REQUEST****A. Type of Report**

**PART II - BURNED-AREA DESCRIPTION****A. Fire Name:** Tadpole Fire**B. Fire Number:** NM-GNF-000232**C. State:** New Mexico**D. County:** Grant**E. Region:** Region 3**F. Forest:** Gila NF**G. District:** Silver City**H. Fire Incident Job Code:** P3M51D (0306)**I. Date Fire Started:** 06/06/2020**J. Date Fire Contained:** estimated July 18th**K. Suppression Cost:** 3,139,000**L. Fire Suppression Damages Repaired with Suppression Funds (estimates):**

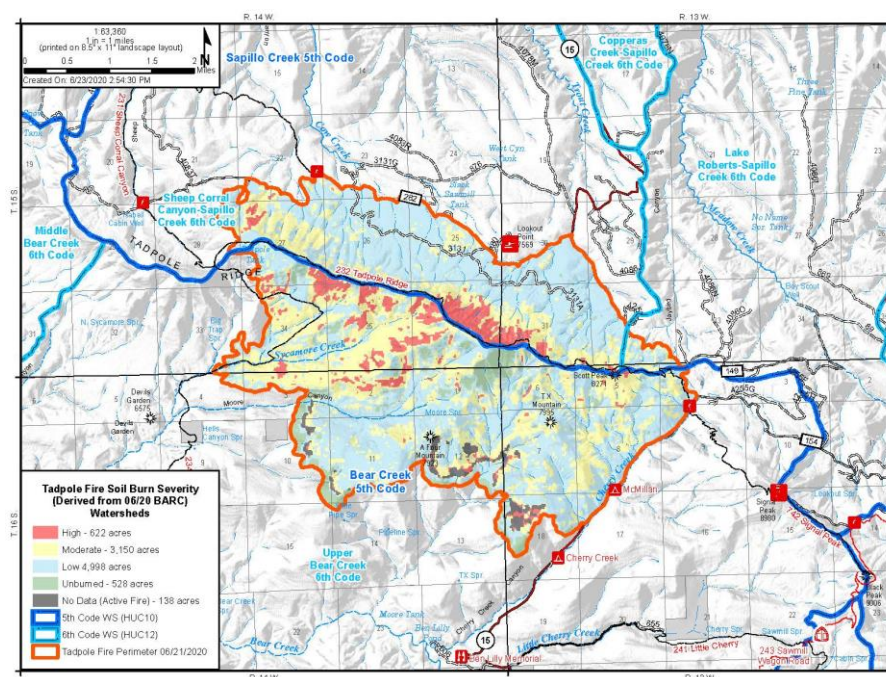
### Soil Burn Severity Map of Tadpole Fire

Soil Burn Severity	NFS	Other Federal (List Agency)	State	Private	Total	% within the Fire Perimeter
Unburned	528					
Low	4,998					
Moderate	3,150					
High	622					
No Data	138					
Total	9,435
