**BURNED-AREA REPORT**  
(Reference FSH 2509.13)**PART I - TYPE OF REQUEST**

**PART II - BURNED-AREA DESCRIPTION**A. Fire Name: RyanB. Fire Number: AZ-CNF-114C. State: ArizonaD. County: Santa Cruz and CochiseE. Region: 3F. Forest: CoronadoG. District: Sierra VistaH. Date Fire Started: April 29, 2002I. Date Fire Contained: May 2, 2002J. Suppression Cost: \$1,408,088

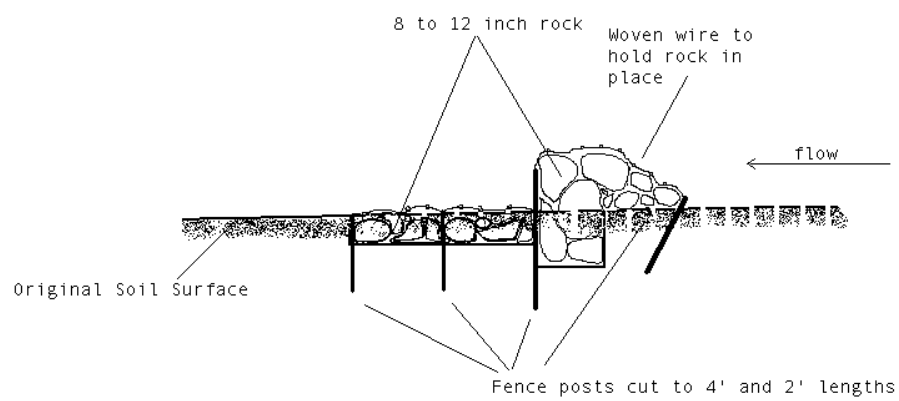
Roads and Trail Treatments: Culverts will be protected from increased sediment by structures up stream from each culvert. Each structure will consist of a small dam approximately 20 feet wide and 1.5 feet tall. The following diagram illustrates a typical design.
