BERRY FIRE BURNED-AREA REPORT
(Reference FSH 2509.13)

PART I - TYPE OF REQUEST

- A. Fire Name: Berry Fire B. Fire Number: CA-SHU-009460
C. State: CA D. County: Shasta
E. Region: 5 F. Forest: Shasta-Trinity
G. District: SMMU(Shasta-T) H. Fire Incident Job Code: P5?
I. Date Fire Started: 9/12/2017 J. Date Fire Contained: 9/22/2017
K. Suppression Cost: \$1 million
L. Fire Suppression Damages Repaired with Suppression Funds
1. Fireline waterbarred (miles): 12
2. Fireline seeded (miles): 0
3. Other (identify): 0
M. Watershed Number (HUC 6): Tunnel Reservoir (18020030904)

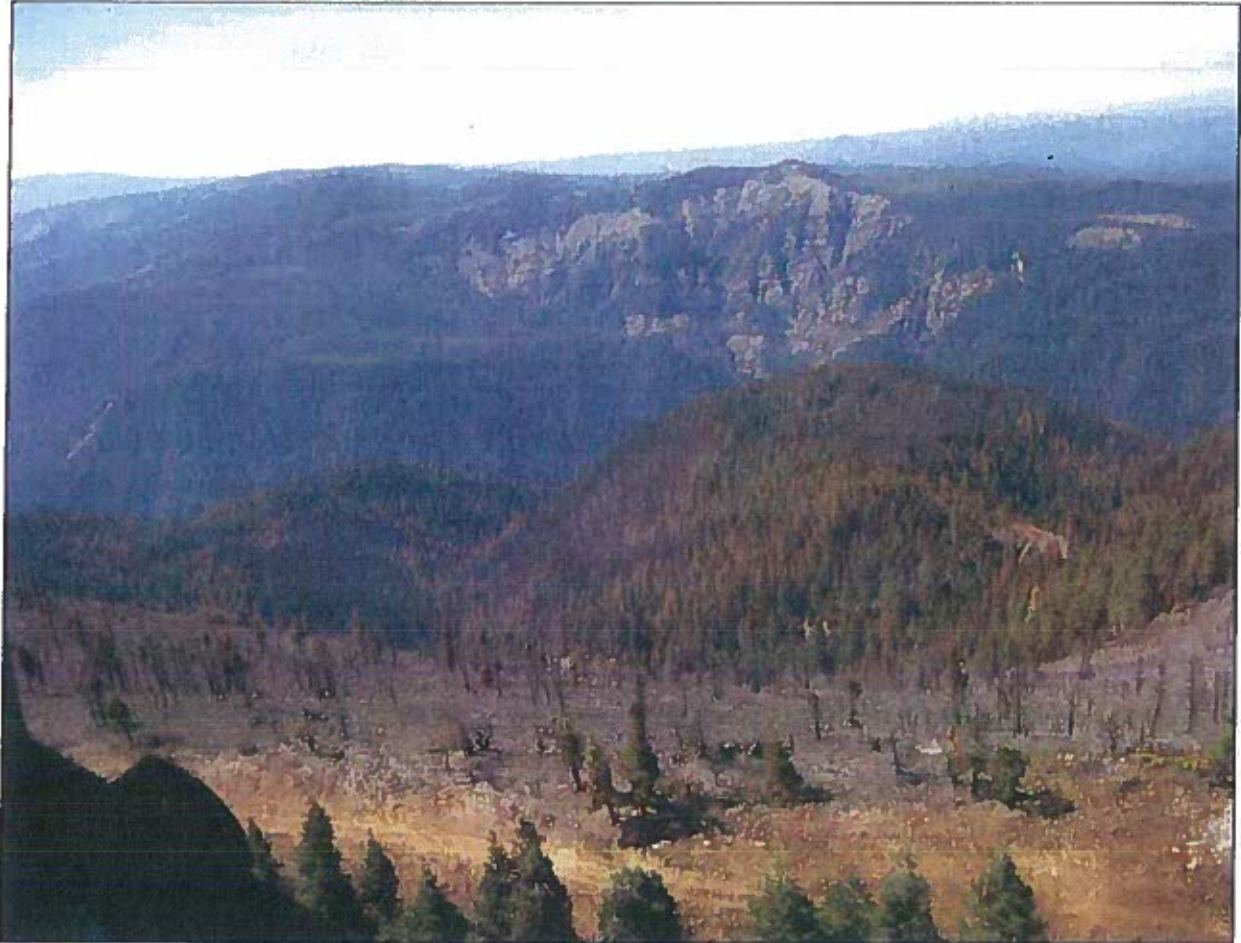
Berry Fire looking into Blackberry Ck. watershed above the Pit River near Pit 4 dam

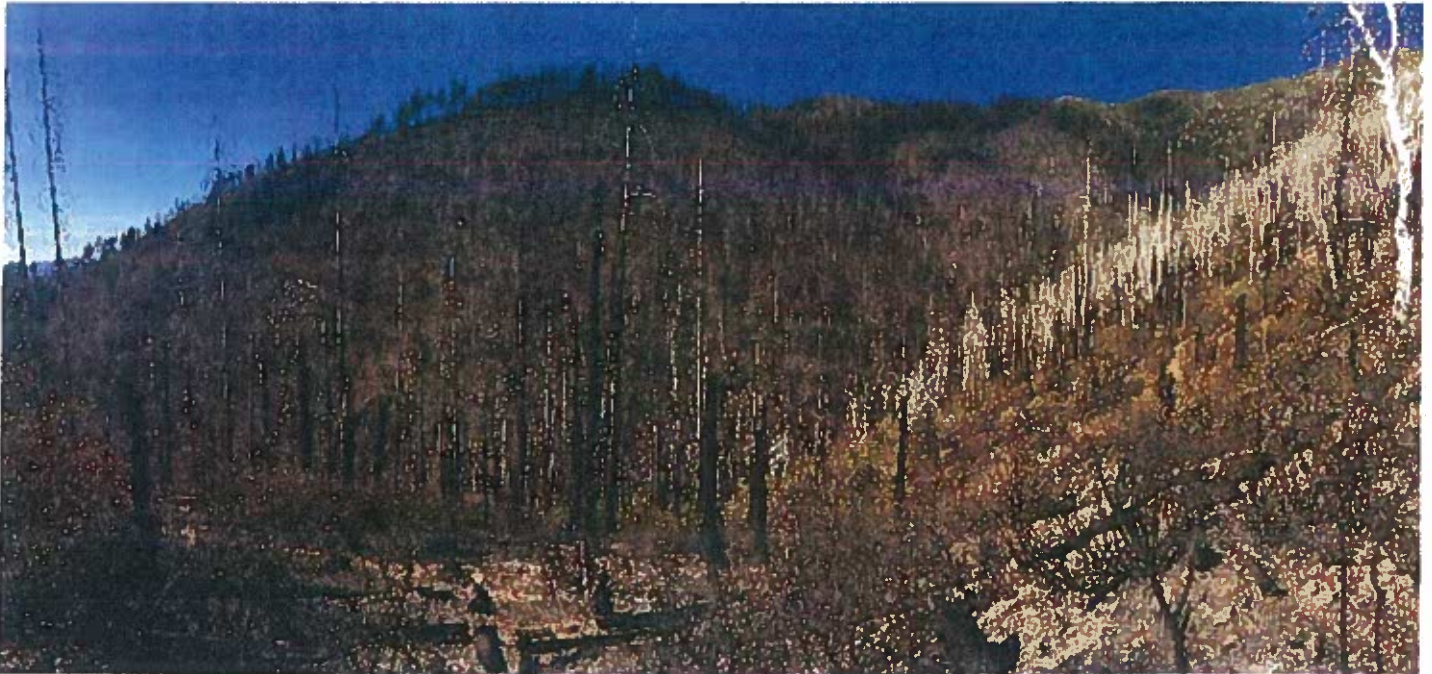
General trends ridges burned moderate to high severity fed by aligned up-canyon Pit River winds. Midslope areas burned moderate and lower areas along creeks and the Pit River had low burn severity.

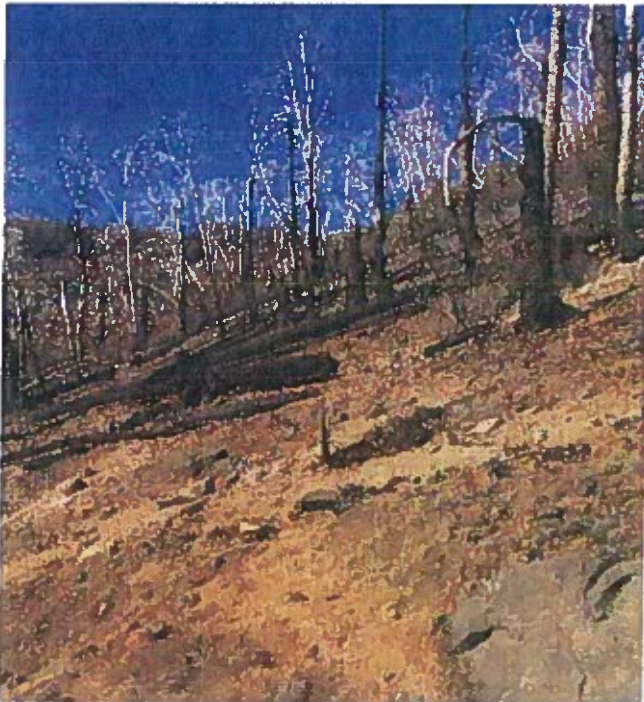
In high soil burn severity areas on mixed brush/white fir in Blackberry Creek had deep water repellency, deep soil char, and repellency to 4 inches.

Blackberry Ck in hot burned vgs/ repellant soils

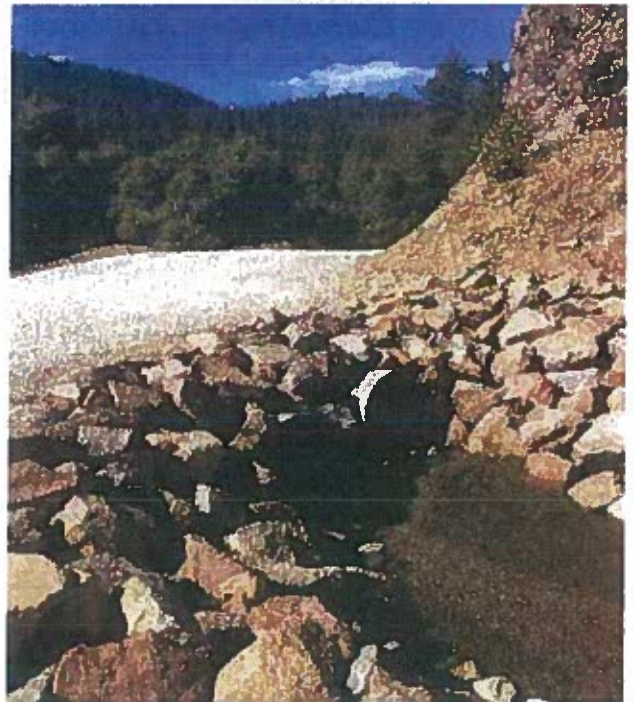
Fox Ck – Crossing above Pit 3 road 36N28Y

- a. Main Pit River road (FS 50) at several crossing (Fox and Blackberry creeks) could experience loss of water control.

| Click red icons for notes. | | NFS Lands | | | | Money Spent \$ | Other Lands | | | Money Left Total \$ | |
|---|---|---|---|---|---|---|---|---|---|---|---|
| Previously approved | | | | | | | Comments: Fox Creek in 2016 had a large debris flow, this fire will likely cause more in Fox and Balckberry Creeks. | | | | |

Posting of areas burned will alert the public to potential dangers of falling trees and rolling rocks on roads that will not be closed. Road and trail closure signs will protect the public from areas where road (FS50 and 36N28Y) will be susceptible to dry ravel, downed trees, debris flows, and landslides.
